TECHNICAL INSTRUCTIONS

SAFETY RECALL H0A

FRONT PASSENGER AIRBAG INFLATOR MODULE

CERTAIN 2009 MODEL YEAR COROLLA

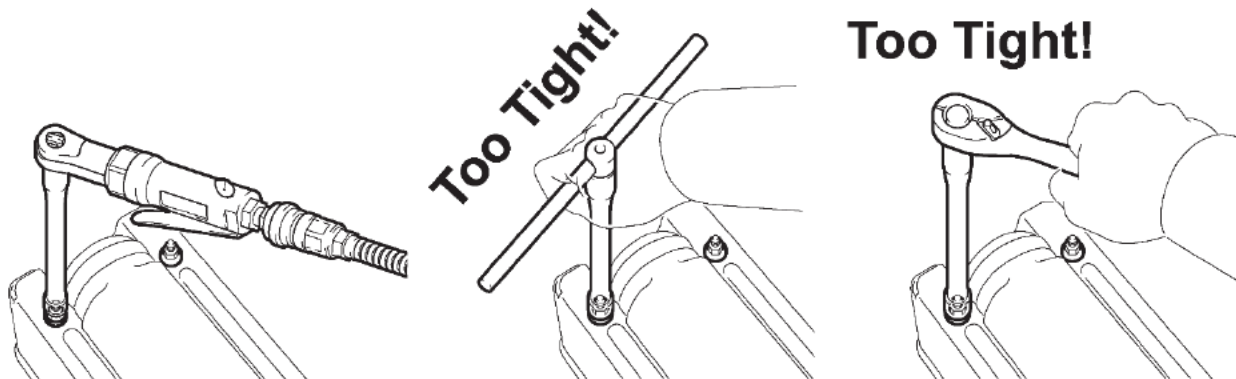
- a) Tighten the 5 nuts evenly in several increments in the sequence shown. Use a socket driver or torque wrench to tighten the nuts.

Torque: 35in. lbf (3.9N·m)

- There will be some resistance when tightening the nuts because they are self-locking, confirm the nuts are tightened correctly.
- **DO NOT** use a power tool, T-handle, or ratchet when tightening the nuts to avoid over torquing and deforming the studs.
- You may need to turn the airbag to the left or right with in the mounting bracket to access the center nut.

These tools cause overtightening !
