# IMPORTANT UPDATE

## TECHNICAL INSTRUCTIONS FOR SAFETY RECALL G0P/G0R/H0A FRONT PASSENGER AIRBAG INFLATOR MODULE CERTAIN 2007 – 2012 MY YARIS SEDAN AND 2006 – 2011 MY YARIS HATCHBACK

**Updated 07-17-18**

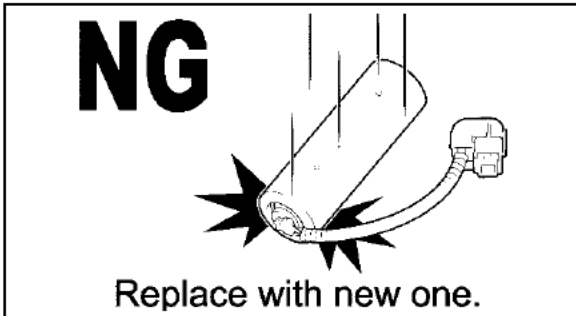
#### 3. HANDLE THE AIRBAG CAREFULLY

- If an inflator is dropped, replace it with a **NEW** inflator.

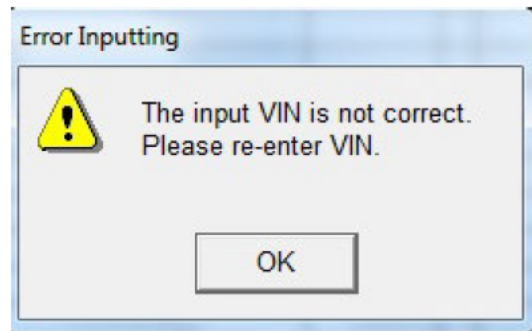
**NOTE: If the VIN was not entered in ALL CAPS when Techstream was launched, an error will be displayed and there will be a prompt to reenter the VIN**

- Enter the vehicle mileage and repair order information, then click the 'report' button.

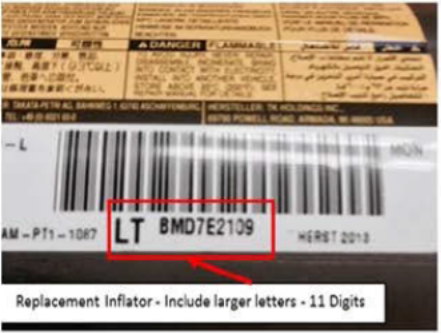
**Replacement Inflator**

The first two characters of the **Replacement Inflator Serial code** will be either 'LT' or 'LR'.

Replacement Inflator - Include larger letters - 11 Digits

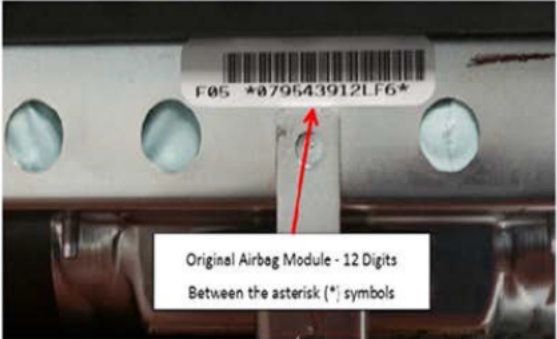
Original Airbag Module - 12 Digits  
Between the asterisk (\*) symbols

Record Airbag Serial Number

The Airbag module Assembly serial number is a 12 digit code. It can be found along with a bar code on opening the Airbag assembly unit. To manually enter these details into the application, the technician has to identify the 12 digit code between two Asterisks (\*) inside the Airbag assembly unit. The first seven characters of this 12 digit code are numbers and the 10<sup>th</sup> digit is either 'K' or 'L' always.
