TECHNICAL INSTRUCTIONS FOR SAFETY RECALL G0R FRONT PASSENGER AIRBAG INFLATOR MODULE CERTAIN 2010 MY 4RUNNER

UPDATE 9-5-18

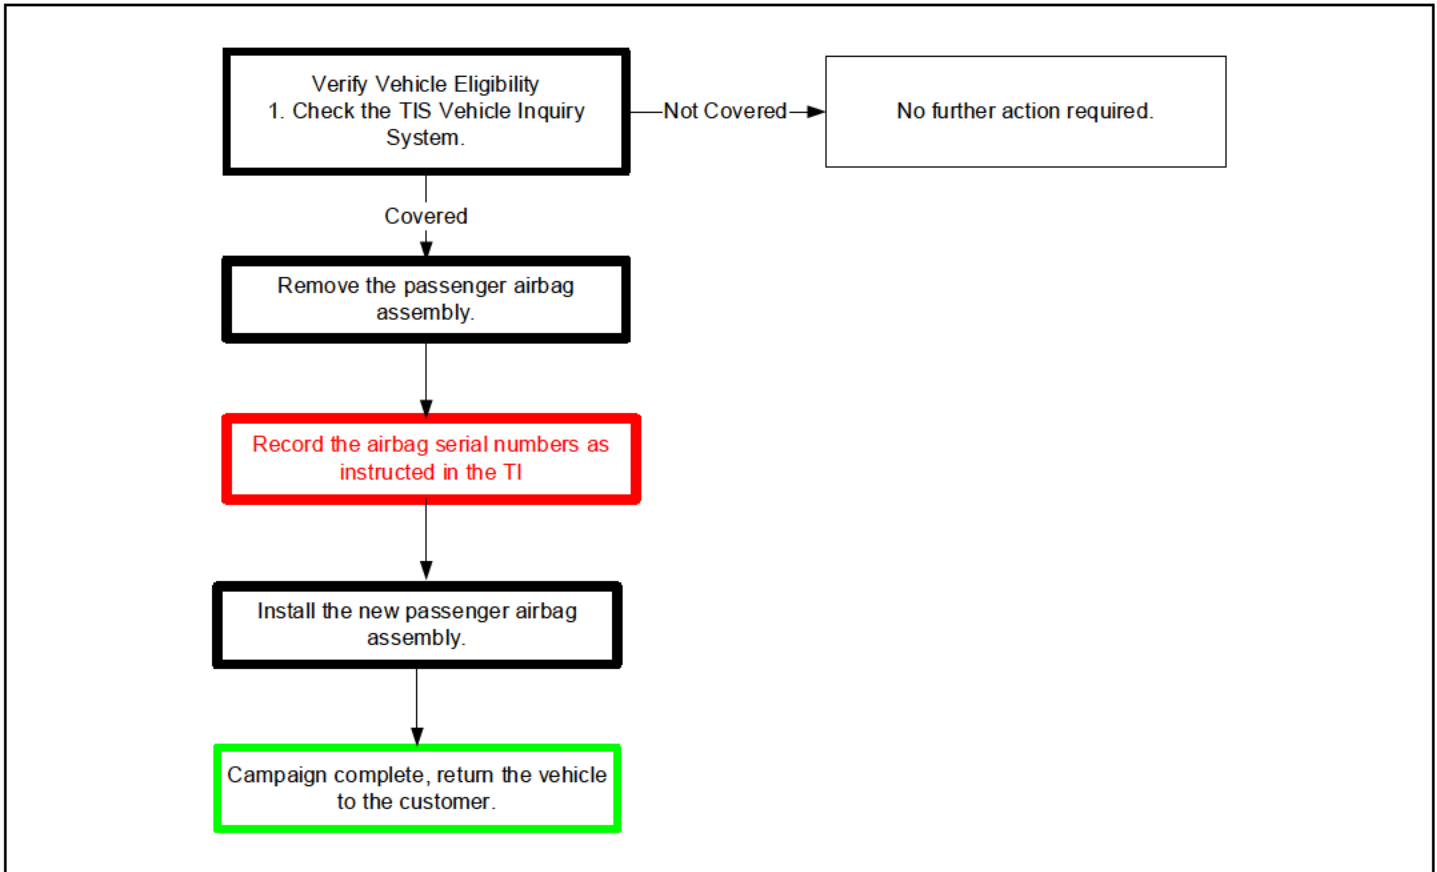
I. OPERATION FLOW CHART

The flow chart is for reference only. **DO NOT** use it in place of the full technical instructions. Follow **ALL** steps as outlined in the full technical instructions to confirm the campaign is completed correctly.

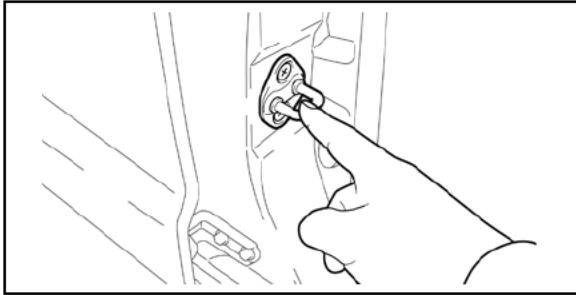
1. ELIMINATE STATIC ELECTRICITY

- a) Before starting work and periodically while working on the vehicle, touch a metallic part of the vehicle to discharge static electricity in the body.

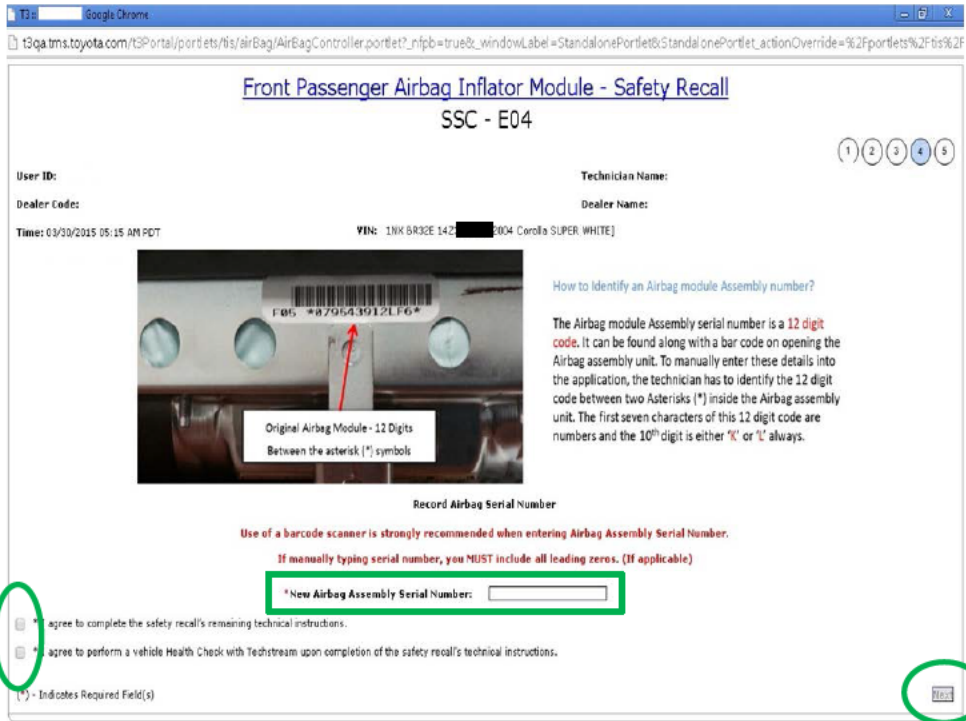
e) Scan the NEW airbag barcode in the Serial Number Recording Application.

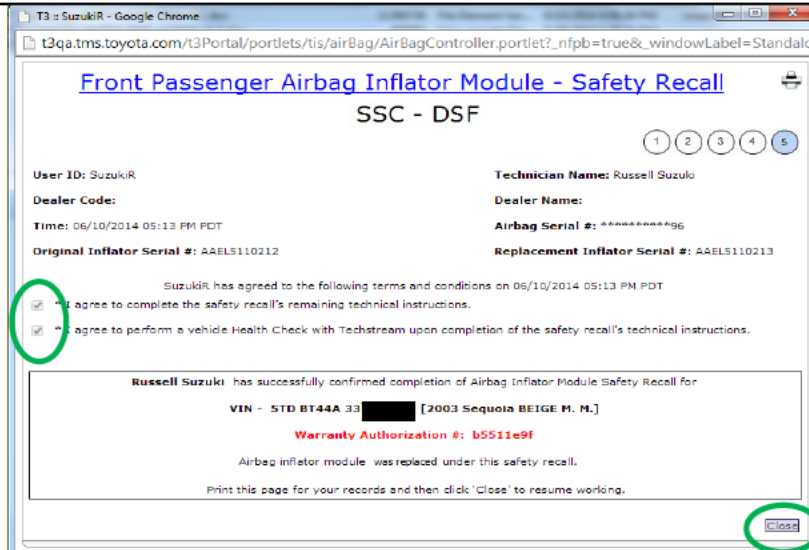
- f) Verify the statements and click the two boxes.
- g) Click next.

- h) Confirm agreement by checking the two boxes.
- i) Record the Warranty Authorization # to be included in the warranty claim.
- j) Place the old module in the parts box and take it immediately to the parts department.

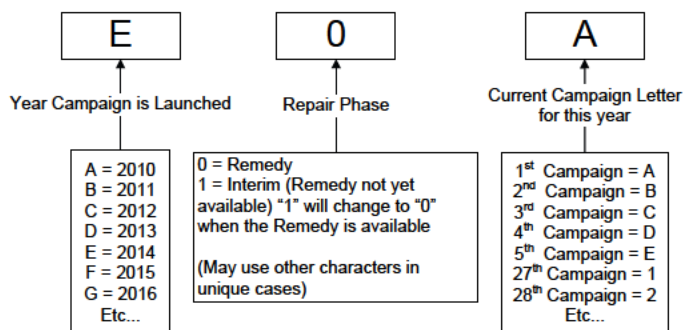
A. CAMPAIGN DESIGNATION DECODER

Examples:

A0D = Launched in 2010, Remedy Phase, 4th Campaign Launched in 2010

B1E = Launched in 2011, Interim Phase, 5th Campaign Launched in 2011

C1C = Launched in 2012, Interim Phase, 3rd Campaign Launched in 2012
