TECHNICAL INSTRUCTIONS
FOR
SAFETY RECALL J0A/J0B/J0C
FRONT PASSENGER AIRBAG INFLATOR MODULE
CERTAIN 2010-2016 MY 4Runner

II. BACKGROUND

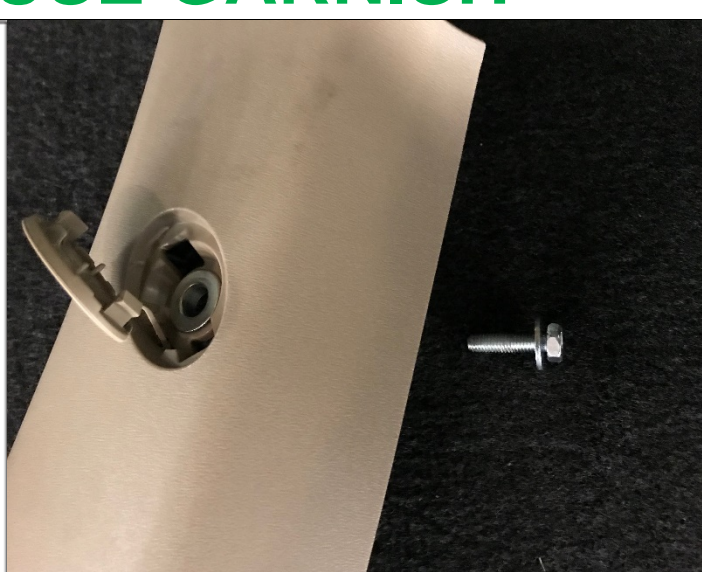
Only 2010 to Certain 2013 Model Year 4Runner vehicles require A-Pillar garnish replacement. If you have a 2013 – 2016 4Runner that contains an A- Pillar garnish that is bolted in at the top, the A-Pillar **DOES NOT require replacement. See photos below for reference.

REPLACE	RE-USE GARNISH	
<p>Part manufactured before August 2013:</p>

<p style="color: red; text-align: center;">● FRONT PILLAR GARNISH LH</p>	<p>Part manufactured after August 2013:</p> <p>No. 1 FRONT PILLAR GARNISH COVER LH</p>

<p style="text-align: center;">FRONT PILLAR GARNISH LH</p>

NOTE: The left front A-Pillar garnish needs to be replaced on vehicles manufactured prior to August 2013. Only one garnish is required per vehicle depending upon color code. The kit contains the garnish and the non-reusable clip. (see parts information)

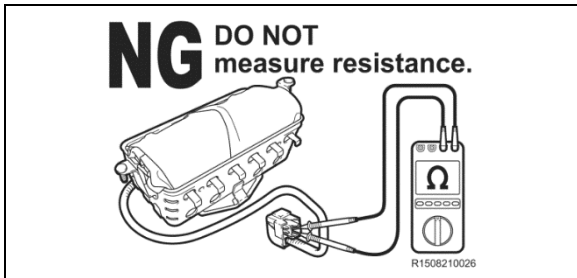
2. DO NOT MEASURE RESISTANCE

- a) **DO NOT** measure resistance of airbag components, this may cause accidental activation.
