TECHNICAL INSTRUCTIONS FOR SAFETY RECALL J0A, J0B, J0C FRONT PASSENGER AIRBAG “MODULE” REPLACEMENT ONLY

CERTAIN 2003 – 2004 MODEL YEAR MATRIX

THE REPAIR FOR 2005 – 2008 MATRIX IS NOT AVAILABLE AT THIS TIME

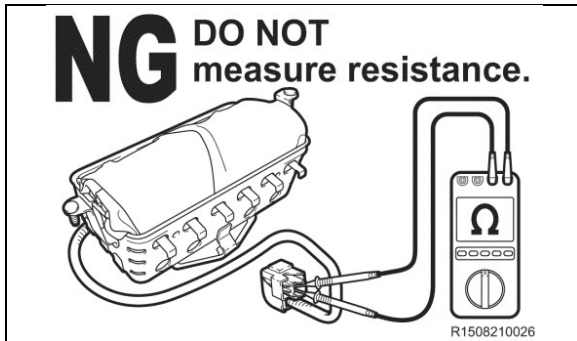
2. DO NOT MEASURE RESISTANCE

- a) **DO NOT** measure resistance of airbag components, this may cause accidental activation.

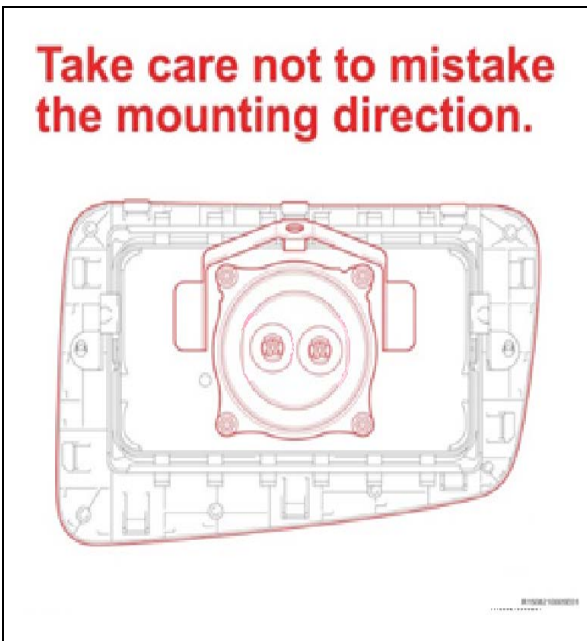
4. INSTALL THE NEW MODULE

Take care not to mistake the mounting direction.

- a) Carefully slide the new module into the airbag door.

NOTE: Mounting direction.
