TECHNICAL INSTRUCTIONS

SAFETY RECALL J0A/J0B/J0C

FRONT PASSENGER AIRBAG INFLATOR MODULE

CERTAIN 2007 – 2012 MY YARIS SEDAN AND 2007 – 2011 MY YARIS HATCHBACK

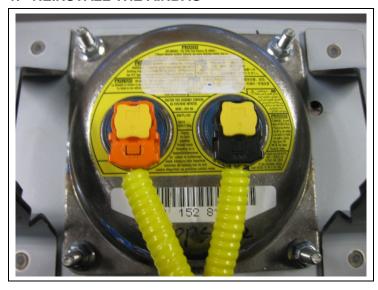
a) Install the new harness onto the new airbag by plugging in the two connectors.

NOTE: Match the color of the harness connector to that of the airbag. Ensure that the connectors are fully seated.

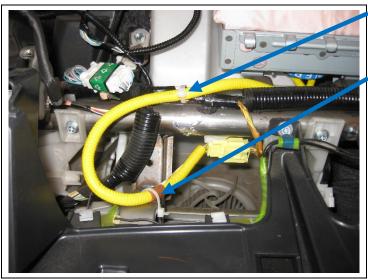
After the upper instrument panel has been installed secure the new airbag adaptor harness as shown.

Secure the adaptor harness to the dash harness.

Also secure the adaptor harness to the dash bracket.

NOTE: The upper instrument panel has been removed for clarity. Both areas can be accessed through the opening for the glove box door and/or the opening for the combination meter.

Check that the adaptor harness has the proper clearances and is not strained.
