**TECHNICAL INSTRUCTIONS**  
**FOR**  
**SAFETY RECALL J0A/J0B/J0C**  
**FRONT PASSENGER AIRBAG INFLATOR MODULE**  
**CERTAIN 2003 – 2008 MODEL YEAR COROLLA**

**UPDATE 11/15/2019**

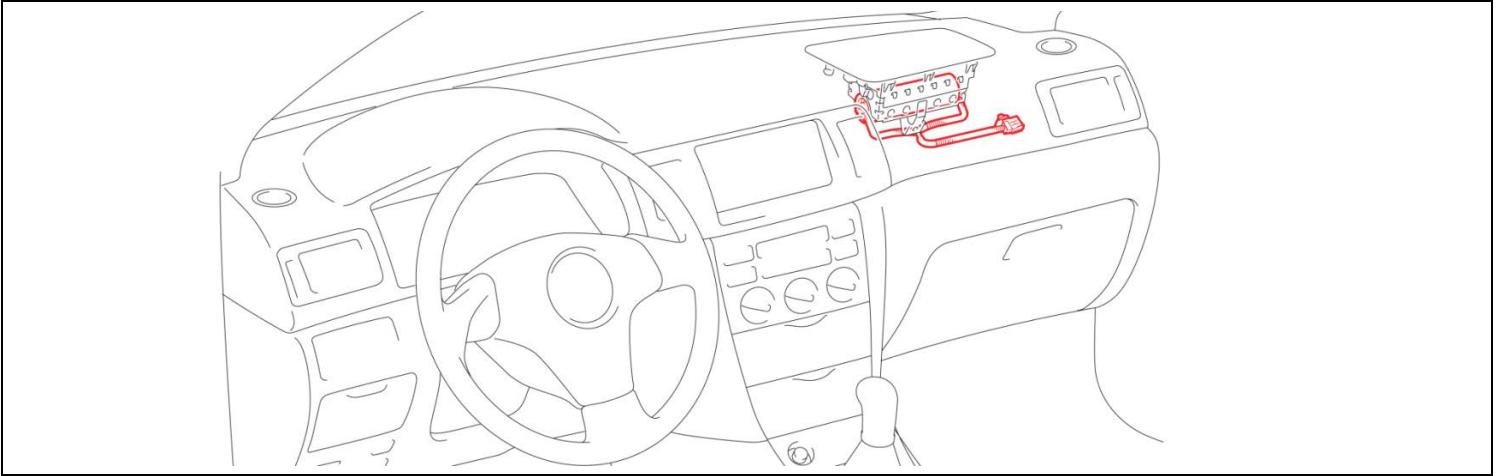
The subject vehicles are equipped with front passenger airbag inflators produced by Takata. The propellant in these inflators may degrade after prolonged exposure to high absolute humidity and fluctuating high temperatures. Degraded propellant can cause the inflator to explode during airbag deployment. In the event of an inflator explosion, metal fragments could pass through the airbag cushion material, striking the vehicle occupants, and result in serious injury or death.

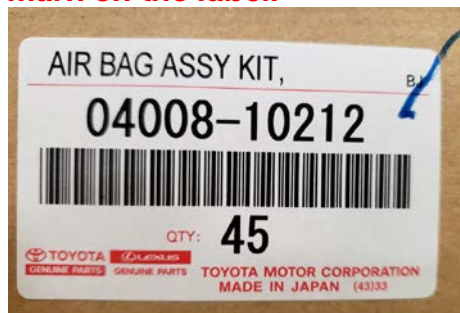
Make sure the parts box has a check mark as seen in the image above

***Dealers should discontinue the installation of the parts listed below for the recalls, customer pay repairs AND over-the-counter sales (if applicable) unless they have a mark on the label.***

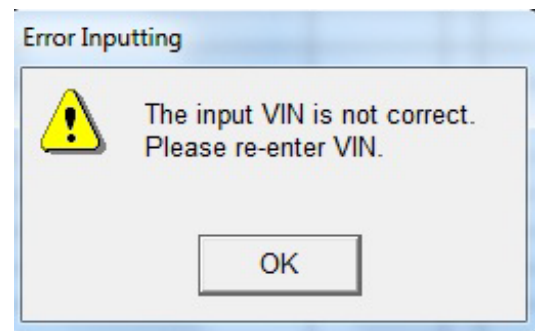
**NOTE: If the VIN was not entered in ALL CAPS when Techstream was launched, an error will be displayed and there will be a prompt to reenter the VIN**

- Enter the vehicle mileage and repair order information, then click the 'report' button.

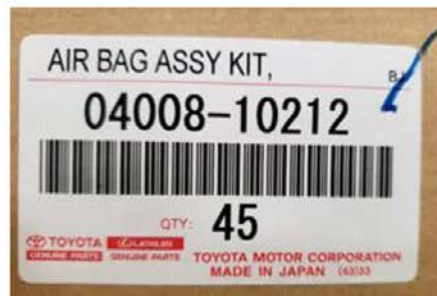
VIN:  
2T1BR32E73C [REDACTED]

Serial Number:  
123456789123
