TECHNICAL INSTRUCTIONS FOR SAFETY RECALL G0P/G0R/H0A FRONT PASSENGER AIRBAG INFLATOR MODULE CERTAIN 2007 – 2012 MY YARIS SEDAN AND 2006 – 2011 MY YARIS HATCHBACK

Updated 01-14-2021

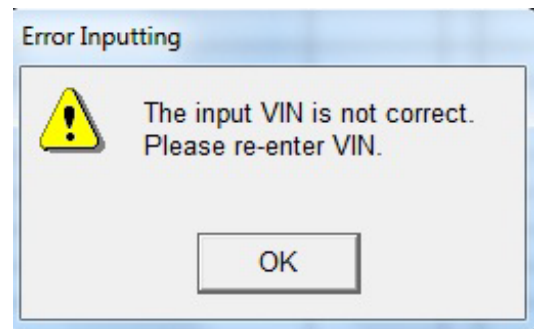
NOTE: If the VIN was not entered in ALL CAPS when Techstream was launched, an error will be displayed and there will be a prompt to reenter the VIN

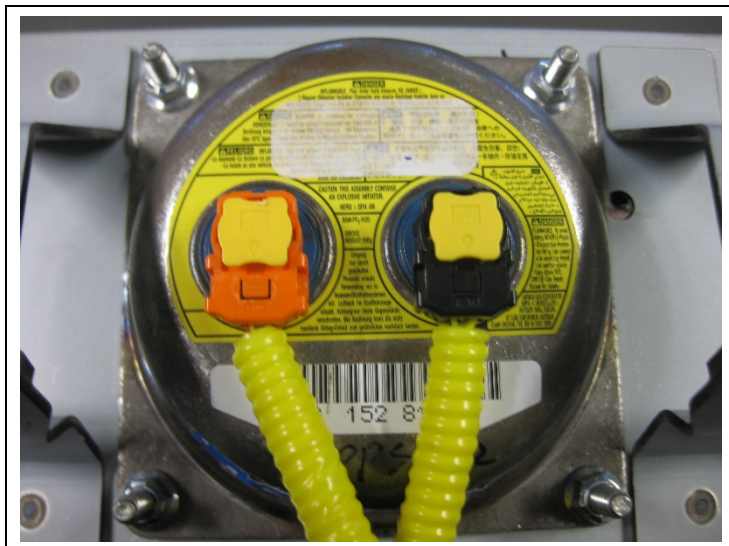
- a) Install the new harness onto the new airbag by plugging in the two connectors.

NOTE: Match the color of the harness connector to that of the airbag. Ensure that the connectors are fully seated.

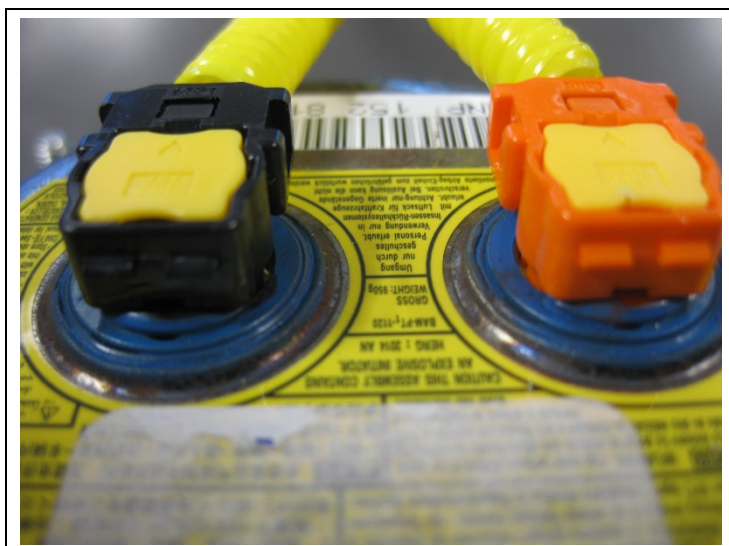
- b) Engage the secondary locks.
