TECHNICAL INSTRUCTIONS
FOR
SAFETY RECALL J0A/J0B/J0C
FRONT PASSENGER AIRBAG INFLATOR
CERTAIN 2008 – 2012 MY SCION xB

Updated 01-14-2021

The subject vehicles are equipped with front passenger airbag inflators produced by Takata. According to Takata, the propellant in these inflators may degrade after prolonged exposure to high absolute humidity and fluctuating high temperatures. Degraded propellant can cause inflator rupture during airbag deployment. In the event of an inflator rupture, metal fragments could pass through the airbag cushion material, striking the vehicle occupants, and result in serious injury or death.

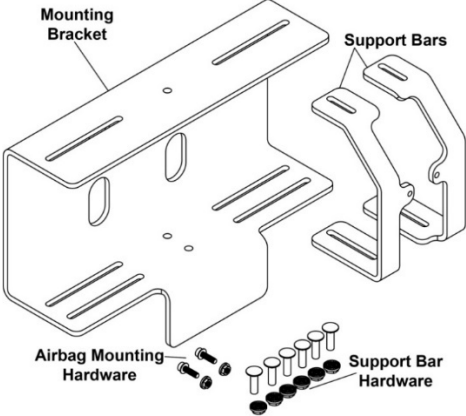
Airbag Mounting Bracket & hardware (Provided to the dealership at the launch of SSC DLC)	1

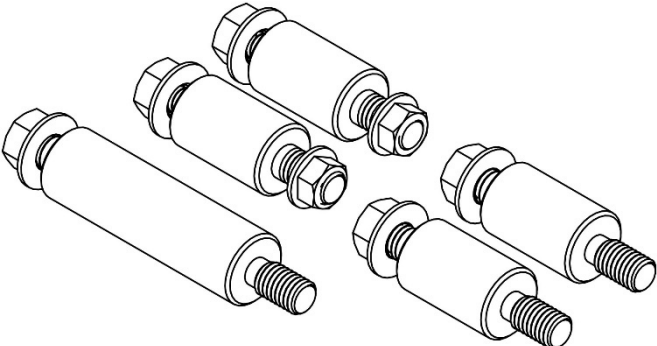
579943 Adaptor set*	1

*The adaptor set was sent to dealers prior to the start of this campaign.

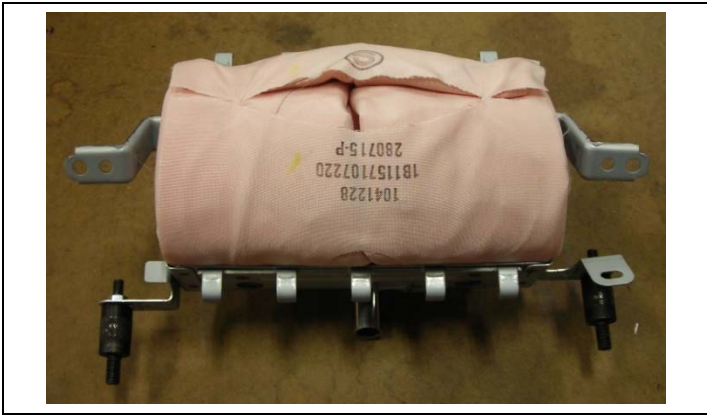
a) Mount the adaptors (579943-3R3) to the airbag as shown.

NOTE: The 6mm stud mounts to the airbag.

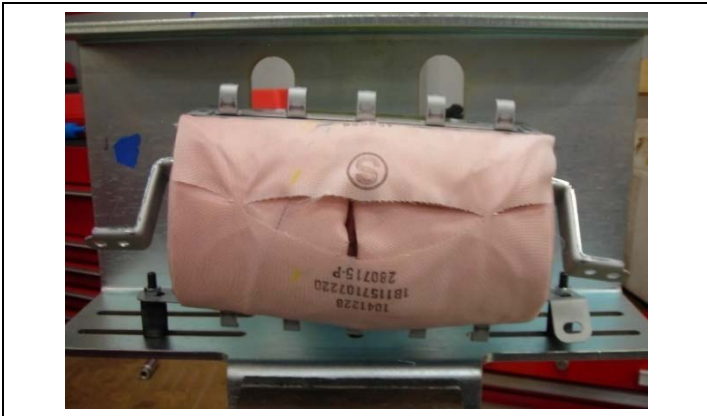
b) Mount the airbag to the mouting bracket as shown.

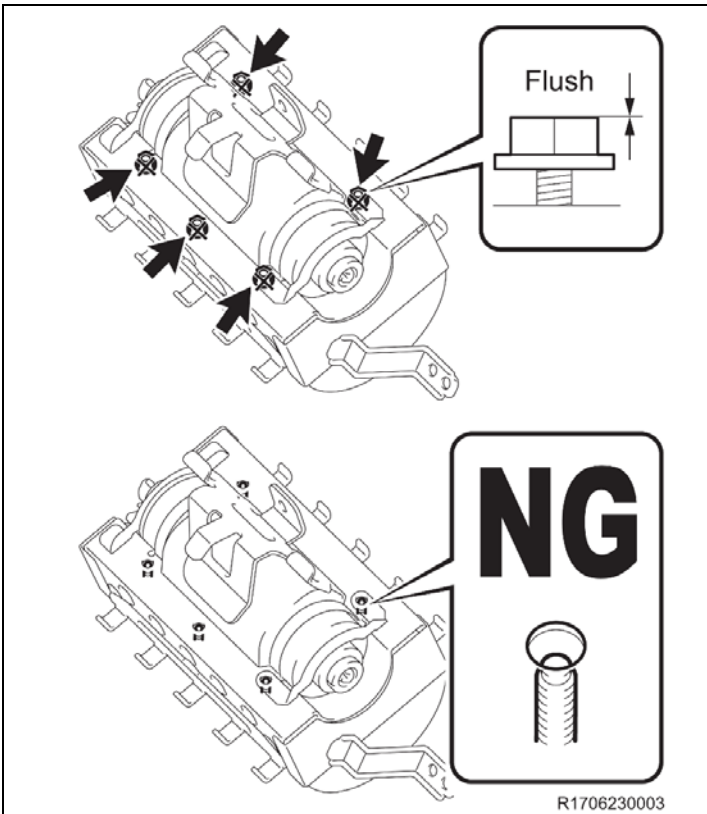
c) Loosen the 5 nuts until each nut is flush with the top of the stud as shown.

NOTE: You may need to slide the airbag to the left or right to access the middle nut. DO NOT use power tools to remove the nuts.

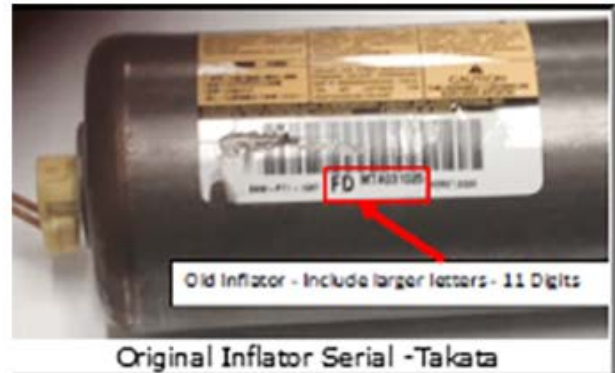
Check if the inflator serial number is missing or not visible, OR if installing a new airbag assembly

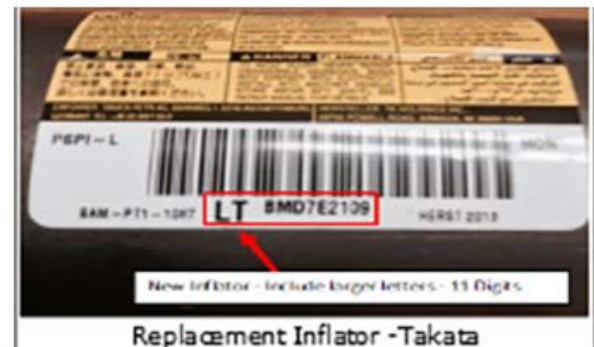
REPLACEMENT Inflator Serial Number

Scan or enter the **replacement** Inflator serial number into the website.

* Serial Number of **Replacement** Inflator:

* Re-confirm the Serial Number of **Replacement** Inflator:

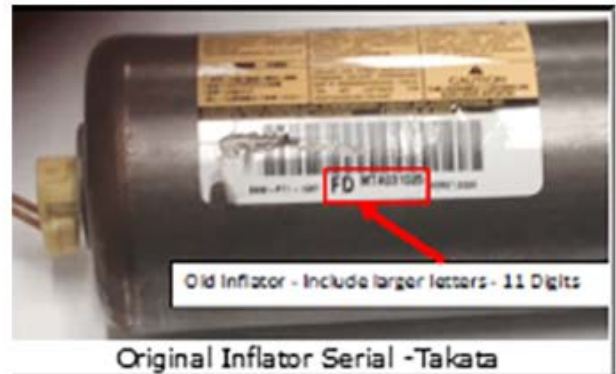
ORIGINAL Inflator Serial Number

c) If the inflator serial number cannot be scanned or is not present check the box as shown below.

Check if the inflator serial number is missing or not visible. OR if installing a new airbag assembly

Checking this box requires Air Bag Assembly replacement.

****Note** Contact your region in the event that you are unable to read the serial number.**
