**TECHNICAL INSTRUCTIONS**  
**FOR**  
**SAFETY RECALL JLI/JLJ/JLK**  
**FRONT PASSENGER AIRBAG INFLATOR REPLACEMENT**  
**CERTAIN 2006 – 2012 MY IS 250/350 and 2008 – 2009 MY IS F**

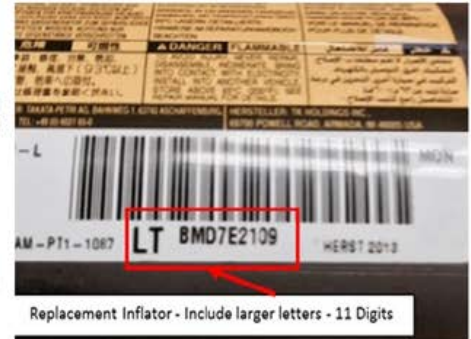
## Replacement Inflator

The first two characters of the **Replacement Inflator Serial code** will be either 'LT' or 'LR'.

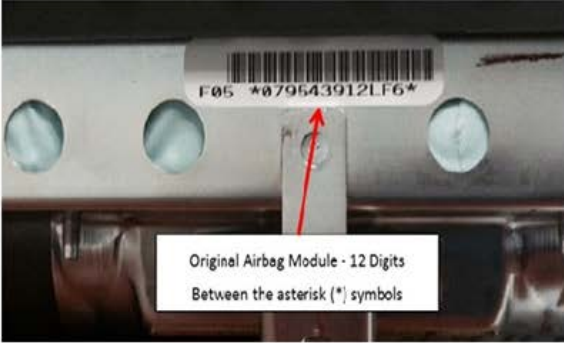
Original Airbag Module - 12 Digits  
Between the asterisk (\*) symbols
