TECHNICAL INSTRUCTIONS
FOR
SAFETY RECALL J0A/J0B/J0C
FRONT PASSENGER AIRBAG INFLATOR MODULE
CERTAIN 2011-2013 MODEL YEAR SIENNA

II. BACKGROUND

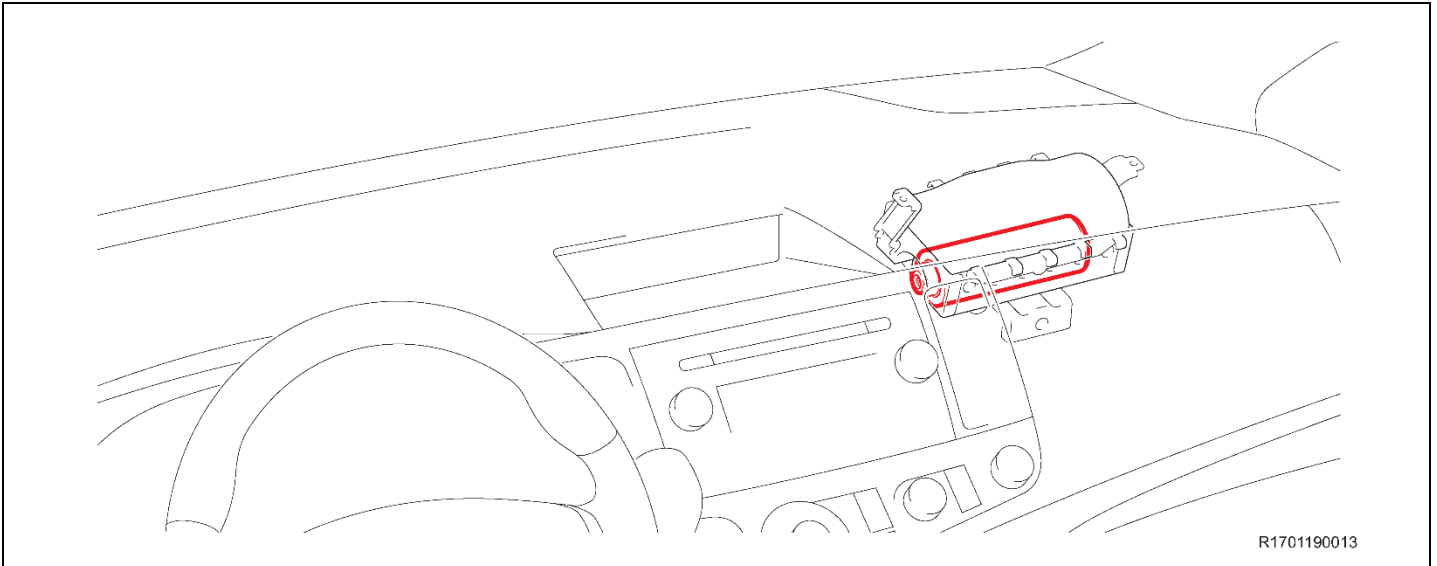
R1701190013

The subject vehicles are equipped with front passenger airbag inflators produced by Takata. The propellant in these inflators may degrade after prolonged exposure to high absolute humidity and fluctuating high temperatures. Degraded propellant can cause inflator rupture during airbag deployment. In the event of an inflator rupture, metal fragments could pass through the airbag cushion material, striking the vehicle occupants, and result in serious injury or death.

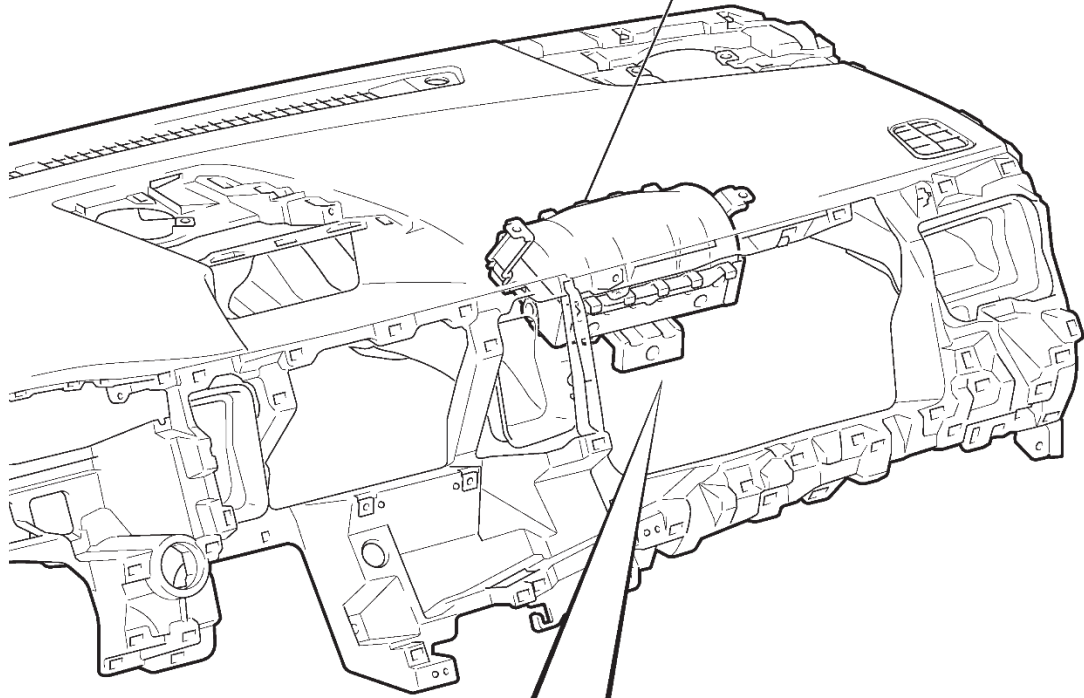
INSTRUMENT PANEL PASSENGER AIRBAG ASSEMBLY

3.9 N·m (40, 35 in.*lbf)
Be careful not to overtighten.

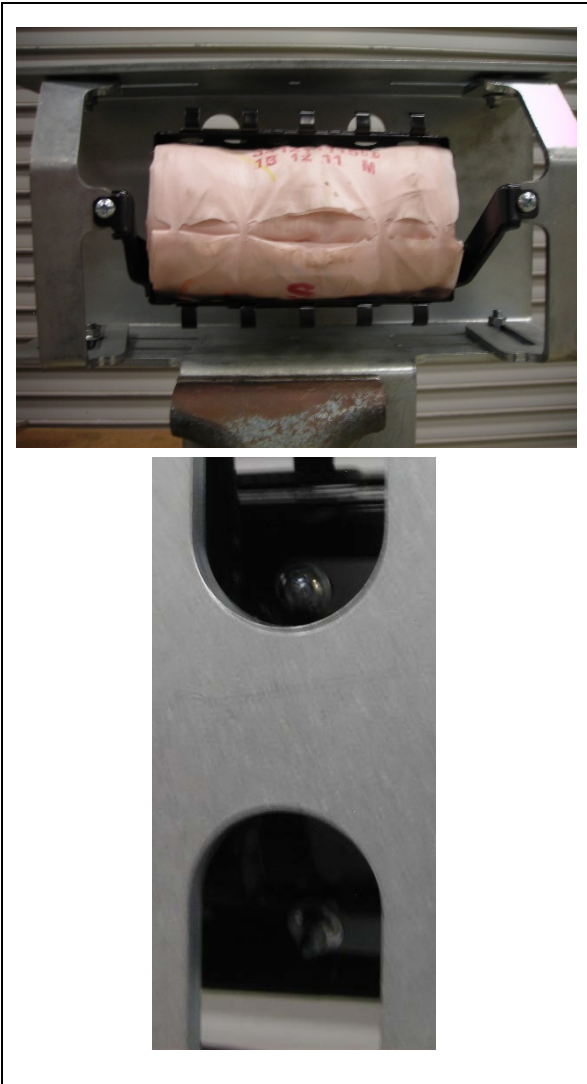
f) Mount the airbag into the mounting bracket as shown.

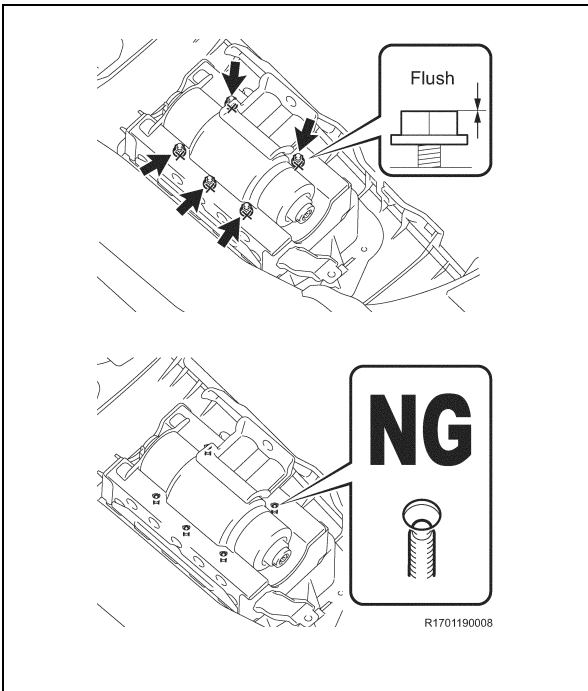
3. LOOSEN THE SELF-LOCKING NUTS

- a) Loosen the 5 nuts until the nuts are at the top of the studs as shown, through the openings in the mounting bracket.

NOTE: Do not use power tools. It may be necessary to slide the airbag to the left or right to access the middle nut.

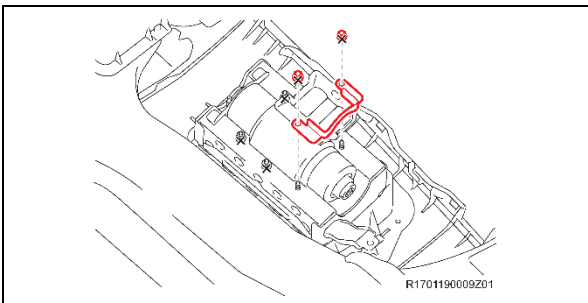
- b) Remove and discard the 2 nuts on the end where the bracket is removable.
- c) Remove the bracket and discard.

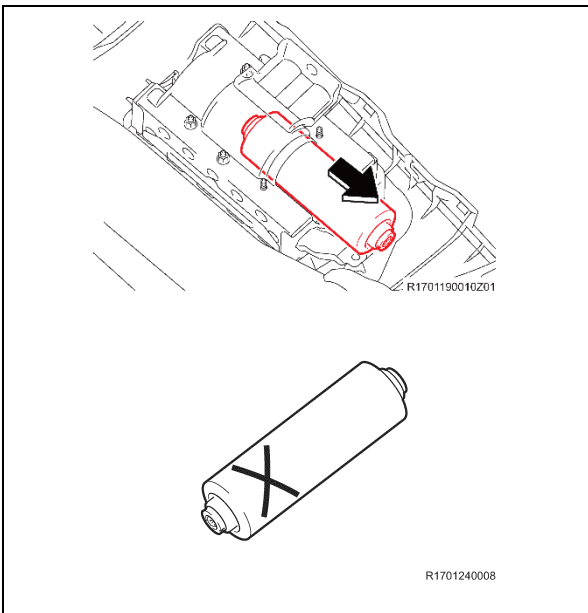
- a) Gently push the inflator in the direction shown.

- b) Remove the inflator from the airbag assembly and place it on a safe work surface.
- c) Mark the old inflator so it is not reused.

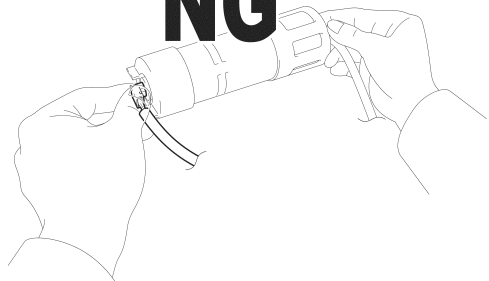
R170128003

- **DO NOT** connect the inflator harness at this time. It is **CRITICAL** to first confirm that the inflator is installed in the correct position before connecting the harness.

DO NOT CONNECT PREMATURELY
CANNOT DISCONNECTED

NG

NOTE: Once connected the inflator harness cannot be disconnected without damaging the connector, and would require that the inflator and harness be replaced.

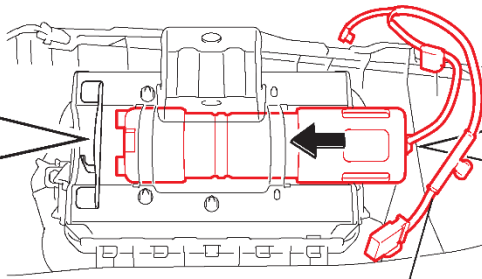
R1702010006H

- a) Carefully slide the new inflator half way into the airbag assembly and align as shown.

DO NOT insert fully.

Instrument panel wire

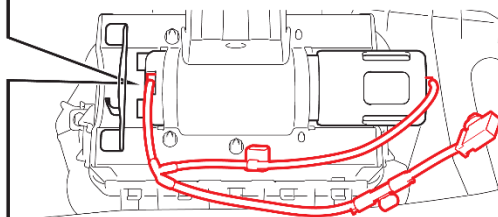
R1702010008H

- b) Connect the connector to the inflator and ensure that the connector lock is fully engaged as shown.

ALIGN CONNECTORS

Wire Harness Side:

Inflator Side:

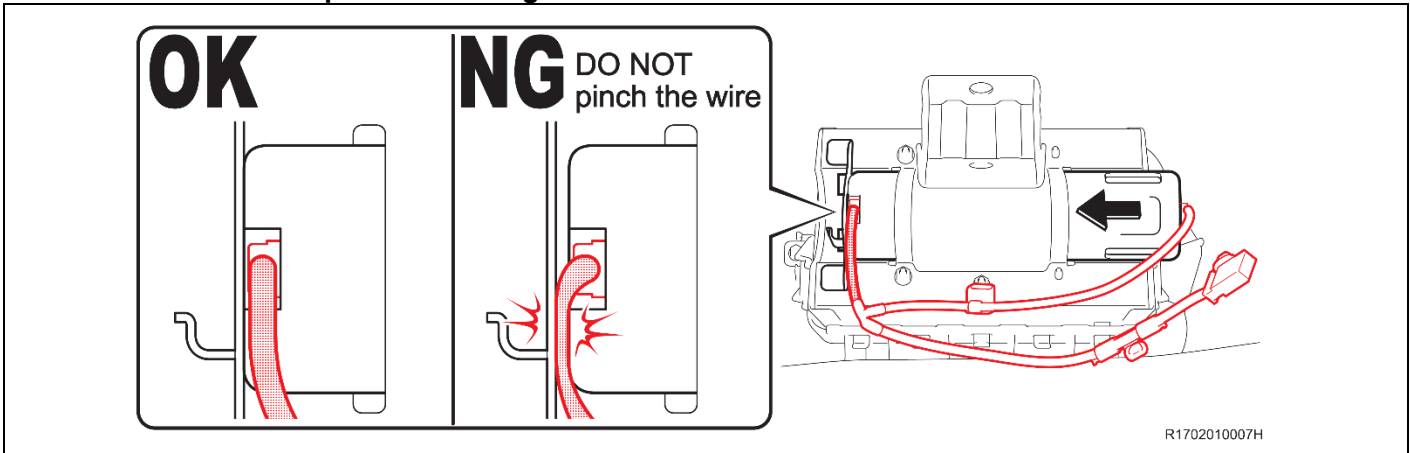
R1702010007H

a) Fully insert the inflator and ensure that the inflator is correctly oriented as shown.

NOTE: DO NOT pinch the wiring between the bracket and the inflator.

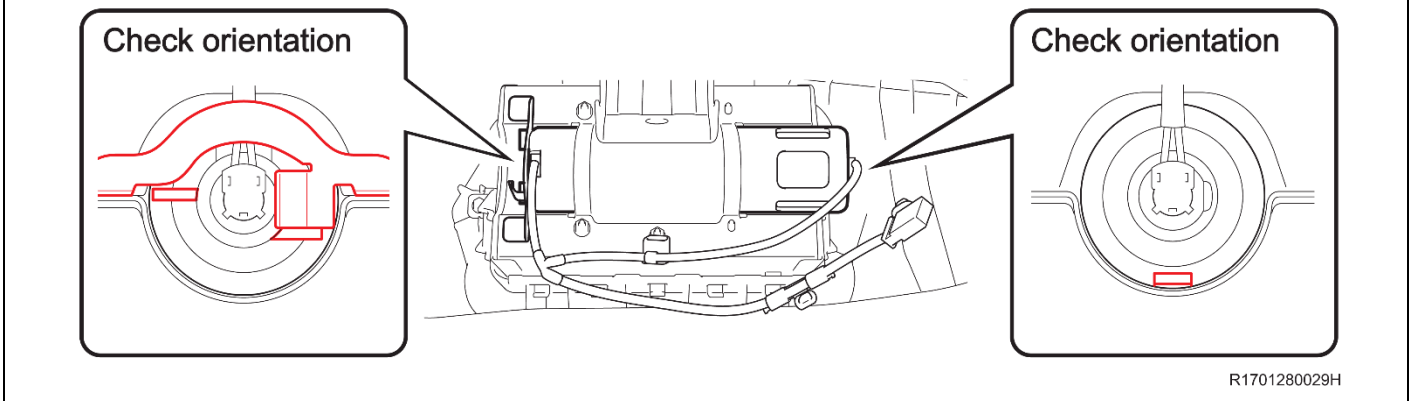
R1701280029H

NOTE: Ensure the inflator is correctly oriented.

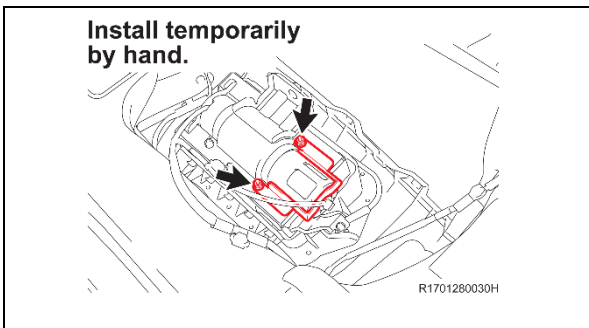
R1701280030H

b) Install the **NEW** stopper plate.

c) Install 2 **NEW** nuts by hand.

NOTE: Ensure that the stopper plate is the one from the kit and installed in the correct orientation.

Install temporarily by hand.

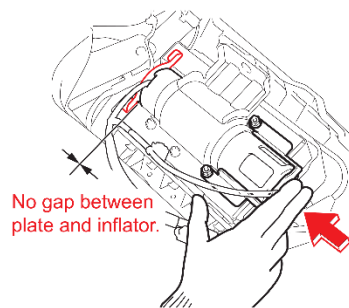
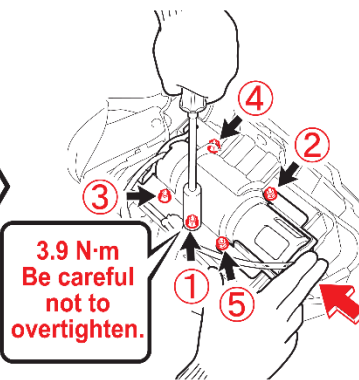
R1702010002H

- a) Tighten the 5 nuts evenly in several increments in the sequence shown. Use a socket driver or torque wrench to tighten the nuts.

Torque: 35in. lbf (40 kgf.cm, 3.9N·m)

- There will be some resistance when tightening the nuts because they are self-locking, confirm the nuts are tightened correctly.
- **DO NOT** use a power tool, T-handle, or ratchet when tightening the nuts to avoid overtorquing and deforming the studs.
- You may need to turn the airbag to the left or right with in the mounting bracket to access the center nut.

OK

Socket Driver

These tools cause overtightening !

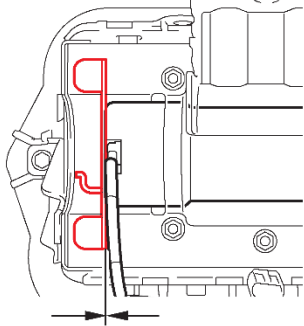
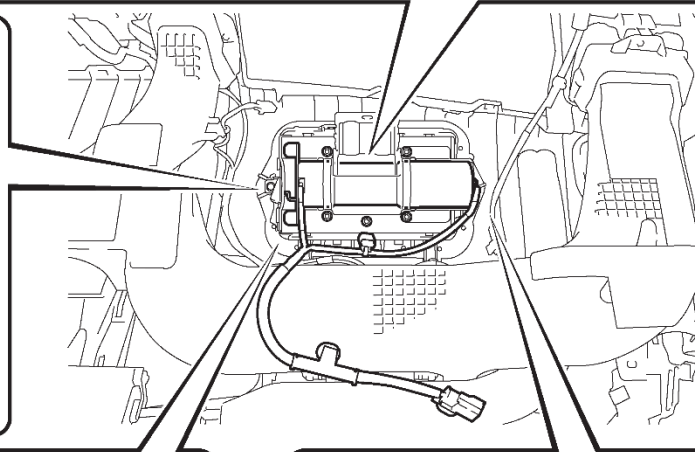
R1701280031H

- a) Confirm the **NEW** inflator and 5 **NEW** nuts have been installed.
- b) Confirm the position of the inflator and position determining plates are correct.
- c) Confirm the routing of the inflator wire harness.

(a) Replacement
of parts.

(b) No gap.

(b) Check
orientation
