TECHNICAL INSTRUCTIONS
FOR
SAFETY RECALL J0A/J0B/J0C
FRONT PASSENGER AIRBAG INFLATOR MODULE
CERTAIN 2009 – 2013 MODEL YEAR COROLLA

II. BACKGROUND

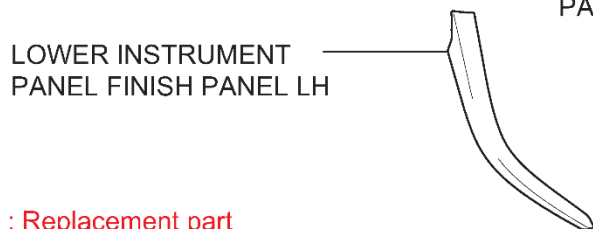
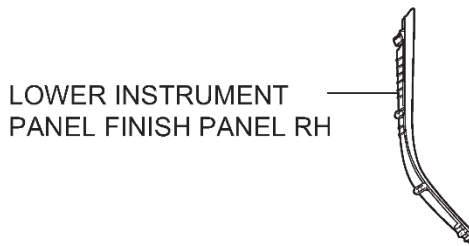
V. COMPONENTS

No. 1 INSTRUMENT PANEL BOX DOOR SUB-ASSEMBLY

GLOVE COMPARTMENT DOOR ASSEMBLY

FRONT PASSENGER AIRBAG ASSEMBLY

BE CAREFUL!
DO NOT remove the
 No. 4 INSTRUMENT PANEL CUSHION.

3.9 N·m (40, 35 in.*lbf)
Be careful not to overtighten.

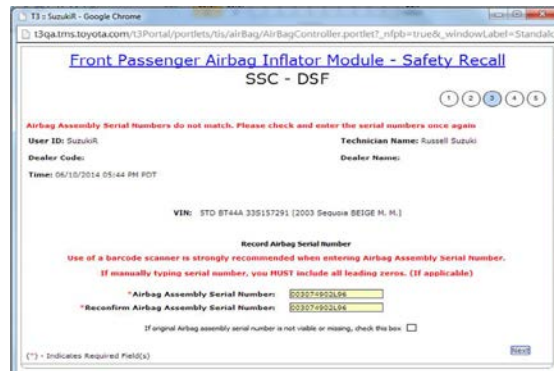
Airbag Serial Number Label Example

- The airbag serial number is **ALWAYS** the **12 DIGITS** located between the asterisks.
- The 3 digits before the asterisk **ARE NOT** part of the serial number, and **SHOULD NOT** be entered or an inaccurate response may be returned.

The **AIRBAG ASSEMBLY** serial number and the **INFLATOR** serial number are **DIFFERENT**. The **AIRBAG ASSEMBLY** serial number **MUST** be recorded prior to replacement.
