TECHNICAL INSTRUCTIONS

SAFETY RECALL JLI/JLJ/JLK

FRONT PASSENGER AIRBAG INFLATOR REPLACEMENT

CERTAIN 2010-2015 MY IS 250 CONVERTIBLE CERTAIN 2010-2011 MY IS 350 CONVERTIBLE

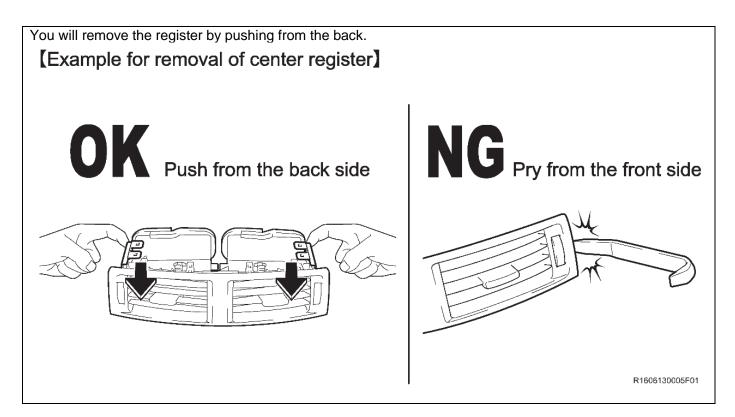
Using your finger on the left side push out at the point shown to disengage the 4 claws.

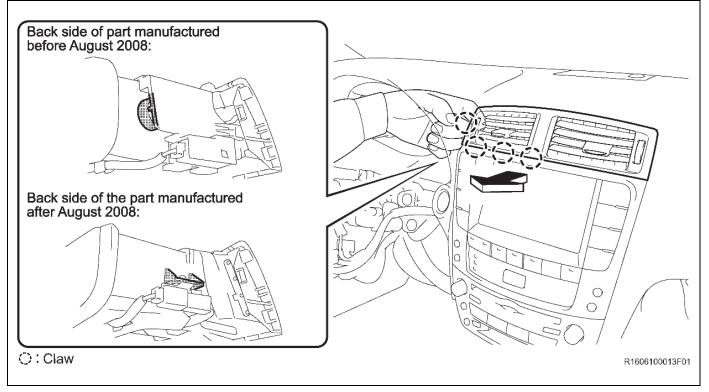
Using your finger on the right side push out at the point shown to disengage the 3 claws and remove the register from the instrument panel.

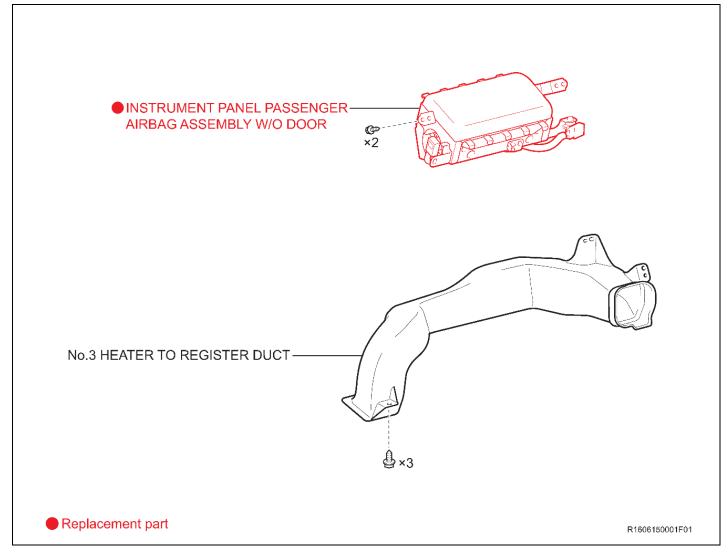
- a) Remove the 3 screws and the side defroster nozzle.
- b) Remove the 2 screws and the heater to register duct.

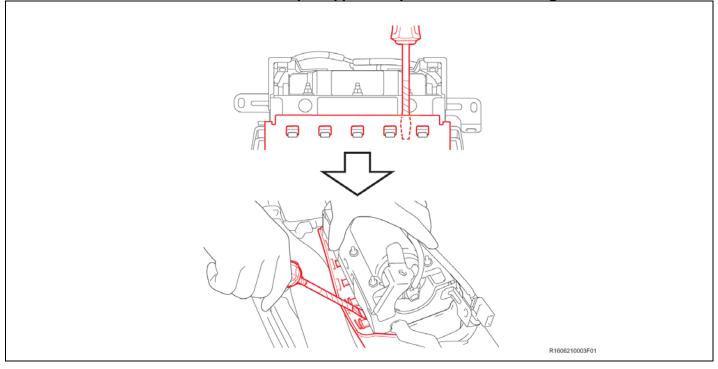
c) Remove the 4 bolts, disengage the straps, and then remove the airbag assembly. NOTE: Use a screwdriver with the tip wrapped in tape to remove the airbag from the dash.

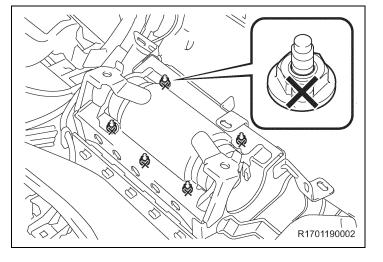
- d) Using a screwdriver to release the lock button of the connector.
- e) Disconnect the 2 connectors.
- f) Disengage the 2 clamps.
- NOTE: The removed instrument panel wire will not be reused.

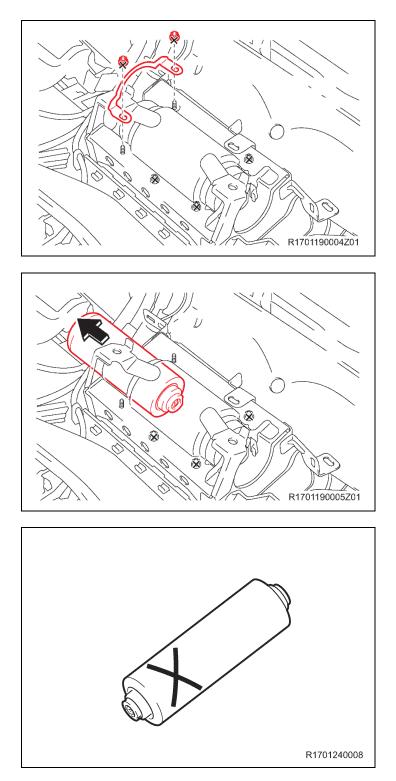
- c) Mount the airbag to the mouting bracket as shown.
- d) Loosen the 5 nuts until each nut is flush with the top of the stud as shown.
- NOTE: You may need to slide the airbag to the left or right to access the middle nut. DO NOT use power tools to remove the nuts.

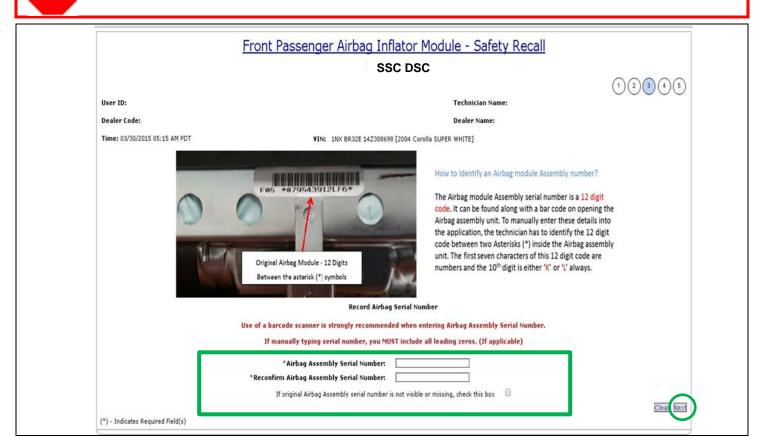
Airbag Serial Number Label Example

- AIRBAG SERIAL NUMBER IDENTIFICATION
- The airbag serial number is *ALWAYS* the 12 *DIGITS* located between the asterisks.
- The 3 digits before the asterisk *ARE NOT* part of the serial number, and *SHOULD NOT* be entered or an inaccurate response may be returned.

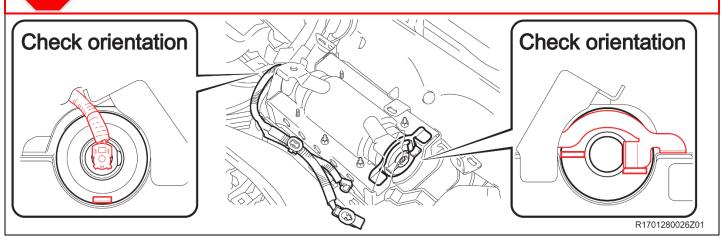
b) Ensure that the inflator is oriented in the correct position as shown.

- Make sure the inflator is correctly positioned.
 - The inflator cannot be fully inserted if it is upside down.

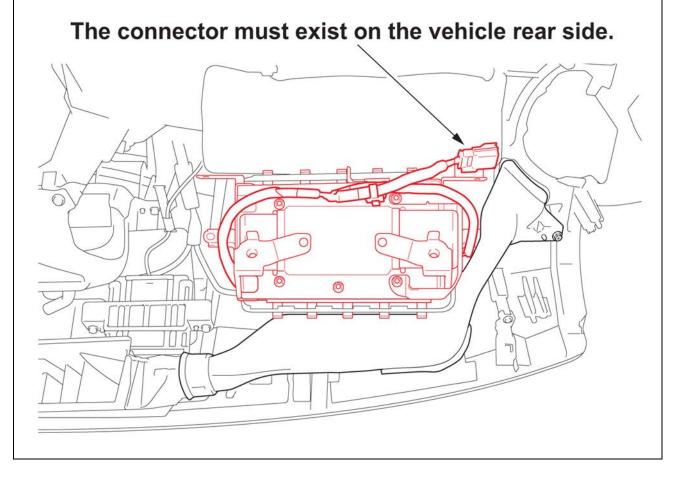
NOTE: Ensure the airbag connectors is positioned as shown
