TECHNICAL INSTRUCTIONS

SAFETY RECALL G0P/G0R/H0A

FRONT PASSENGER AIRBAG INFLATOR MODULE

CERTAIN 2007 – 2012 MY YARIS SEDAN AND 2006 – 2011 MY YARIS HATCHBACK

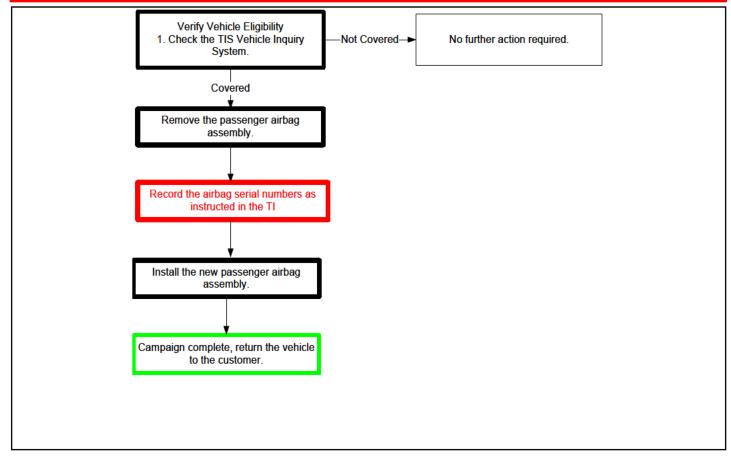
I. OPERATION FLOW CHART

The flow chart is for reference only. *DO NOT* use it in place of the full technical instructions. Follow *ALL* steps as outlined in the full technical instructions to confirm the campaign is completed correctly.

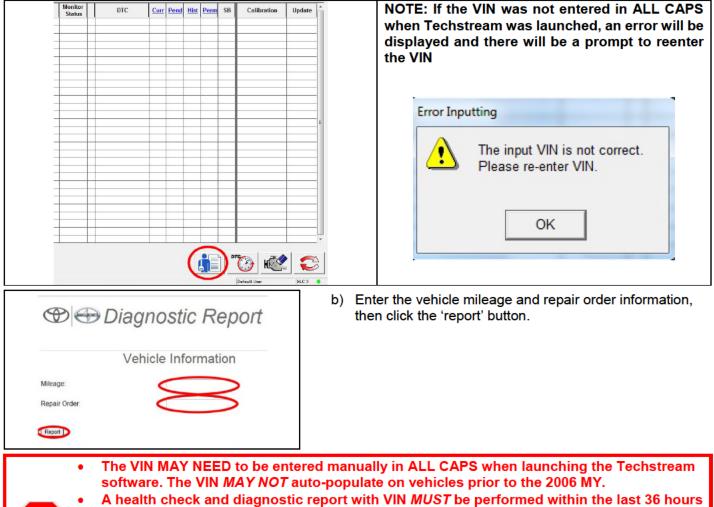
a) After the health check has completed, run a diagnostic report by clicking on the link on the health check screen.

- and recorded by TMS. If the diagnostic report is not run, the healthcheck will not be recognized by TMS.
- The serial number recording application will be disabled and the repair cannot be completed if a health check and diagnostic report is not performed and recorded by TMS.
 This comparison only covers the replacement of the percentage size and the results.
- This campaign only covers the replacement of the passenger airbag module. NO other SRS components are covered under this campaign.

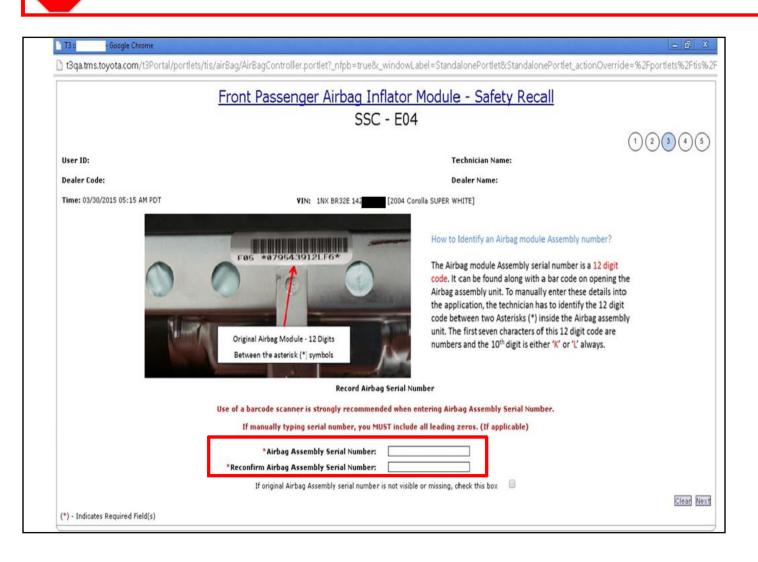
Airbag Serial Number Label Example

- The airbag serial number is *ALWAYS* the 12 *DIGITS* located between the asterisks.
- The 3 digits before the asterisk ARE NOT part of the serial number, and SHOULD NOT be entered or an inaccurate response may be returned.

The AIRBAG serial number MUST be recorded prior to replacement.

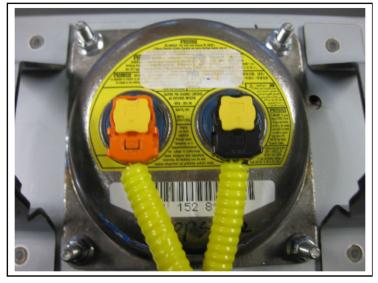
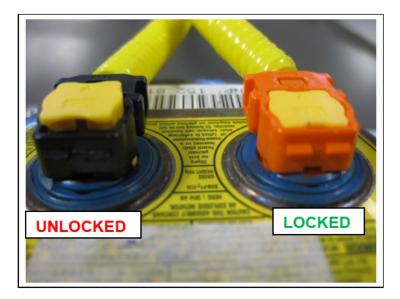
- a) Install the new harness onto the new airbag by plugging in the two connectors.
 - NOTE: Match the color of the harness connector to that of the airbag. Ensure that the connectors are fully seated.

b) Engage the secondary locks.

NOTE: Ensure the secondary locks are fully engaged.

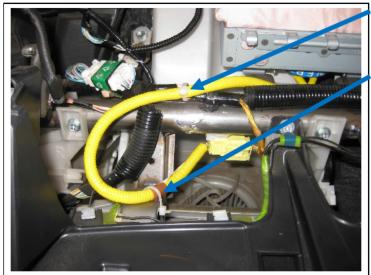
After the upper instrument panel has been installed secure the new airbag adaptor harness as shown.

Secure the adaptor harness to the dash harness.

Also secure the adaptor harness to the dash bracket.

NOTE: The upper instrument panel has been removed for clarity. Both areas can be accessed through the opening for the glove box door and/or the opening for the combination meter.

Check that the adaptor harness has the proper clearances and is not strained.
