RECALL: THIS MODIFICATION HAS TOP PRIORITY AND MUST BE PERFORMED IMMEDIATELY TO ENSURE CUSTOMER SAFETY

FRONT BRAKE MASTER CYLINDER PISTON REPLACEMENT

**AFFECTED MODELS: 2015, 2016, 2017, 2018 1290 SUPER DUKE R
2016, 2017, 2018 SUPER DUKE GT**

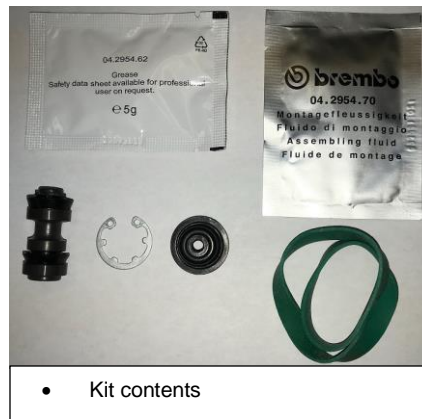
1 QTY. 61313008000 Front master cylinder piston replacement kit D=16mm
