2006 B-SERIES - DRIVER AIR BAG SAFETY RECALL 2218A

**DRIVER AIR BAG SAFETY RECALL 2218A
REPAIR PROCEDURE**

B. REPAIR PROCEDURE - Overview:

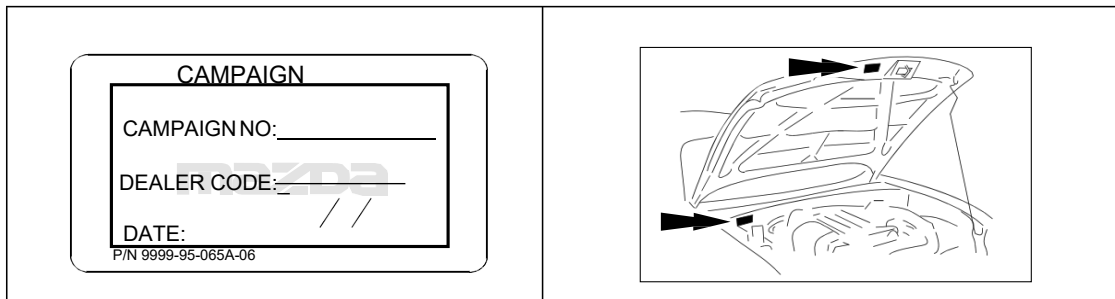
- If the vehicle is within the above ranges, proceed to Step 2.
 - If the vehicle is not within the above ranges, return vehicle to the customer or inventory.
2. Perform a Warranty Vehicle Inquiry using your eMDCS System and inspect vehicle for Campaign Labels **Recall 2218A** attached to the vehicle’s hood or bulkhead. Refer to eMDCS System - Warranty Vehicle Inquiry Results table below.

NOTE: Be sure to verify Recall number as the vehicle may have multiple Recall labels.

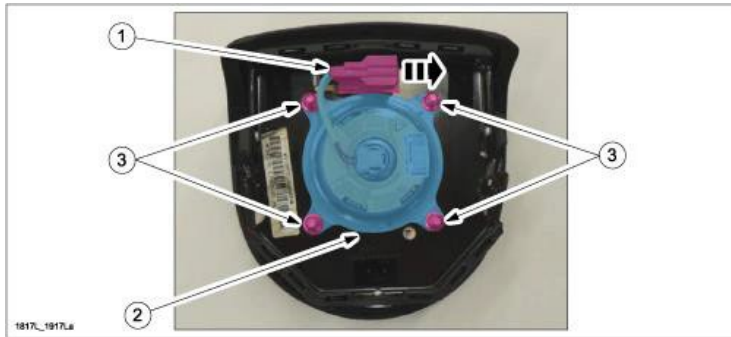
1. Release the retaining tab and slide the connector (1) of the air bag inflator (2) off the retainer.

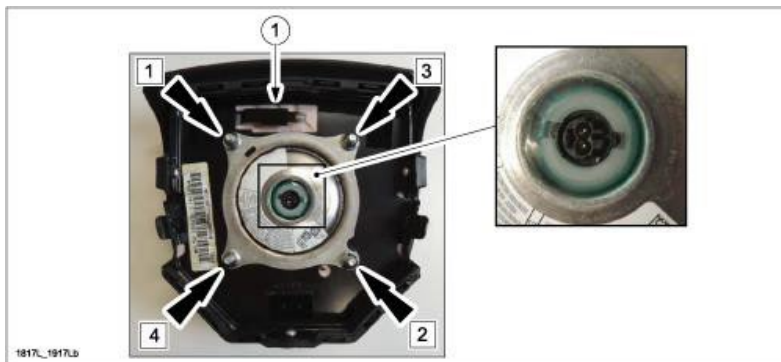
2. Remove and discard the four air bag inflator retaining nuts(3) using hand tools only. **NO POWER TOOLS!**
3. Remove the air bag inflator and set aside for return shipping.
NOTE: In order to verify the correct air bag inflator is installed, mark the old air bag inflator with a felt tip marker prior to removal.
4. Install the new inflator into the driver air bag. The retainer (1) will be used for the electrical connector.

NOTE: The new air bag inflator must be installed in the same orientation as the original part to ensure the inflator module and air bag harness electrical connector T-shape indexes are aligned properly.

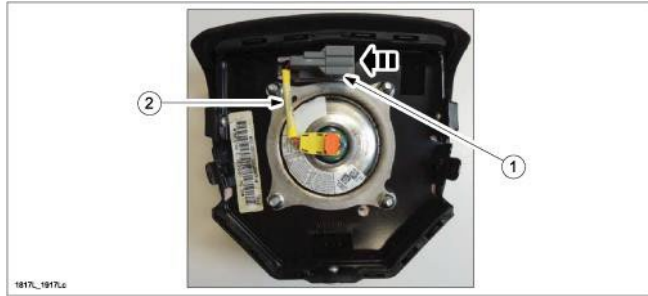
5. Install four new air bag inflator nuts onto the driver air bag using hand tools only. **NO POWER TOOLS!** Tightening torque: 6.5 Nm (57 lb-in) in the specified sequence [1] [2] [3] [4]
6. Align the T-shape index on both the wiring harness electrical connector and the air bag inflator by gently pulling on the wiring harness to ensure it is properly seated.

- Slide the connector (1) of air bag inflator (2) onto the retainer.

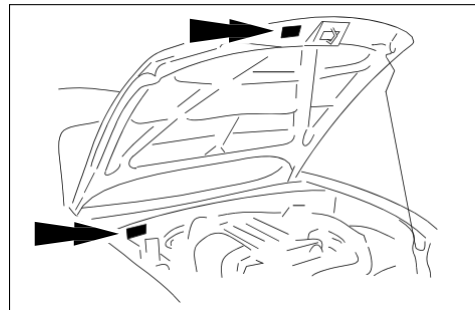
- Fill out a black "Campaign Label" (9999-95-065A-06) and Campaign "2218A", your dealer code, today's date.

- Affix it to the hood or bulkhead as shown:
