2006 B-SERIES - PASSENGER AIR BAG SAFETY RECALL 2318A

PASSENGER AIR BAG SAFETY RECALL 2318A  
REPAIR PROCEDURE

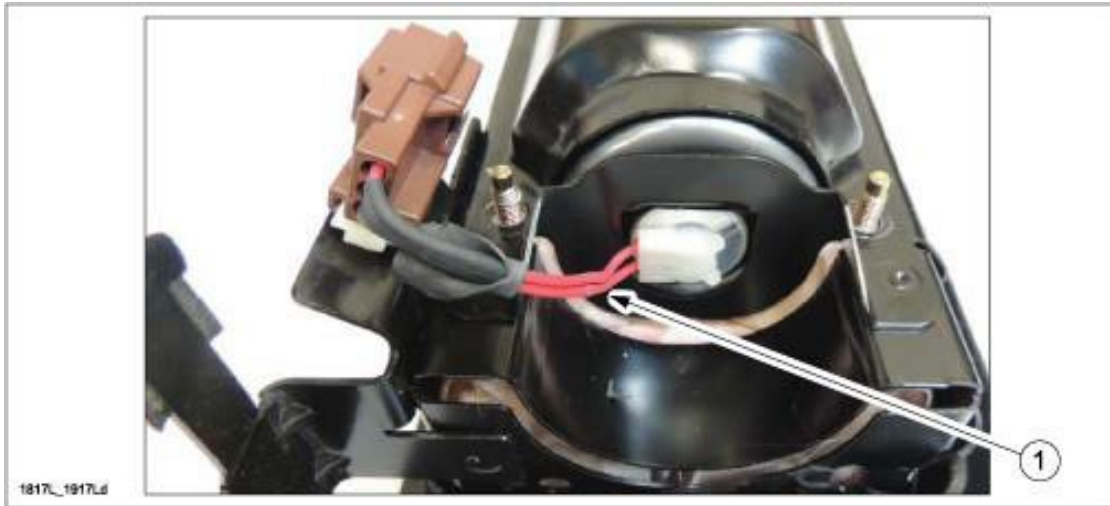
1. Cut and peel back the wiring sleeve to expose the inflator wiring (1).

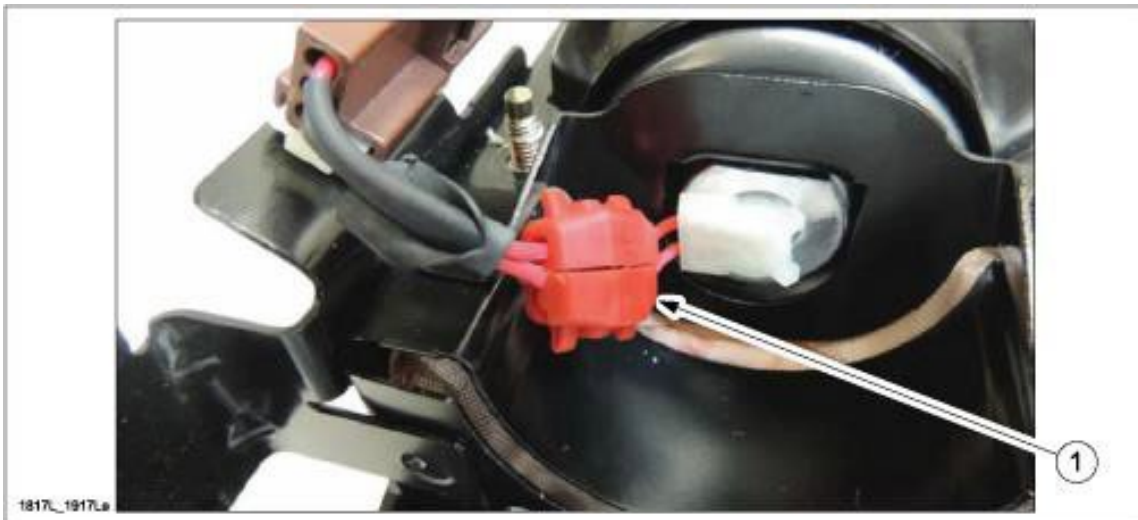
2. Install a wiring shunt (1) between the inflator wiring connector and the inflator body. This will cause the inflator to become inert.

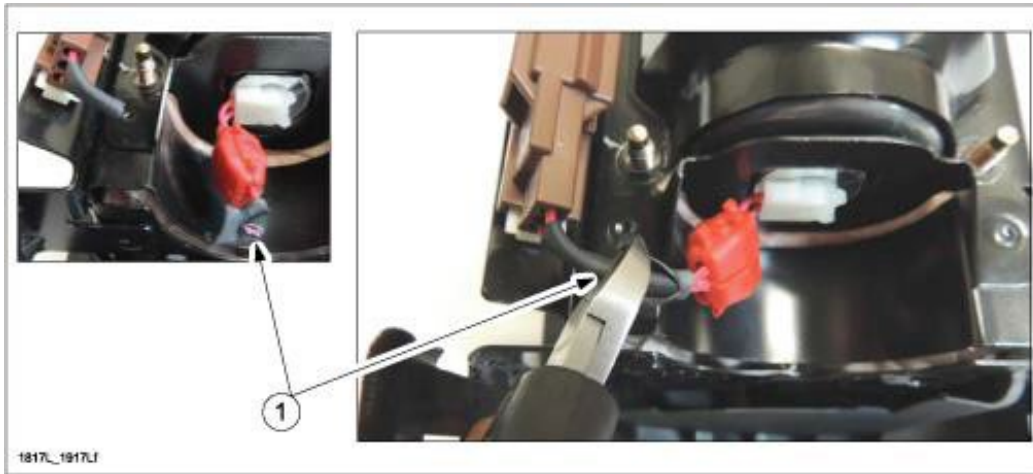
3. Cut the inflator wiring between connector and the shunt (1).

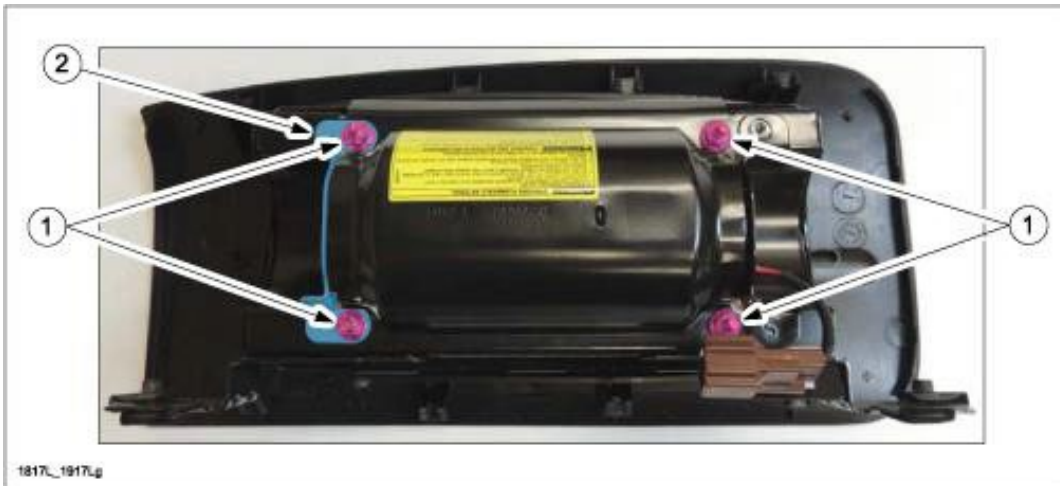
4. Remove and discard the four airbag inflator retaining nuts (1) and the bracket (2) using Hand tools.

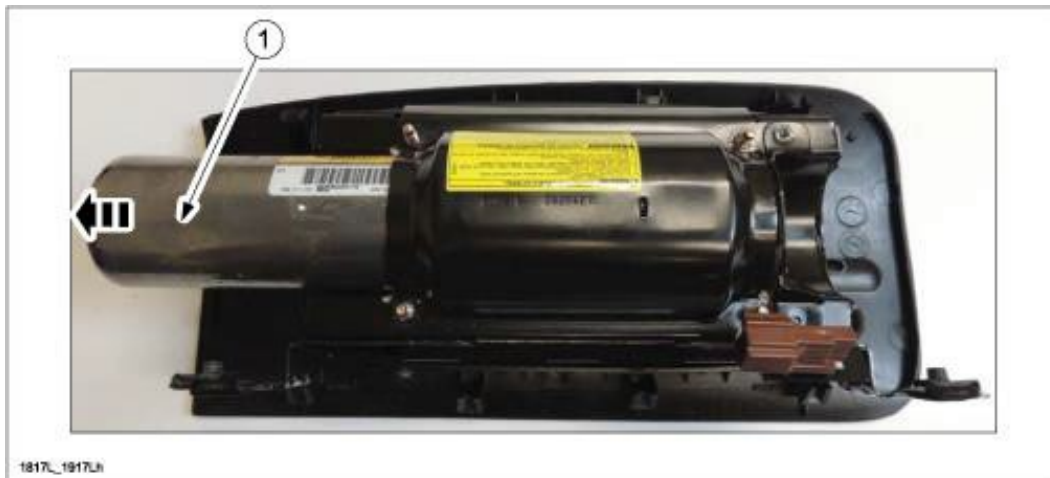
5. With an assistant holding the airbag assembly, remove the inflator from the airbag assembly by pushing outward on the inflator (1).

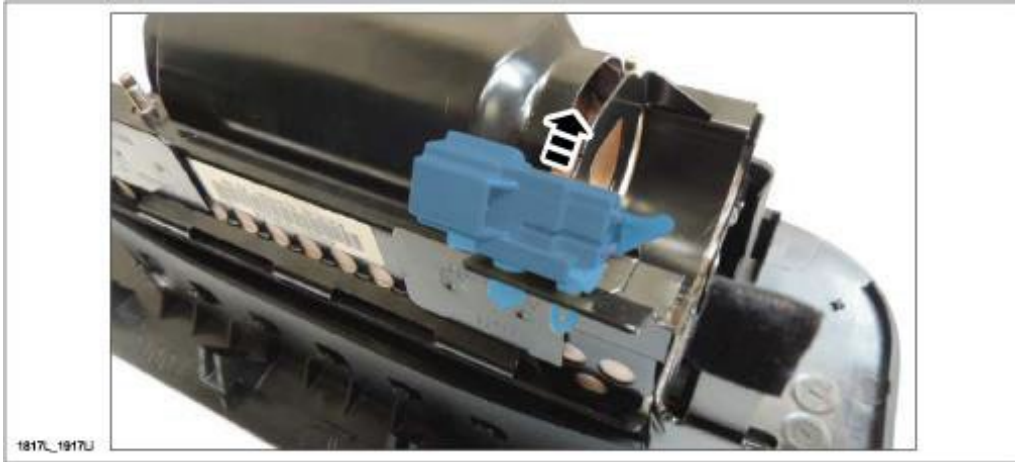
6. Remove the airbag inflator harness electrical connector.

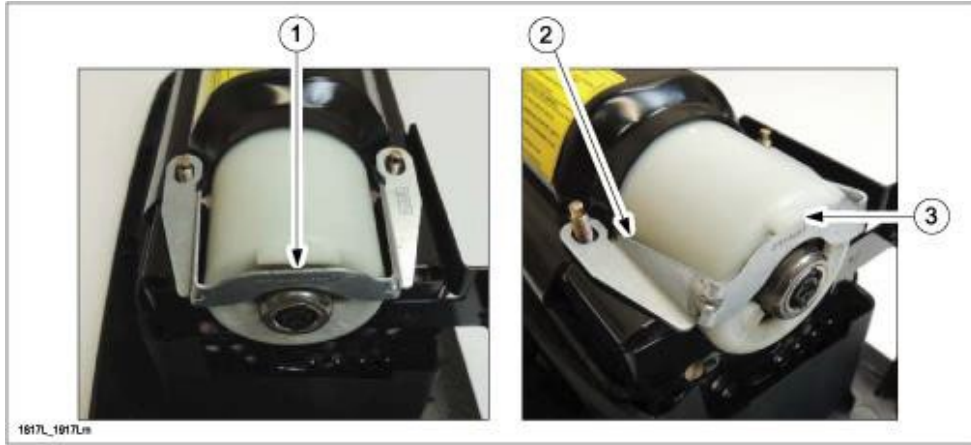
8. Install (1) the new bracket under the notch for inflator alignment (2) the retaining bracket is positioned so the inflator retaining bracket is aligned under the notch (3)

**IF THE NOTCH IS NOT PRESENT ABOVE THE BRACKET, GO BACK TO STEP 7 AND REPEAT THE STEP. THE NOTCH ON LEFT LARGE CAP MUST BE IN THE UP POSITION ABOVE THE BRACKET**

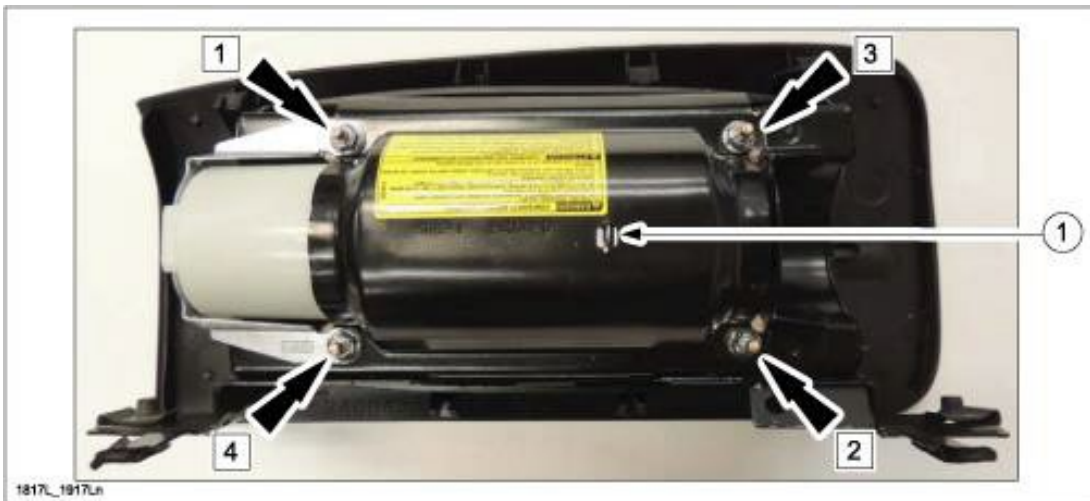
9. Install the new nuts, making sure the pop-up indicator (1) on the air bag assembly is present.

**Tightening torque: 3.9 Nm (35 lb-in) in the specified sequence [1] [2] [3] [4]**

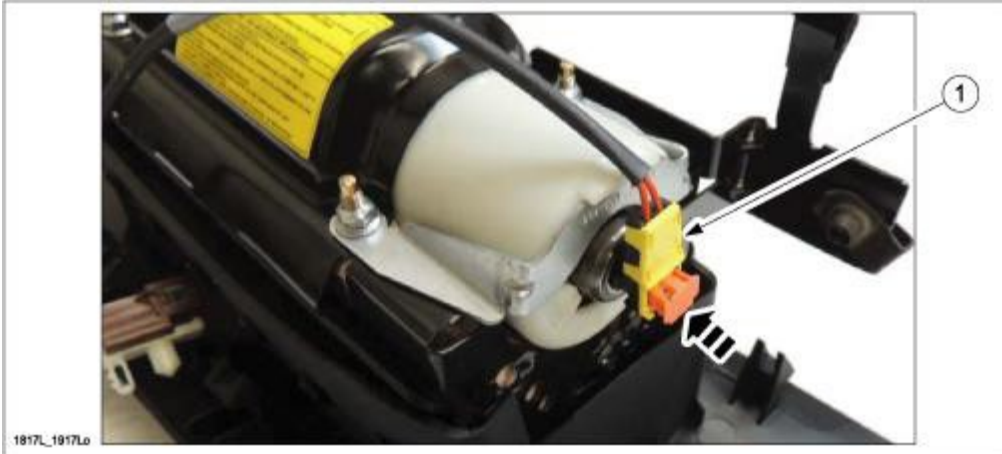
10. Align the T-shape index on both the wiring harness electrical connector and the airbag inflator, then connect the new airbag wiring harness to the inflator module and fully seat the orange tab.

11. Make sure the connection between the wiring harness electrical connector and the airbag inflator (1) is properly seated by gently pulling on the wiring harness.

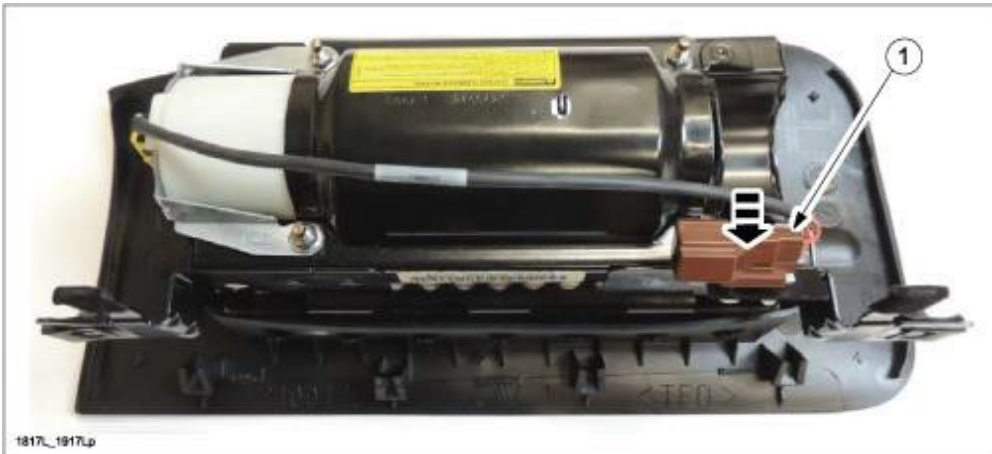
12. Install the inflator harness connector (1) to the air bag assembly bracket.

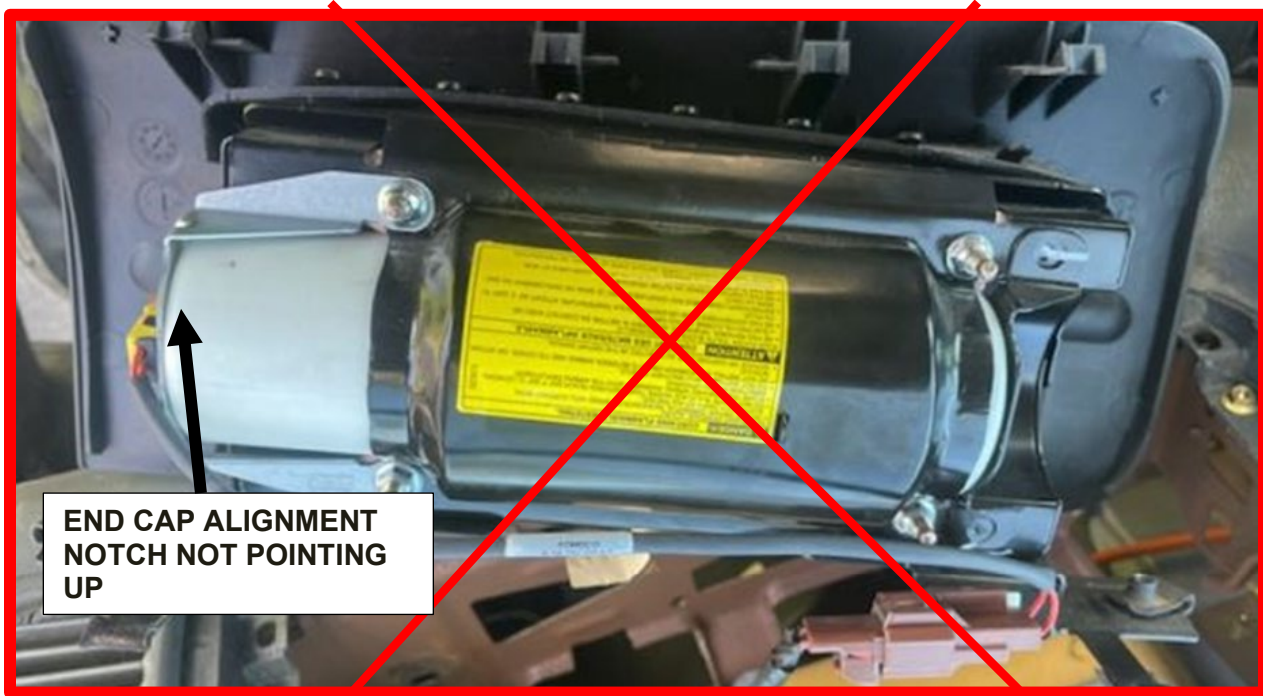
FIGURE 3 – NO GOOD (NG) INCORRECT ORIENTATION OF END CAP

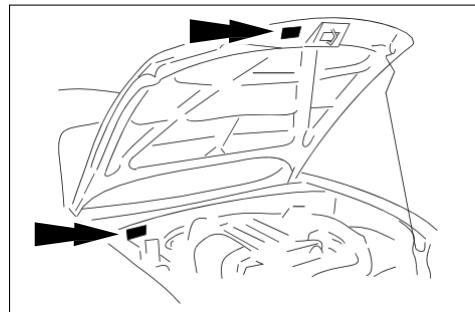
2. Affix it to the hood or bulkhead as shown:
