Campaign No.2019110016, December 2019

SUBJECT: **Model 204 and 207****Model Year 2012-2013****Replace Front Passenger-side Airbag**

Based on the defect decision of TK Holdings, Inc. ("Takata"), in certain passenger side airbags produced by Takata used in certain Model Year 2012-2013 Mercedes-Benz vehicles, under specific circumstances, the front passenger side airbag inflator housing may explode during deployment due to excessive internal pressure. This condition is more likely to occur if the vehicle has been exposed to high levels of absolute humidity for extended periods of time. A frontal passenger side inflator explosion during deployment could result in sharp metal fragments striking the passenger or other occupants, possibly causing serious injury or death. To remedy this concern, an authorized Mercedes-Benz dealer will replace the front passenger side airbag on the affected vehicles.

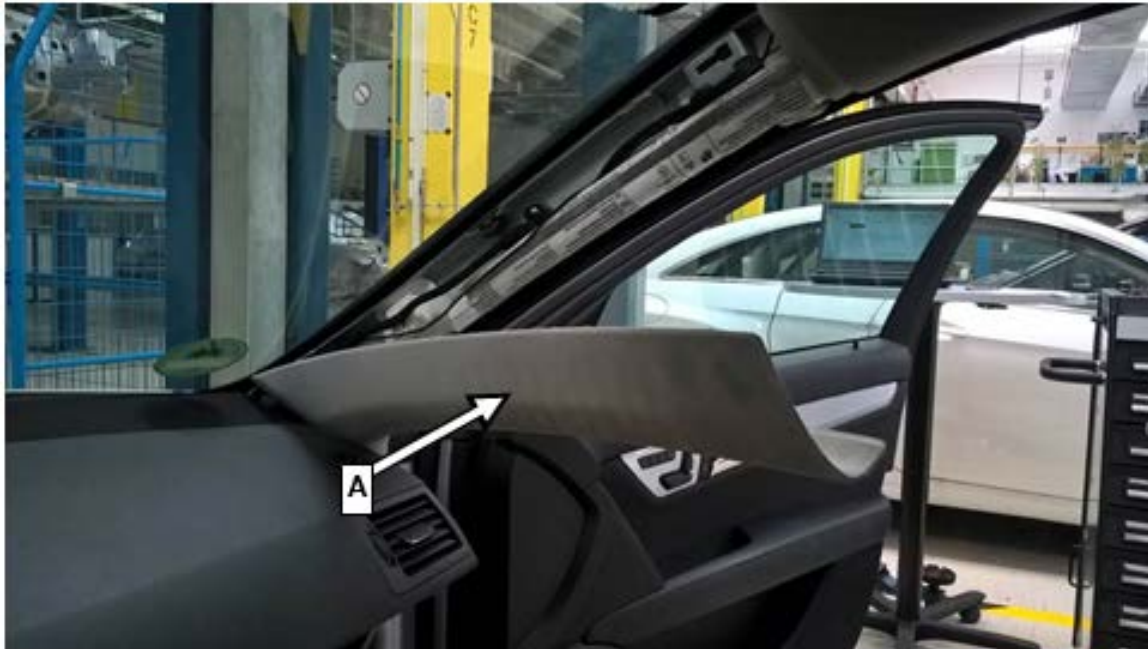
Figure 2

1. Disconnect ground line from the on-board electrical system battery.
2. Remove right A-pillar trim (**A**, figure 2).

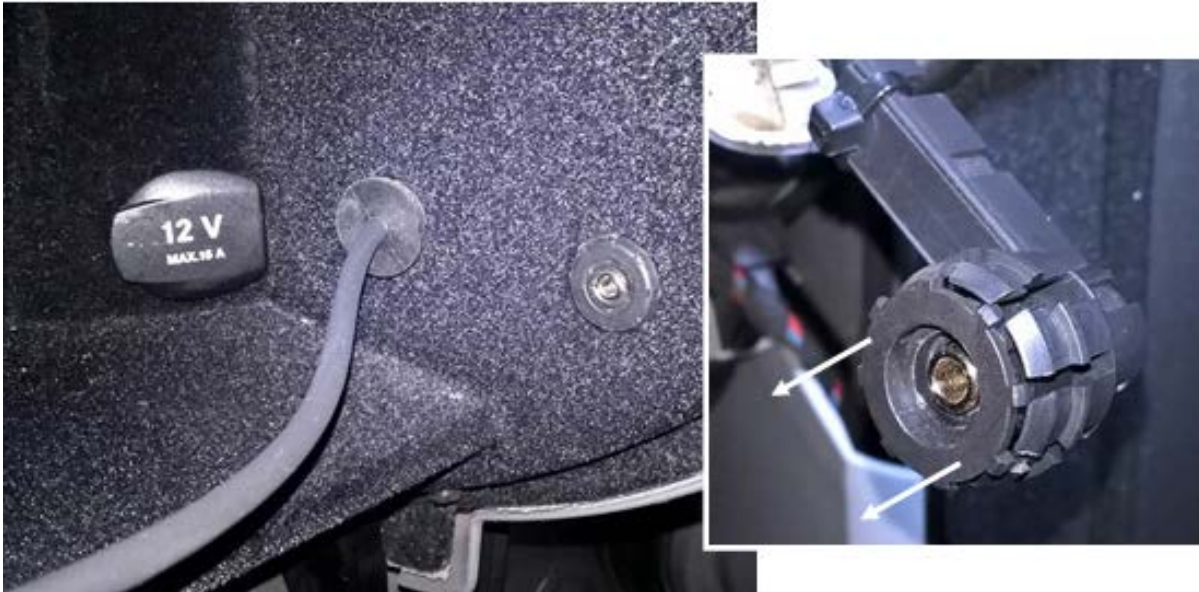
Figure 3

**i** Release inner retaining ring (**figure 3**) at the AUX connection towards the inside. The connection can then be removed from the glove box housing.

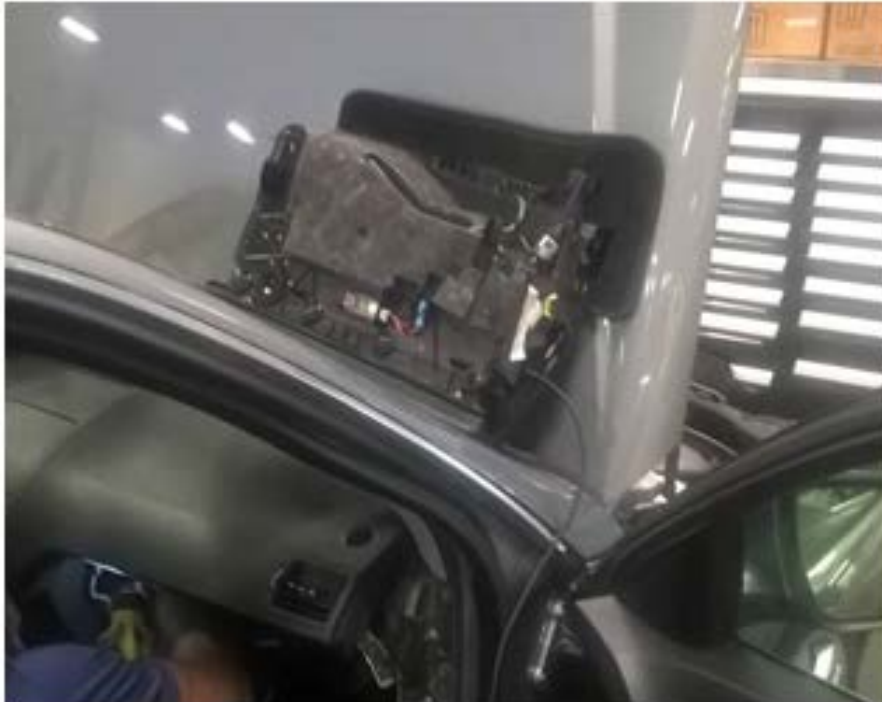
Figure 4

**i** Pull out the iPod cable as far as possible and set down glove box housing on the windshield **with** exterior iPod cable connected (**figure 4**).

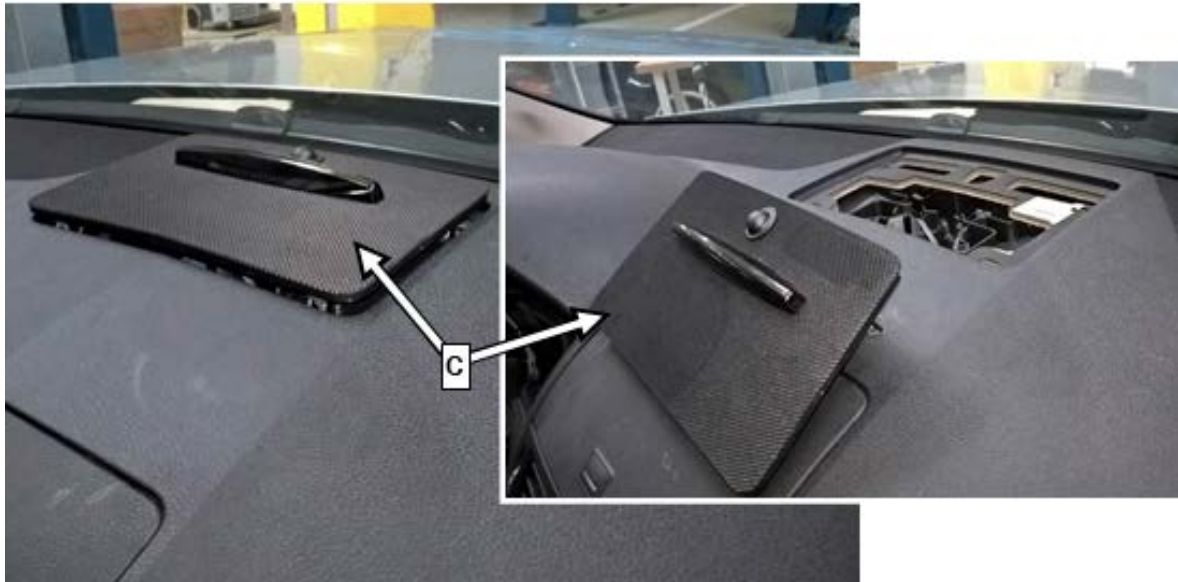
Figure 6

5. Unclip and remove cover (C, figure 6) at the instrument panel on top.  
**i** With a sound system, also remove speaker under the cover.

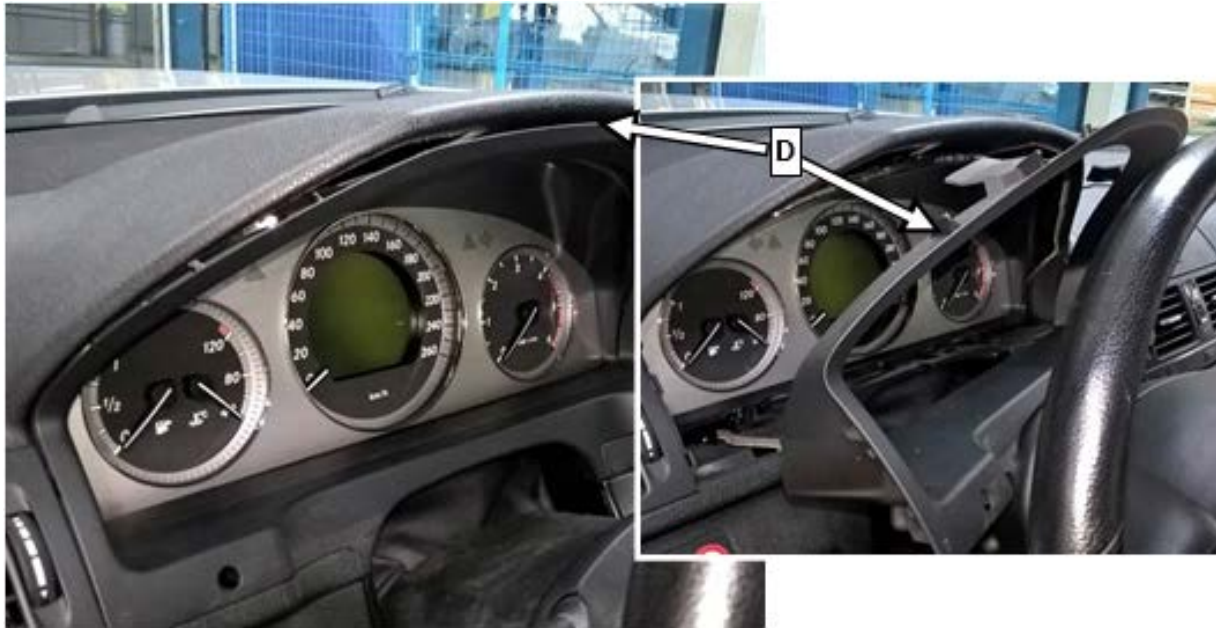
Figure 7

For basic data of model 207, see **AR83.25-P1124EC.**
8. Remove trim (**D, figure 7**) around the instrument cluster.
  -

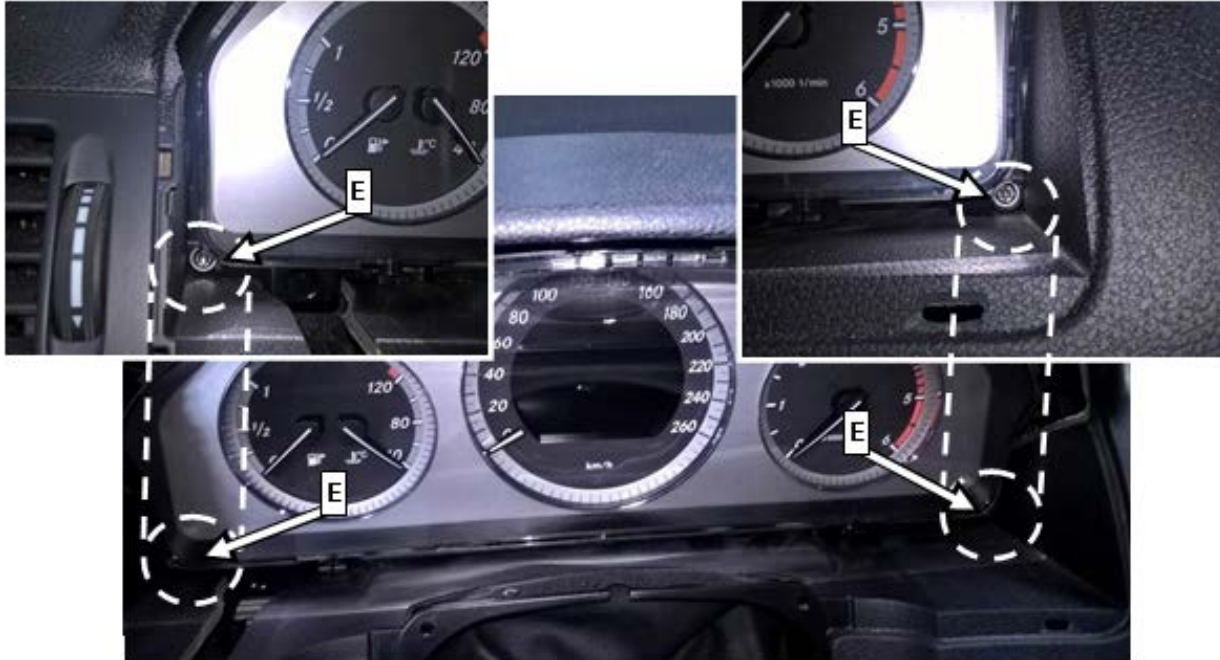
Figure 8

9. Remove the two bottom threaded connections (**E, figure 8**) of the instrument cluster.

**i** These screws are simultaneously fasteners for the instrument panel.

**i** The upper two screws do not need to be removed.

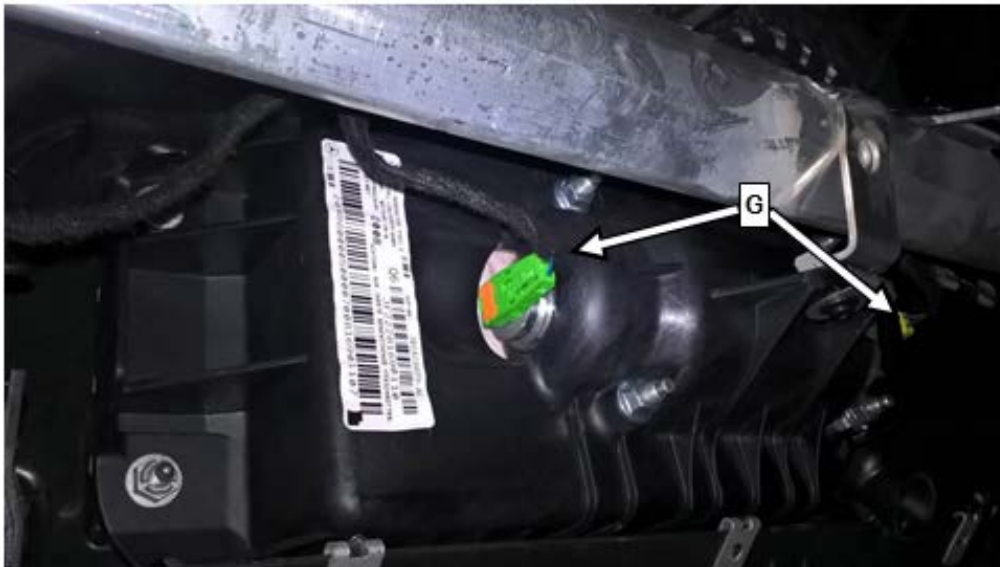
Figure 10

11. Disconnect electrical contacts (**G**, figure 10) at the front passenger airbag.

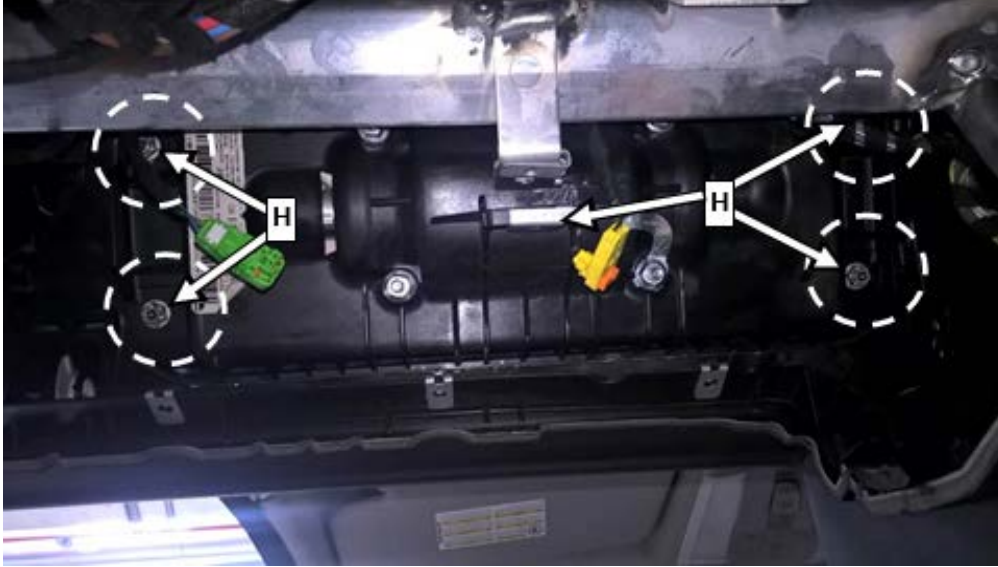
Figure 11

12. Remove lock nuts (**H**, figure 11) for the front the passenger airbag.

**i** Lock nuts should only be replaced if they are damaged. For more info see:  
**AH00.00-N-0001-01A / Modification notes 27.10.2016**

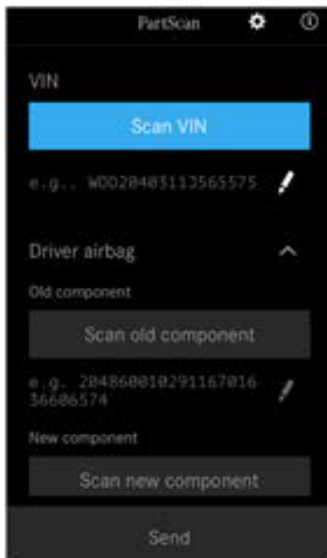
Figure 12

14. Use the "Scan VIN" button (figure 12) to scan the vehicle identification number either by the barcode or the text field.

**i** After scanning, compare the vehicle identification number that has been read in the app and correct any scanning errors manually.

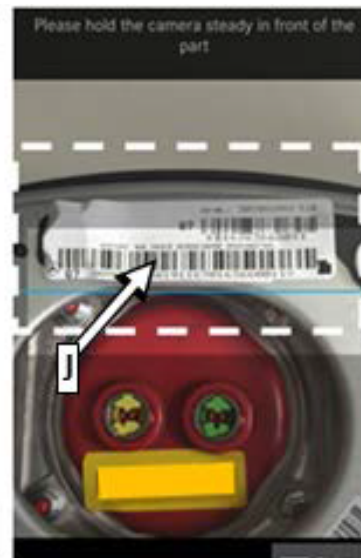
Figure 14

Ensure that the lower barcode (**J, figure 14**) is scanned.

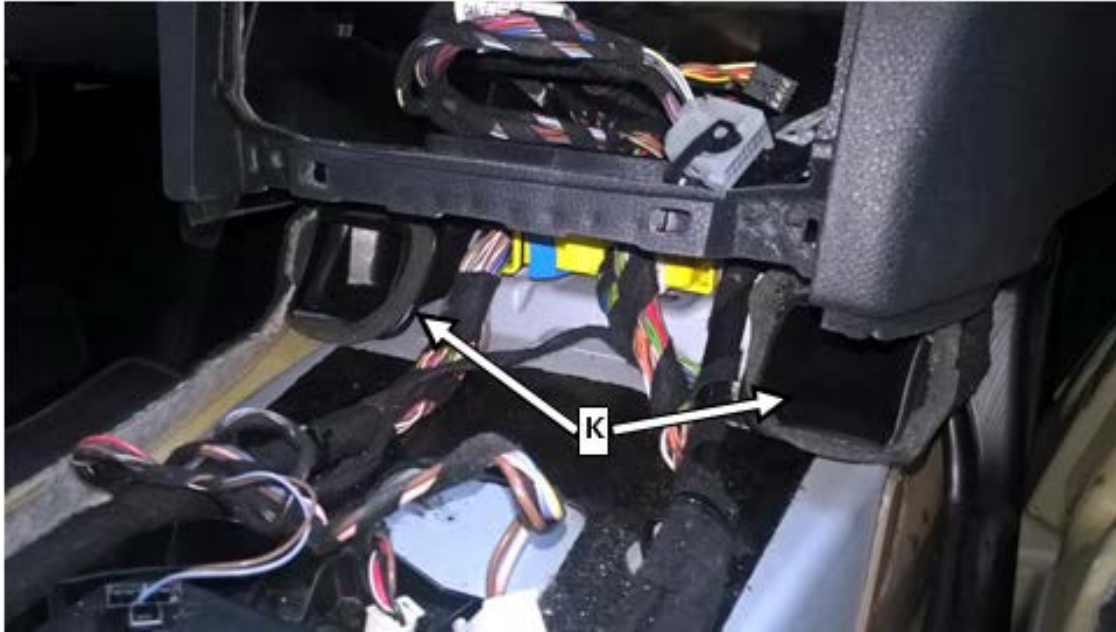
Figure 17

19. Place instrument panel back into position and install the air ducts (**K, figure 17**) correctly.

The air ducts are pulled out when the instrument panel is raised.
