SAFETY RECALL BULLETIN

SUBJECT:			No: SR-18-002REV
PARKING BRAKE CORROSION – SAFETY RECALL CAMPAIGN – REVISED			DATE: April 2018
			MODEL: See Below
CIRCULATE TO:	<input checked="" type="checkbox"/> GENERAL MANAGER	<input checked="" type="checkbox"/> PARTS MANAGER	<input checked="" type="checkbox"/> TECHNICIAN
<input checked="" type="checkbox"/> SERVICE ADVISOR	<input checked="" type="checkbox"/> SERVICE MANAGER	<input checked="" type="checkbox"/> WARRANTY PROCESSOR	<input checked="" type="checkbox"/> SALES MANAGER

PURPOSE

This campaign bulletin instructs dealers to inspect the rear brake calipers and, if necessary, replace the parking brake boot and lever or the brake caliper body. On certain affected vehicles, the dealer must also replace the piston assembly and piston boot.

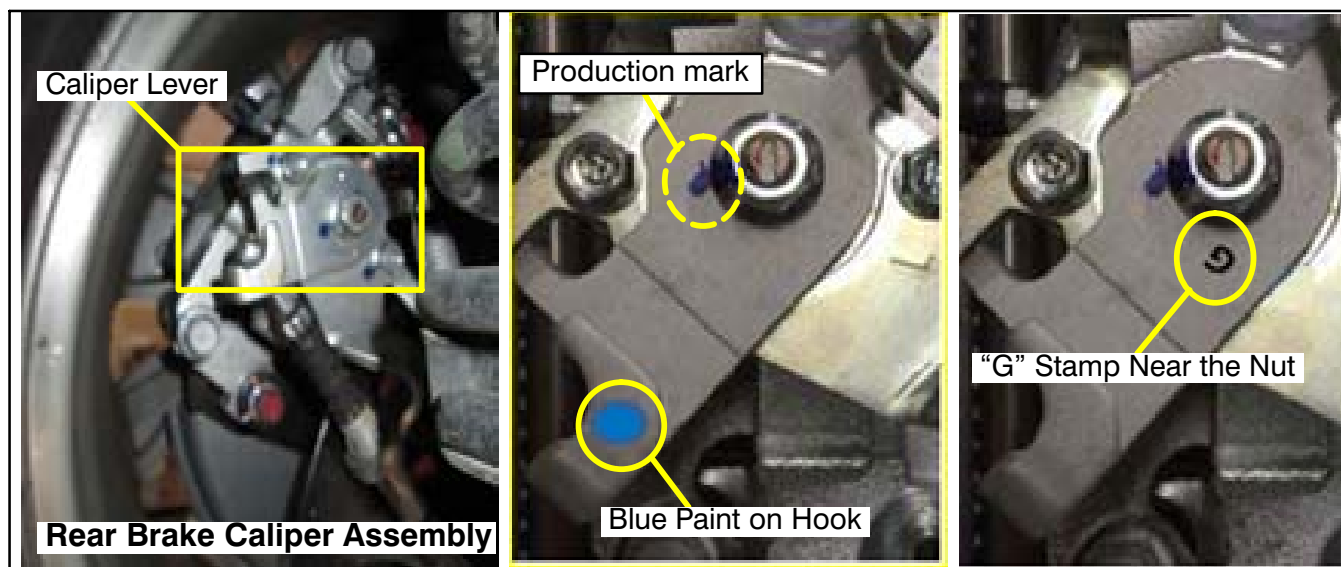
If blue paint mark is found on the hook of the caliper lever or if “G” is stamped near the nut, the caliper is already a countermeasure unit. No further inspection or replacement work is required.

NOTE: Blue or green marks located on areas other than the lever hook are production marks and do not mean they are improved parts.

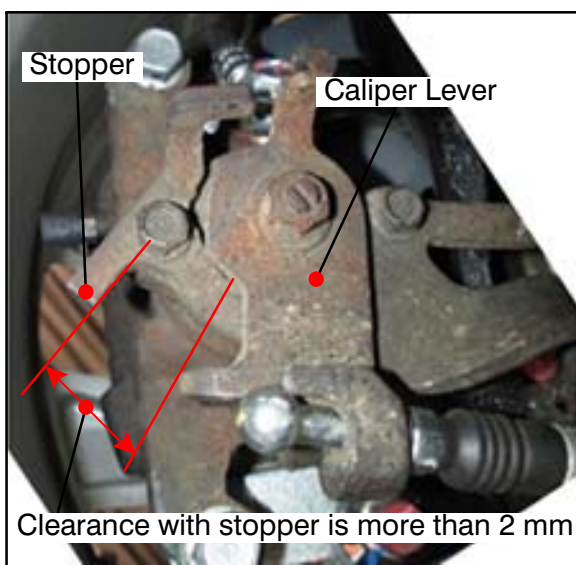
7. Inspect the clearance between the Caliper Lever and Stopper.
 - a. If the rear brake caliper lever is not in original position (clearance between the lever and stopper is more than 2 mm) when the parking lever inside the cabin is released, **replace caliper body assembly**.
 - b. If the clearance between the lever and stopper is less than 2 mm, but the rear brake caliper lever will not return to the original position when the caliper lever fixing nut is turned using a box end wrench and released, or if the lever is stiff to return when manually operated, **replace caliper body assembly**.

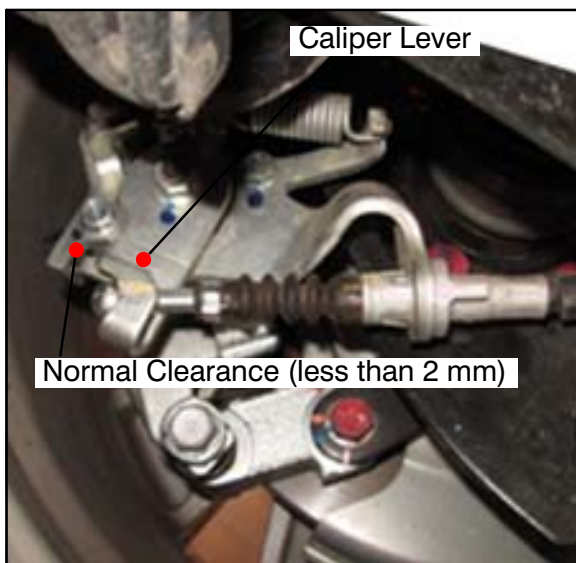
- c. If the caliper lever is at the original position (clearance between the lever and stopper is less than 2 mm), and the caliper lever smoothly returns to position, proceed to **INSPECT OPERATING SHAFT AND CALIPER BODY GROOVE (page 8)**.

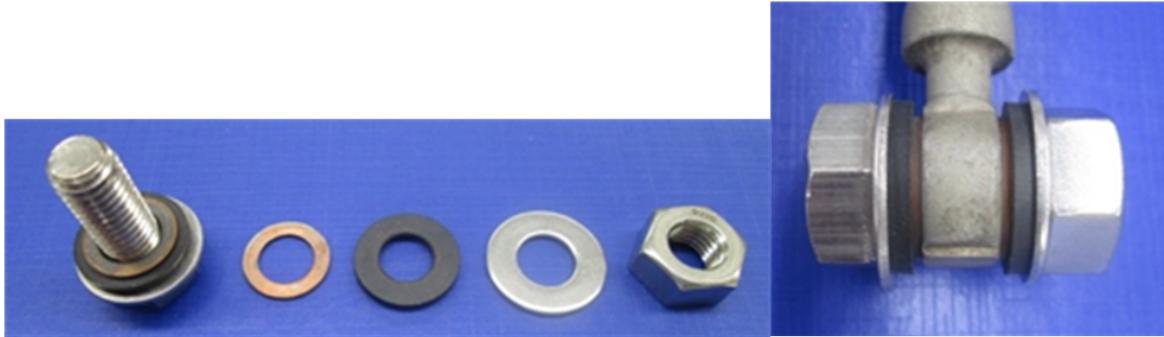
Introduction of brake fluid stopper.

Bolt(M10*25), 2*Plain washer(M10 10.5x21) Rubber seal(M10: 10*18*2mm), 2*Gasket(from the vehicle), Nut(M10).

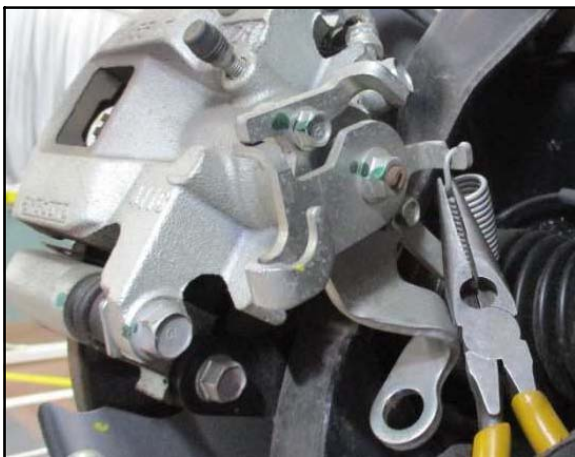
INSPECT OPERATING SHAFT AND BODY CALIPER GROOVE

1. Unhook the spring from the lever, using needle nose pliers.

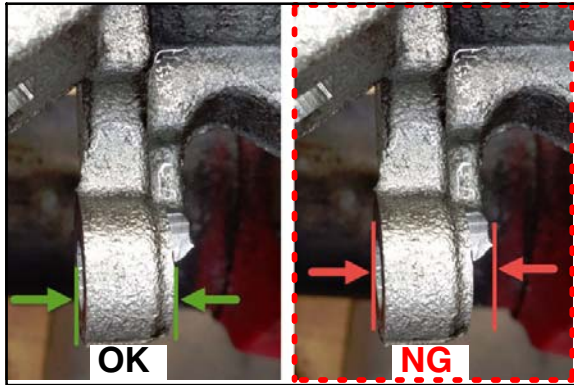
4. Clamp the caliper body assembly with a vise, at the illustrated section. **(Only if caliper body has been removed, on page 7.)**

CAUTION: DO NOT fix the caliper body assembly at the stepped section (NG).

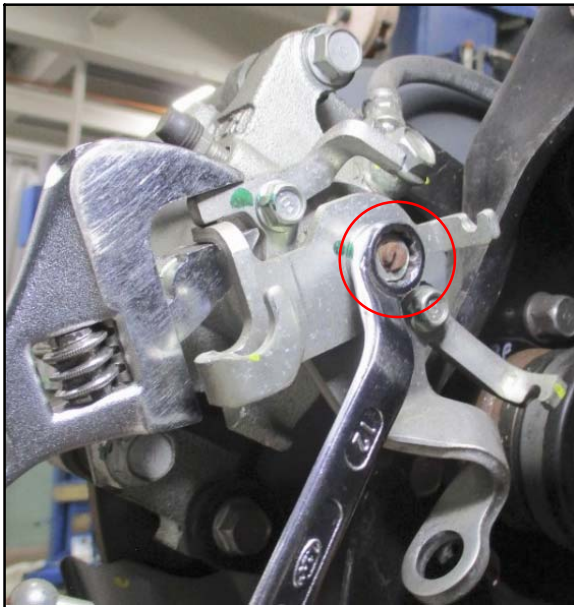
WARNING **Risk of Injury.** Force is required to remove the caliper lever as it is press-fitted. Ensure that the circled nut is loosened and **not** completely removed in the next step.

5. Loosen, **but do not remove**, the nut.

NOTE: To prevent the caliper lever from rotating, fix the stopper on the bracket and lever with an adjustable wrench or locking pliers.

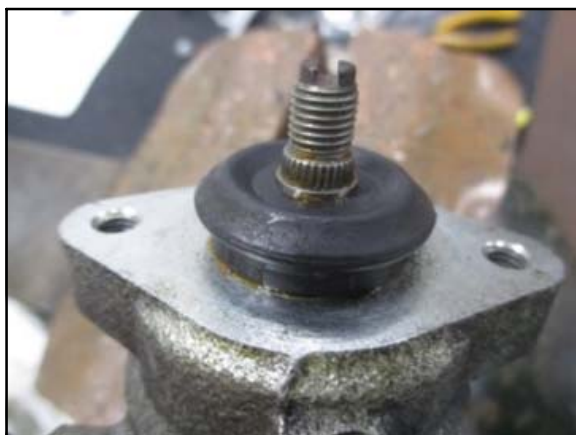
9. Unbolt and remove the bracket.

(After bracket removal.)

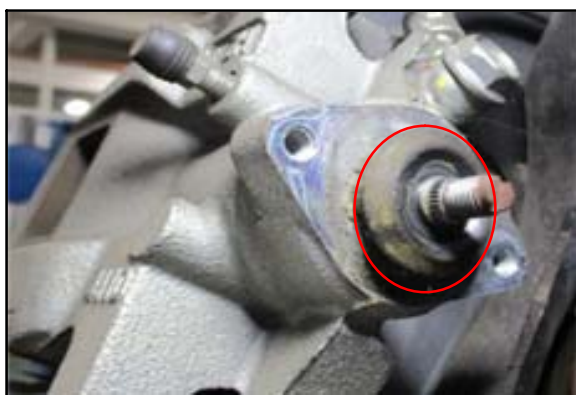
10. Remove the lever boot.

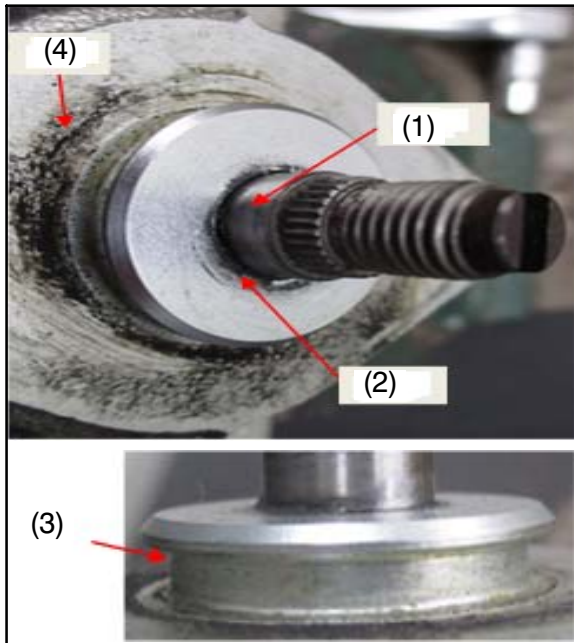
- a. Wipe the operating shaft (1), the hole in the caliper body (2), the caliper body groove (3), and the caliper bracket installation surface (4) with clean rags.

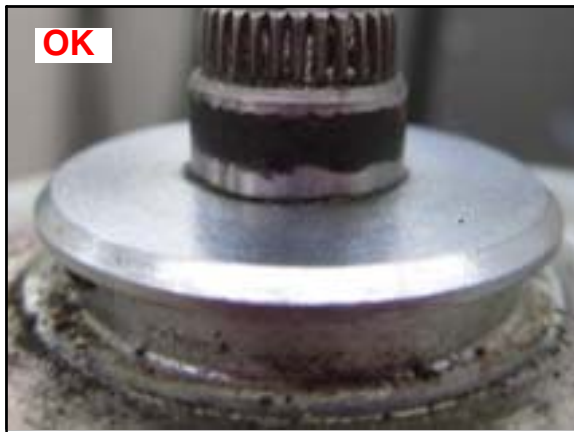
12. Evaluate the rust condition of the operating shaft and caliper body groove.

- a. From the operating shaft, if rust has not reached the caliper body surface and no rust is observed on the flange surface inside the boot, the condition is acceptable. Proceed to **REPLACE CALIPER LEVER AND LEVER BOOT (page 12)**.

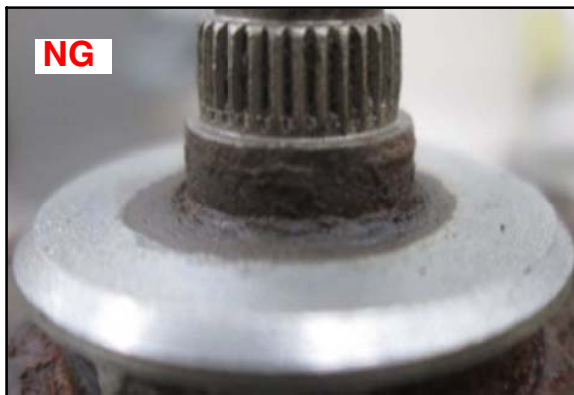
- b. If rust has reached the caliper body surface and/or rust is observed on the flange surface inside the boot, obtain a new Caliper Body Assembly and proceed to **INSTALL CALIPER BODY ASSEMBLY (page 25)**.

NOTE: The condition must be evaluated as NG if any scarring is found on the operating shaft (1) or near the caliper body groove.

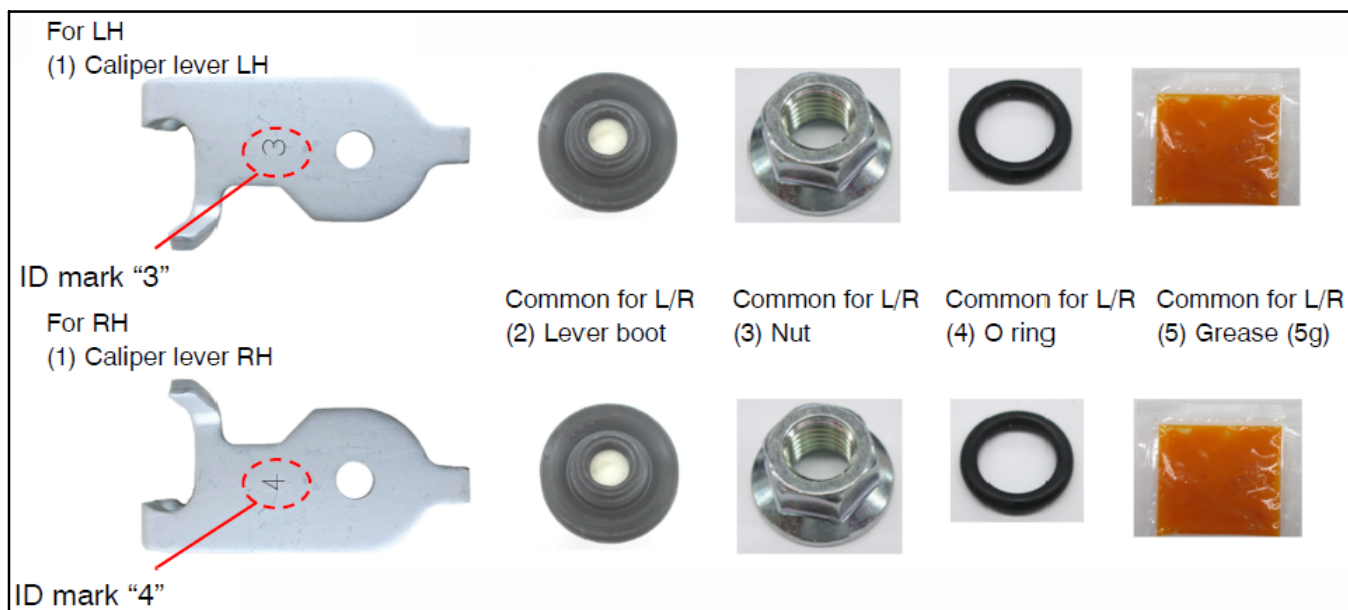
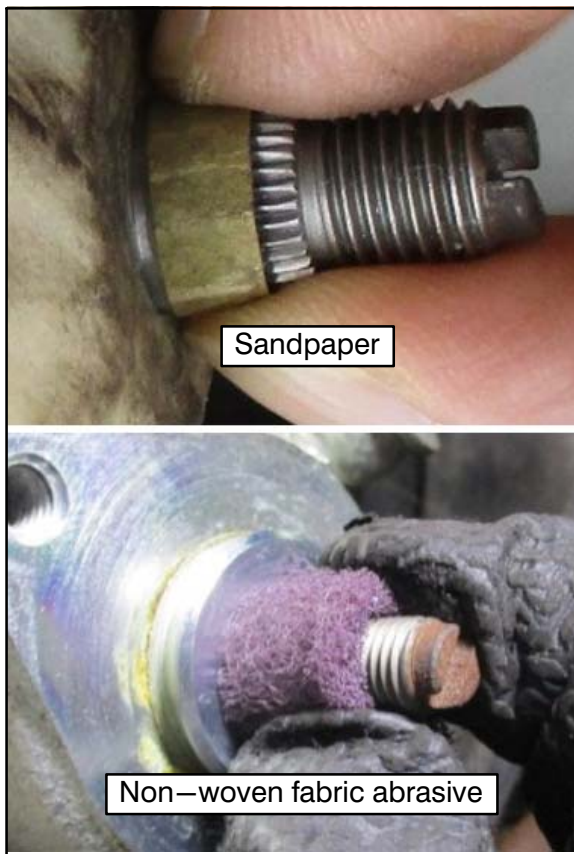
Identify the parts required for the following procedure.

1. Remove the rust on the operating shaft. (Only for cases determined to be "OK" in the evaluation on **page 11**.)
 - a. Remove loose rust using a stainless steel brush and wipe the part with clean rags. Wrap a piece of sandpaper (#400) cut in a strip, non-woven fabric abrasive (3M Scotch-Brite #400), or similar, around the shaft, and rotate it to remove the rust that has built up on the operating shaft surface.
2. Clean the operating shaft's thread with a wire brush.

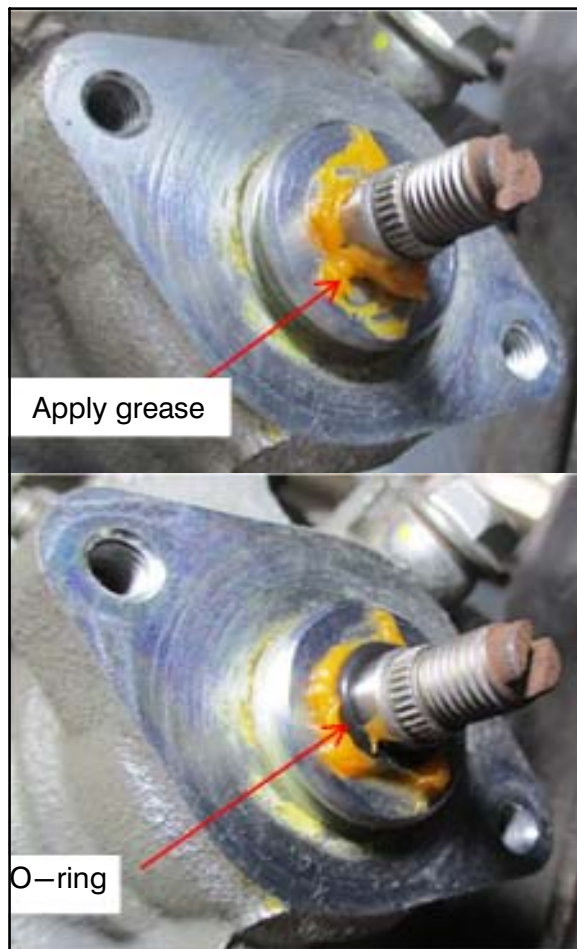
4. Apply grease, included in the lever and boot kit, onto the caliper body around where the operating shaft is inserted, and set the O-ring, included in the lever and boot kit, onto the operating shaft.

NOTE: Make sure no contaminants are present.

NOTE: When applying grease, make sure that it does not go into the threaded bracket mounting holes. Mask the threaded bracket mounting holes, if necessary.

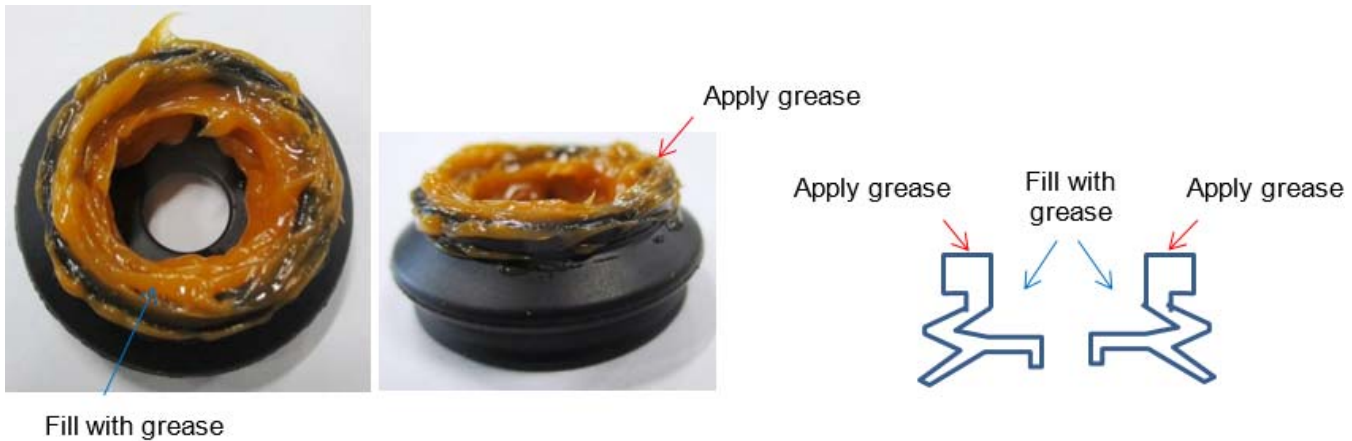
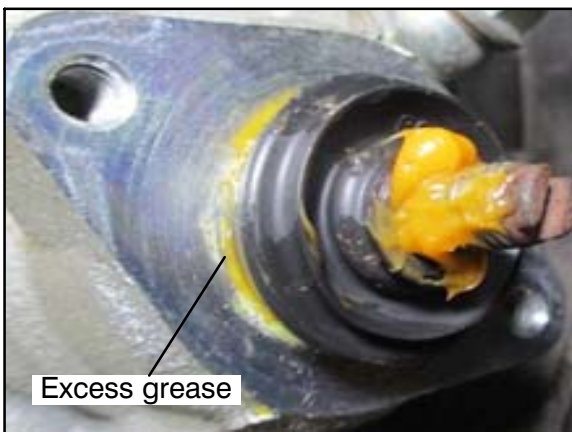
5. Fill inside the lever boot with grease (0.5 g), included in the lever and boot kit, and apply the same grease to the outer circumference of where it mates with the body groove.

6. Securely fit the lever boot to the caliper body groove, and rotate the boot to confirm that it is correctly fitted.
7. Using clean rags, wipe excess grease off of the bracket installation surface.

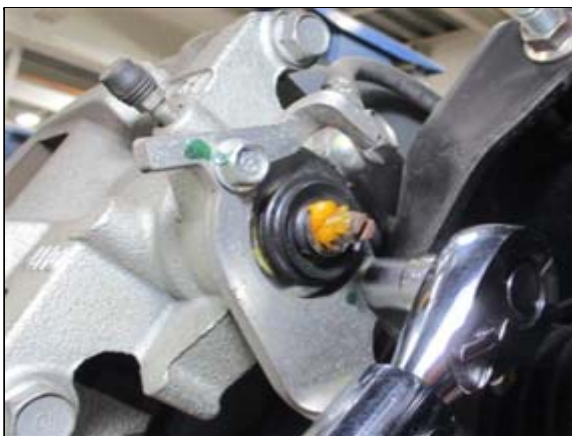
8. Install the bracket.
 - Flange bolt tightening torque: **70 to 103 in-lb (7.85 to 11.7 Nm)**

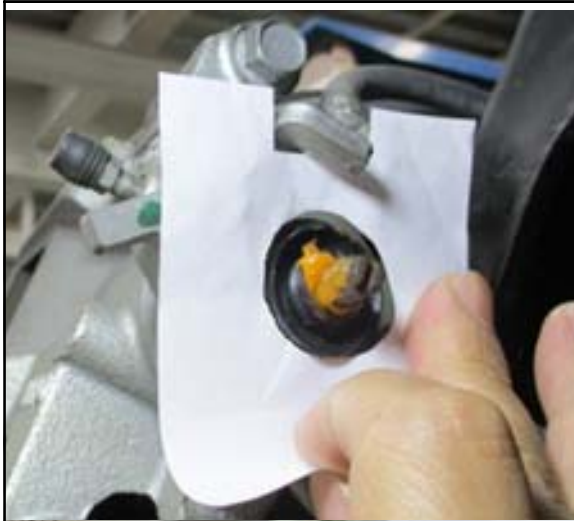
9. Use a masking sheet to prevent grease from spreading to the surrounding surfaces and apply grease on the outside of the lever boot (0.5 g).

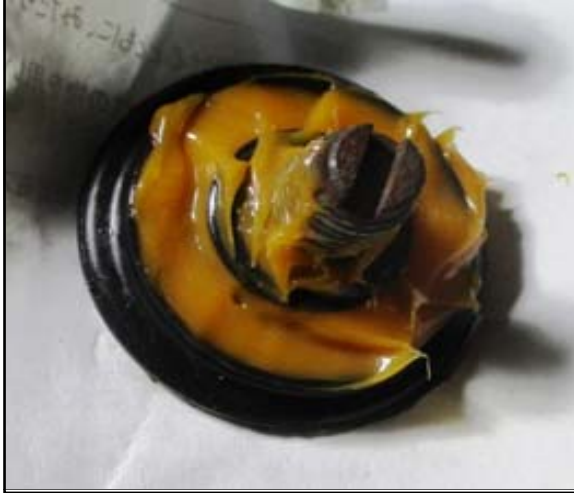
10. Apply grease to the dipped portion and outer lip of the outer surface of the lever boot.
11. Remove the masking sheet.

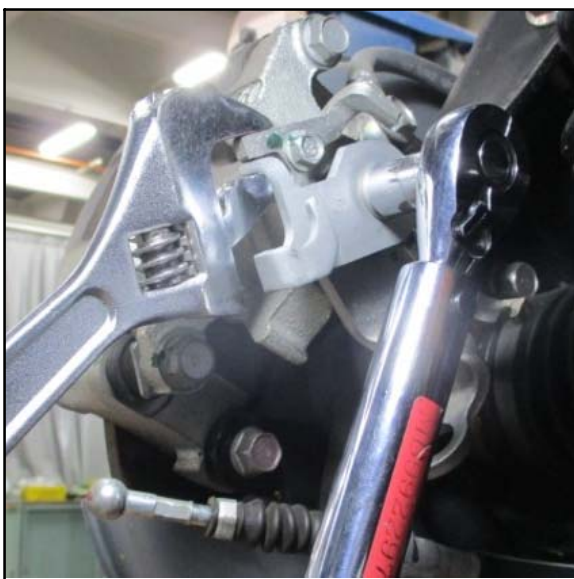
12. Set the new caliper lever to the original position, apply grease to the thread of the operating shaft, pre-assemble the caliper lever **using the original nut that was removed during step 7 of the INSPECT OPERATING SHAFT AND BODY CALIPER GROOVE section (page 9).**

- a. Confirm that grease has been applied to the thread of the operating shaft before tightening the nut. In order to lower the tightening torque, the nut is to be tightened **only after** grease has been applied to the threaded portion of the operating shaft.
- b. Fix the stopper and caliper lever with an adjustable wrench or locking pliers to prevent the operating shaft from rotating, and hand tighten the **original nut** until the caliper lever has been pushed onto the operating shaft's serration.

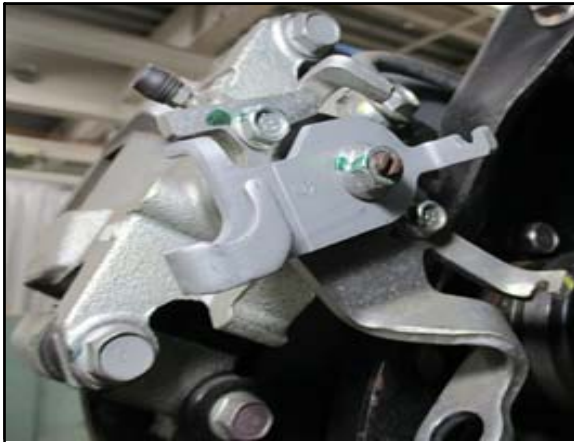
15. Confirm that the caliper lever is at the original position after it is assembled. (The clearance between the lever and stopper must be 1 mm or less.)

NOTE: The lever cannot be reused. Dispose the lever if the clearance is larger than 1 mm.

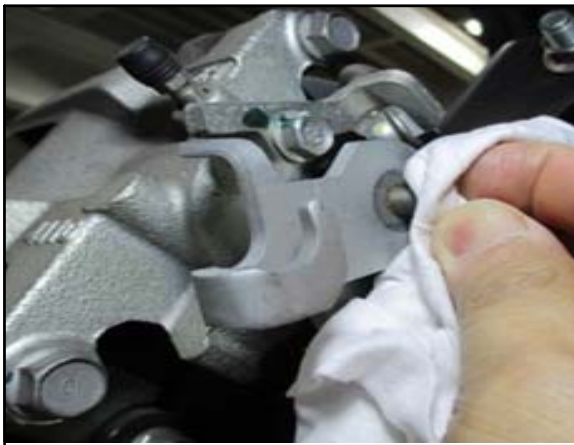
16. Confirm that the caliper lever is press-fitted to the operating shaft.

17. Remove and discard the **original nut**, and wipe off the grease on the thread of the operating shaft with dry, clean rags.

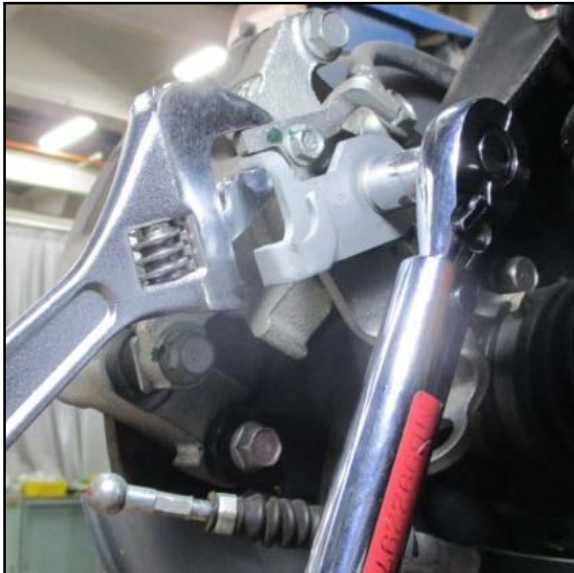
18. Fix the caliper lever using the **new nut** included in the lever & boot kit.

- Tightening torque: **13 to 19.5 ft-lb (17.7 to 26.5 Nm)**

WARNING: If the nut cannot be tightened to the specified tightening torque, it is possible that the operating shaft may be broken. In that case, replace the caliper body assembly.

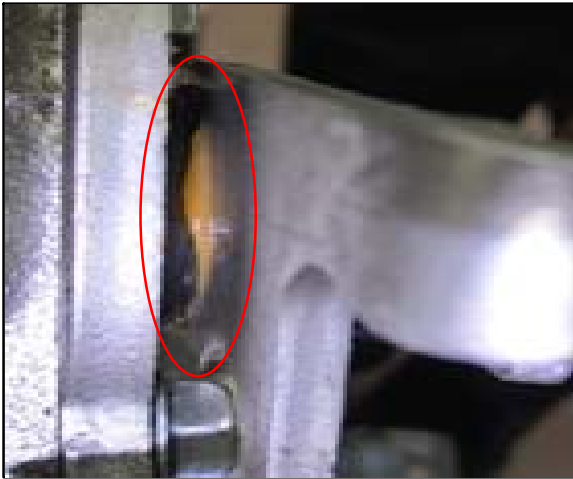
NOTE: There is no need to wipe off excess grease that flows out of the boot after the lever has been tightened (Grease overflows as the boot is filled with a sufficient amount, and therefore, this is not an issue.)

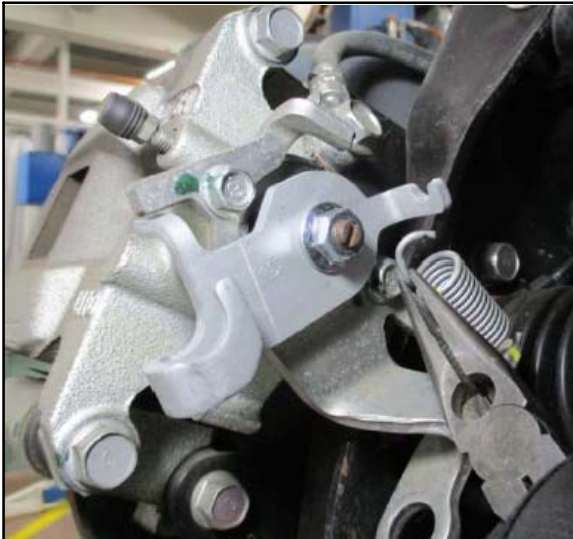
19. Install the spring.

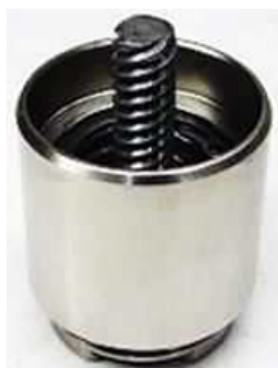
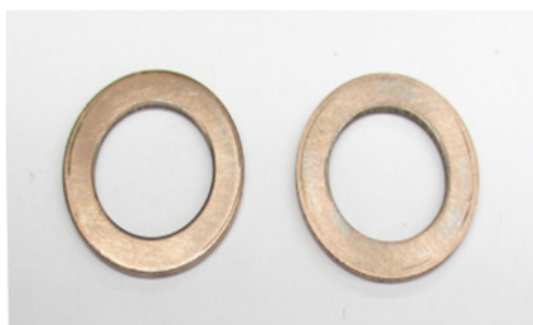
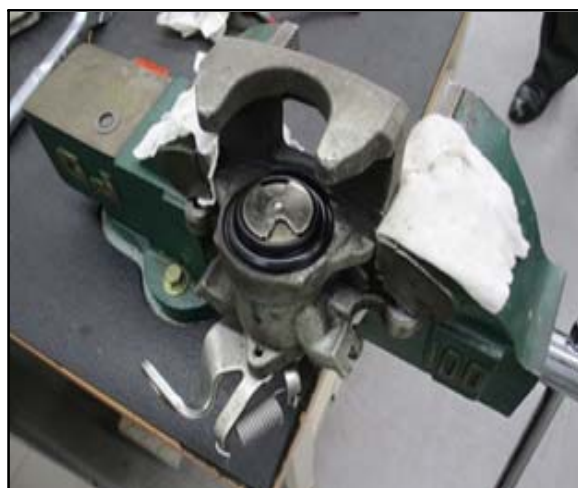
<Piston Assy 4605C046> <Gasket 4650B827QA >>2 gaskets per wheel>

1. Clamp the caliper body assembly in the vise.

CAUTION: When clamping the caliper body assembly with a vise, sandwich the caliper body with wood or rags, to prevent damage to the caliper body.

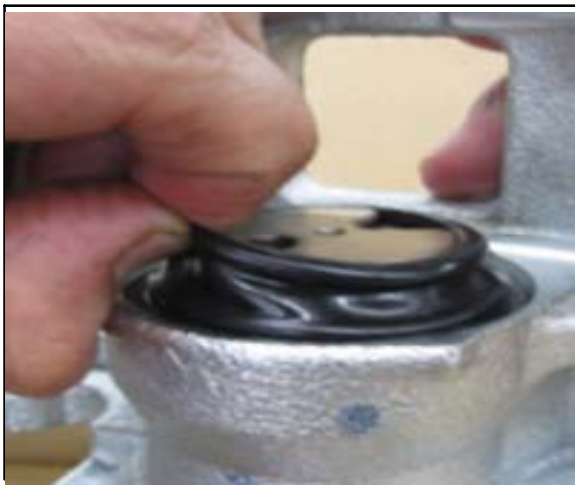
2. Pull up the piston, pinch and remove the piston boot.

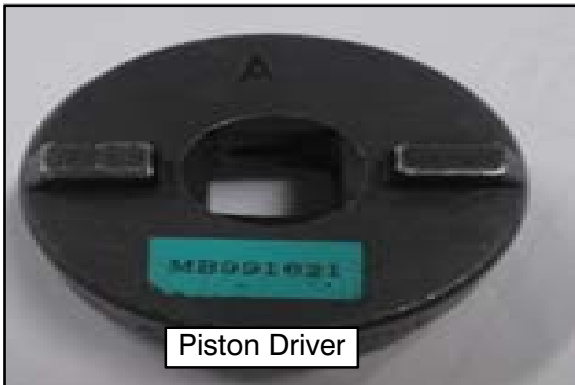
3. Use a Piston Driver and rotate counterclockwise to remove piston assembly from the caliper.

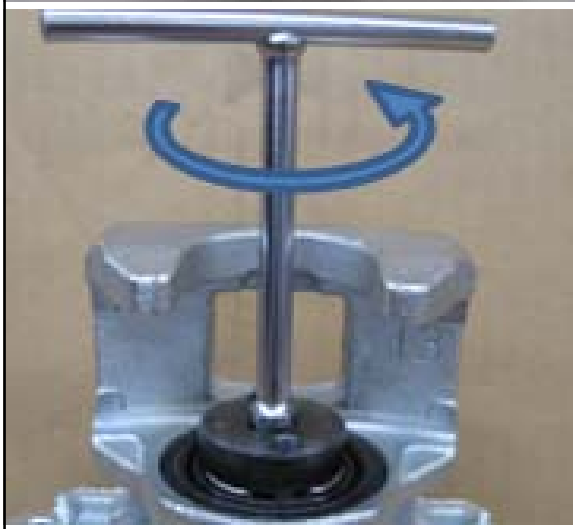
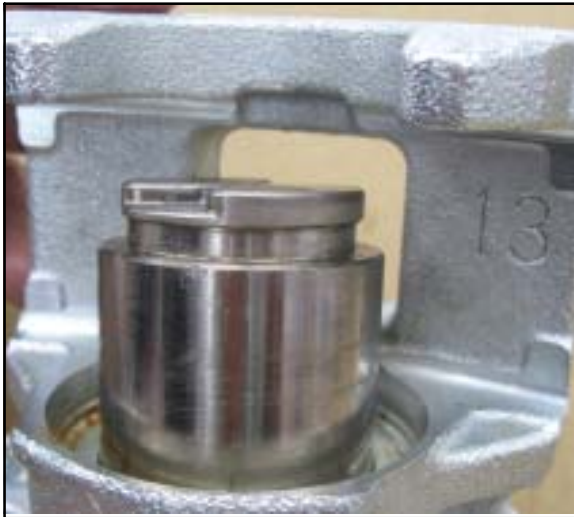
4. Pull up and remove the piston.

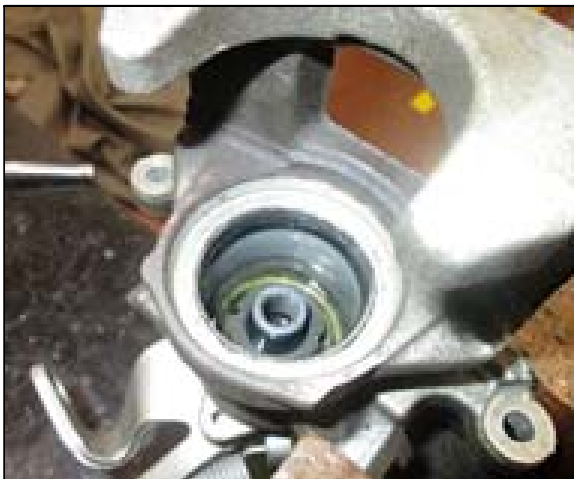
CAUTION: Do NOT allow any foreign materials to enter the caliper cylinder.

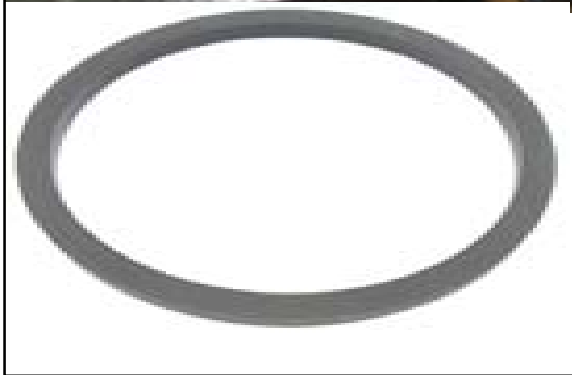
6. Apply the grease in washer kit to the new piston seal, from kit, as shown on the dotted lines.
- a. Fit the new, greased seal into the gap.

CAUTION: Confirm that the seal is fully seated.

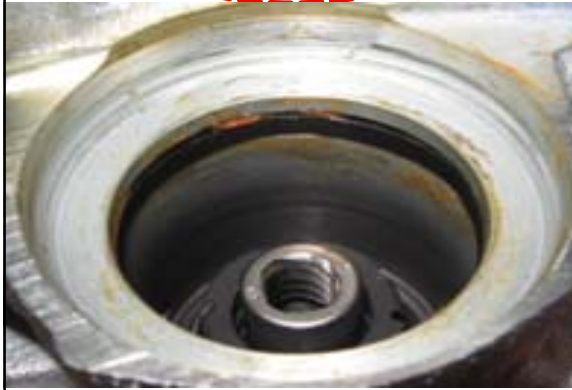
7. Apply the grease to the inner and outer races of the piston boot, as shown on the dotted lines.

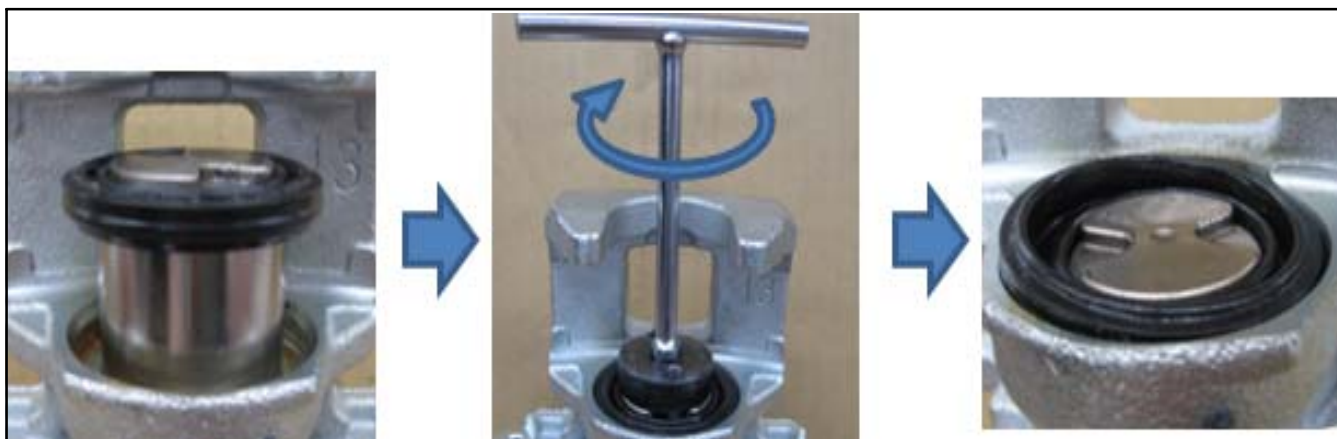
9. Use a Piston Driver to assemble the piston assembly to caliper body.

10. Fit the piston boot outer race to the caliper body gap.

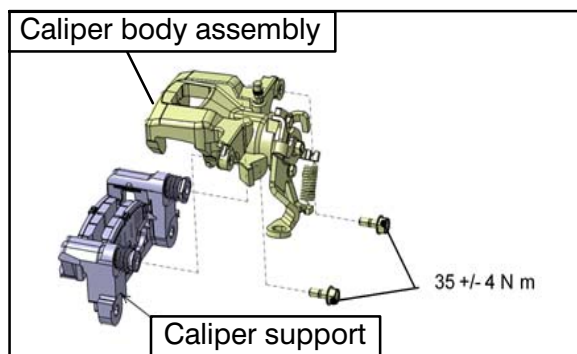
2. Bolt the improved caliper body assembly to the caliper support on the vehicle side.
 - Flange bolt tightening torque: **26 ± 2 ft—lb (35 ± 4 Nm)**

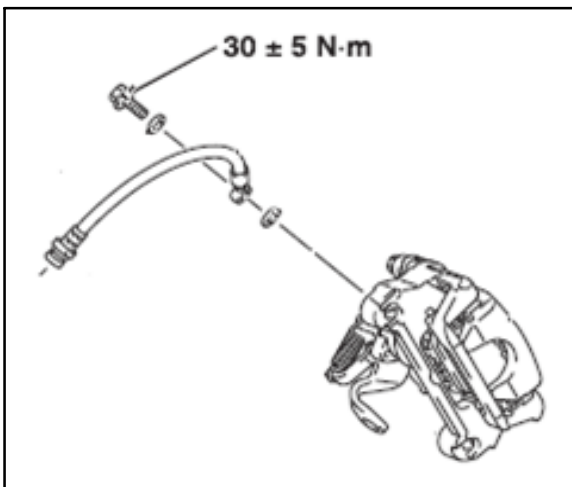
3. Place new gaskets on both sides of the metal fitting of the brake hose and tighten the connector bolt.

- Brake hose connector bolt tightening torque: **22 ± 3 ft-lb (30 ± 5 Nm)**

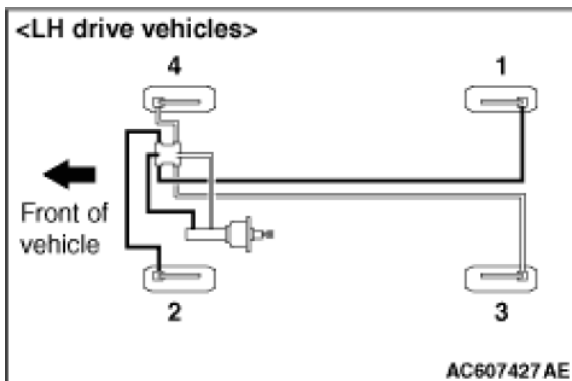
4. Fill brake fluid and bleed air.

- a. Bleed air in the order specified in the drawing.
- Bleeder screw torque: **70 ± 7 in-lb (7.9 ± 0.9 Nm)**
