SAFETY RECALL BULLETIN

SUBJECT:			No:	SR-18-002REVII
PARKING BRAKE	DATE:	June 2018		
CA	MODE	L: See Below		
CIRCULATE TO:	[X] GENERAL MANAGER	[X] PARTS MANAGER		[X] TECHNICIAN
[X] SERVICE ADVISOR	[X] SERVICE MANAGER	[X] WARRANTY PROCES	[X] SALES MANAGER

This campaign bulletin instructs dealers to inspect the rear brake calipers and, if necessary, replace the parking brake boot and lever or the brake caliper body. On certain affected vehicles, the dealer must also replace the piston assembly and piston boot.

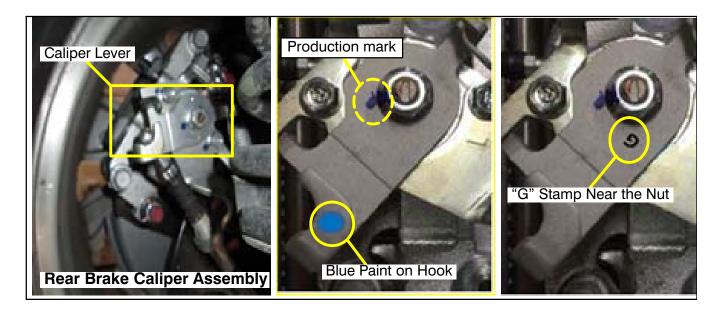
If blue paint mark is found on the hook of the caliper lever or if "G" is stamped near the nut, the caliper is already a countermeasure unit. No further inspection or replacement work is required.

NOTE: Blue or green marks located on areas other than the lever hook are production marks and do not mean they are improved parts.

The affected parts may have already been replaced with improved parts even if the vehicle is listed as a campaign—affected vehicle. Check for identification marks on the caliper lever of the rear brake caliper assembly to determine whether the repair/replacement procedures are required.

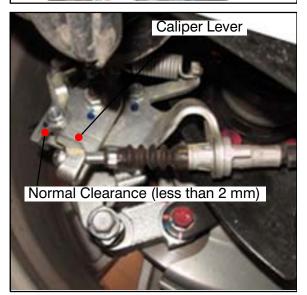
INSPECT CALIPER CLEARANCE AND STICKING

- Loosen the adjusting nut to allow slack in the parking brake cables.
- 5. Raise the vehicle.
- 6. Remove rear left and rear right tires.
- 7. Inspect the clearance between the Caliper Lever and Stopper.

- a. If the rear brake caliper lever is not in original position (clearance between the lever and stopper is more than 2 mm) when the parking lever inside the cabin is released, replace caliper body assembly.

- b. If the clearance between the lever and stopper is less than 2 mm, but the rear brake caliper lever will not return to the original position when the caliper lever fixing nut is turned using a box end wrench and released, or if the lever is stiff to return when manually operated, replace caliper body assembly.

- c. If the caliper lever is at the original position (clearance between the lever and stopper is less than 2 mm), and the caliper lever smoothly returns to position, proceed to INSPECT OPERATING SHAFT AND CALIPER BODY GROOVE (page 8).

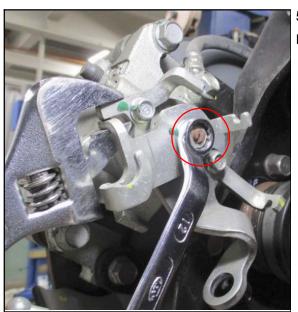
Risk of Injury. Force is required to remove the caliper lever as it is press—fitted. Ensure that the circled nut is loosened and **not** completely removed in the next step.

5. Loosen, but do not remove, the nut.

NOTE: To prevent the caliper lever from rotating, fix the stopper on the bracket and lever with an adjustable wrench or locking pliers.

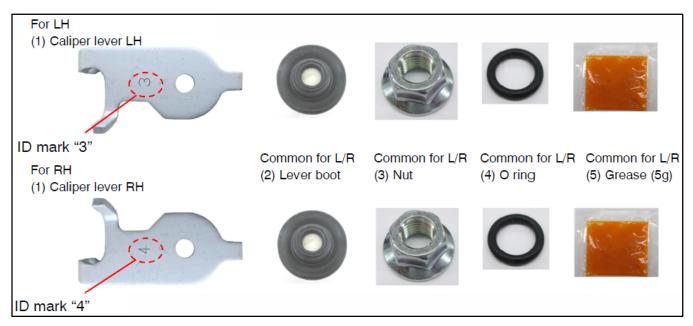
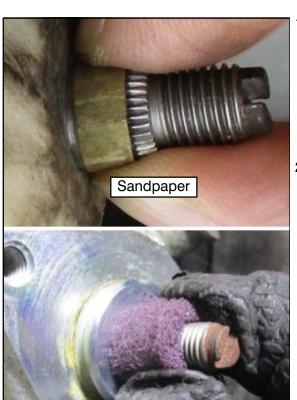
REPLACE CALIPER LEVER AND LEVER BOOT

Identify the parts required for the following procedure.

Non-woven fabric abrasive

- Remove the rust on the operating shaft. (Only for cases determined to be "OK" in the evaluation on page 11.)
 - a. Remove loose rust using a stainless steel brush and wipe the part with clean rags. Wrap a piece of sandpaper (#400) cut in a strip, non—woven fabric abrasive (3M Scotch—Brite #400), or similar, around the shaft, and rotate it to remove the rust that has built up on the operating shaft surface.
- 2. Clean the operating shaft's thread with a wire brush.

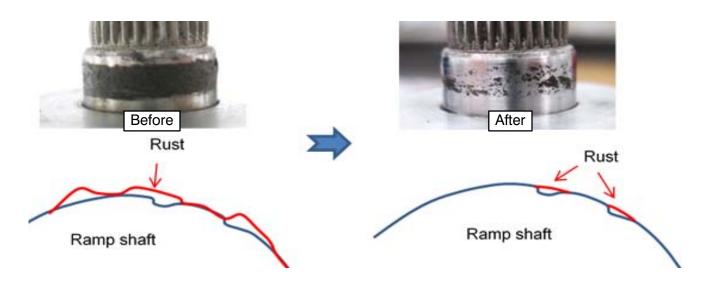
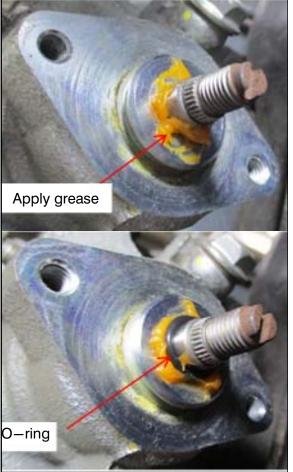
4. Apply grease, included in the lever and boot kit, onto the caliper body around where the operating shaft is inserted, and set the O-ring, included in the lever and boot kit, onto the operating shaft.

NOTE: Make sure no contaminants are present.

NOTE: When applying grease, make sure that it does not go into the threaded bracket mounting holes. Mask the threaded bracket mounting holes, if necessary.

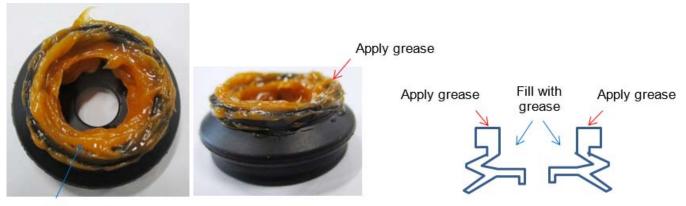
5. Fill inside the lever boot with grease (0.5 g), included in the lever and boot kit, and apply the same grease to the outer circumference of where it mates with the body groove.

Fill with grease

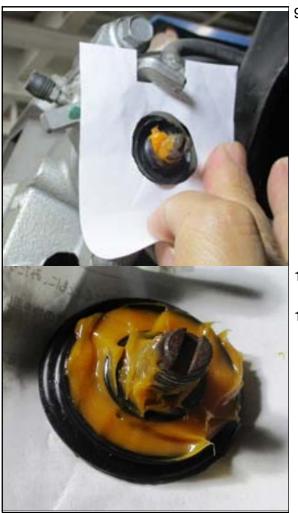
Use a masking sheet to prevent grease from spreading to the surrounding surfaces and apply grease on the outside of the lever boot (0.5 g).

- 10. Apply grease to the dipped portion and outer lip of the outer surface of the lever boot.
- 11. Remove the masking sheet.

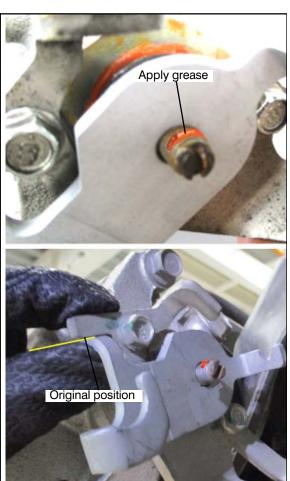
- 12. Set the new caliper lever to the original position, apply grease to the thread of the operating shaft, pre—assemble the caliper lever using the original nut that was removed during step 7 of the INSPECT OPERATING SHAFT AND BODY CALIPER GROOVE section (page 9).
 - a. Confirm that grease has been applied to the thread of the operating shaft before tightening the nut. In order to lower the tightening torque, the nut is to be tightened **only after** grease has been applied to the threaded portion of the operating shaft.
 - b. Fix the stopper and caliper lever with an adjustable wrench or locking pliers to prevent the operating shaft from rotating, and hand tighten the **original nut** until the caliper lever has been pushed onto the operating shaft's serration.

NOTE: Clean the operating shaft's thread with a wire brush if the original nut cannot be tightened by hand.

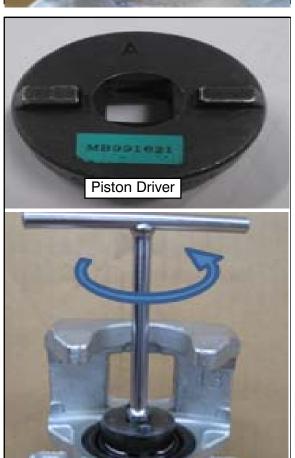
3. Use a Piston Driver and rotate counterclockwise to remove piston assembly from the caliper.

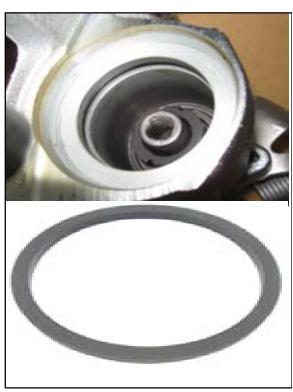
5. Remove the piston seal.

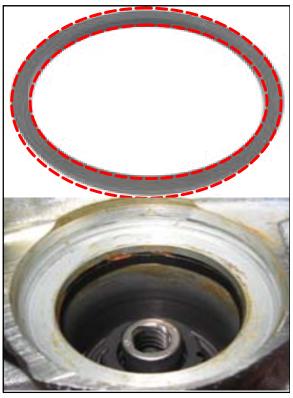
- 6. Apply the grease in washer kit to the new piston seal, from kit, as shown on the dotted lines.
 - a. Fit the new, greased seal into the gap.

CAUTION: Confirm that the seal is fully seated.

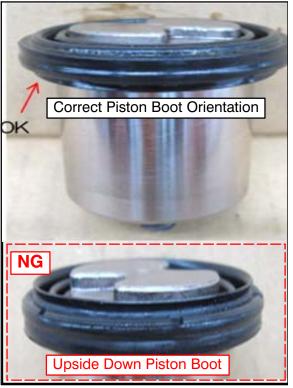
8. Install the new piston boot to the piston assembly.

CAUTION: Do NOT install the piston boot upside down (NG).

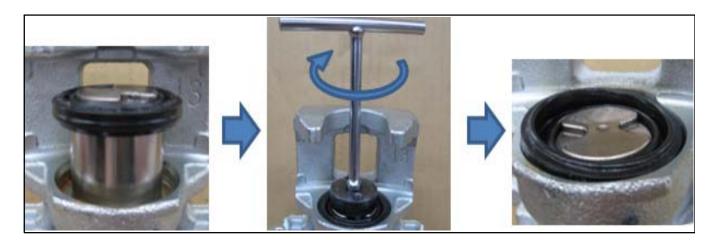
10. Fit the piston boot outer race to the caliper body gap.

- 11. Rotate the piston to the correct position.
- 12. Ensure that the piston does not interfere with the brake pad assembly by ensuring that the brake pad assembly protrusion lines up with the piston stopper groove.
