## **SAFETY RECALL**

**M0320 CONVENTIONAL FUSE BOX  
INSPECTION/REPAIR**

**RECALL NO: M0320**

**SUBJECT VEHICLES:** 18MY-19MY Conventional Trucks equipped with a J08 engine

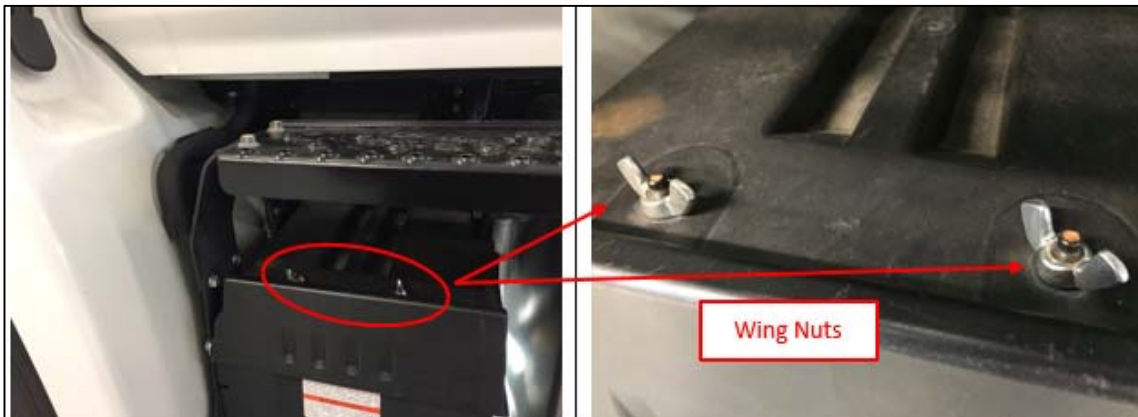
1. Remove the 2 wing nuts securing the battery cover and retain for later reinstallation. Remove the battery cover and retain for later reinstallation.

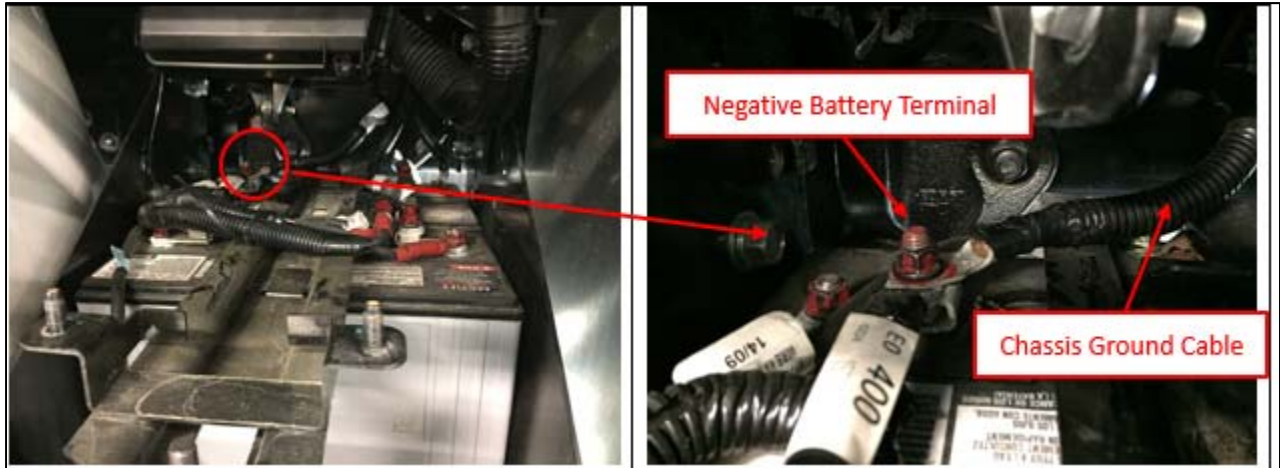
2. Disconnect the negative battery cable (chassis ground) at the negative battery terminal of the battery. Use electrical tape to cover the exposed metal end for the negative battery cable and position away from the battery. This will prevent accidental reconnection to the battery.

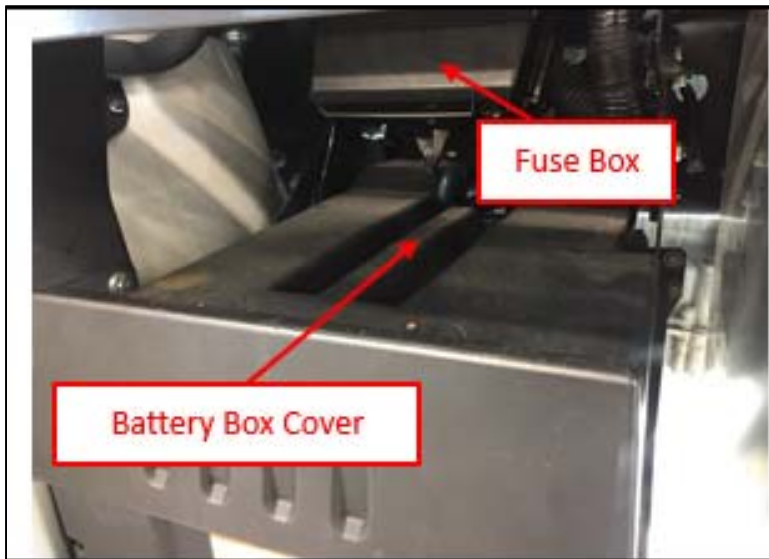
3. Reinstall the plastic battery box cover to the top of the battery box. This should be done to make certain that while working on the fuse box, there are no accidental 12volt short circuits to ground from the exposed battery top. At this time, the wing nuts do not need to be reinstalled.

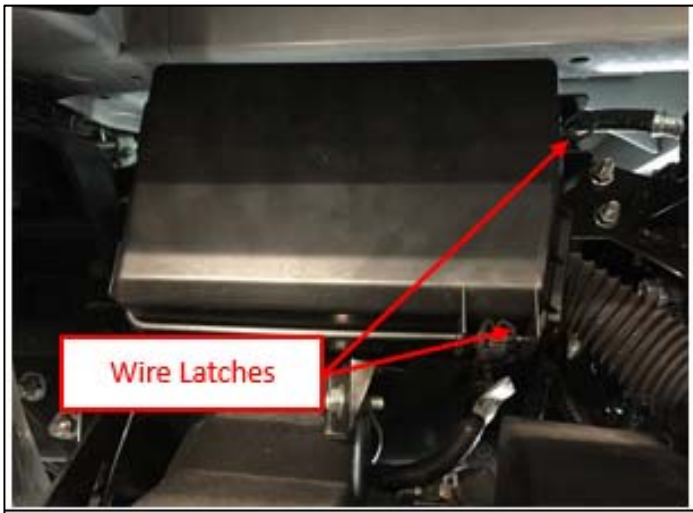
4. Release the (2) fuse box cover wire latches and remove the cover. Retain the cover for later reinstallation.

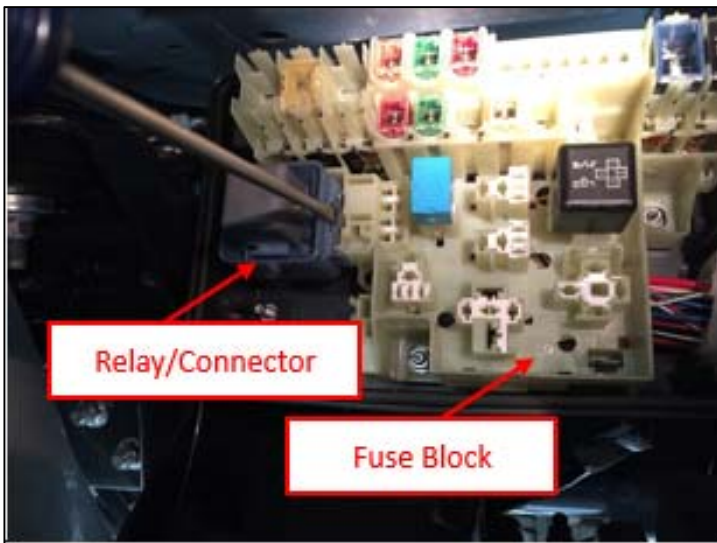
5. Using a small regular screw driver or pick, gently release the relay/connector assembly locking tab and then pull the relay/connector assembly outward from the fuse block.

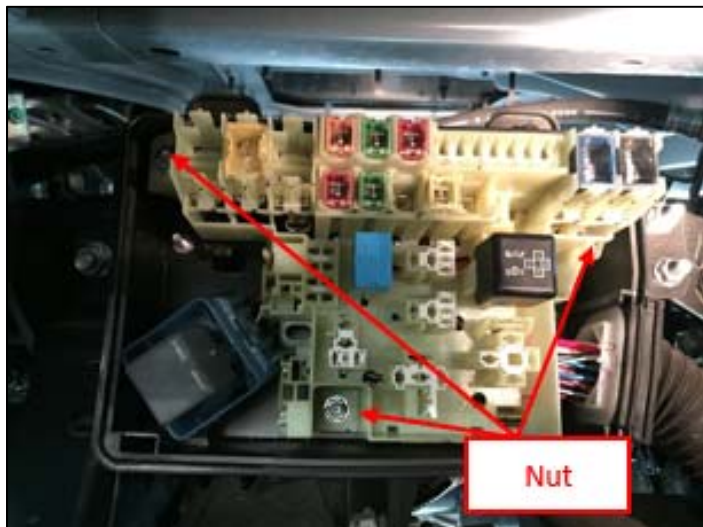
6. Remove the (3) 10mm nuts securing the fuse block to the fuse box. Retain these nuts for later reinstallation.

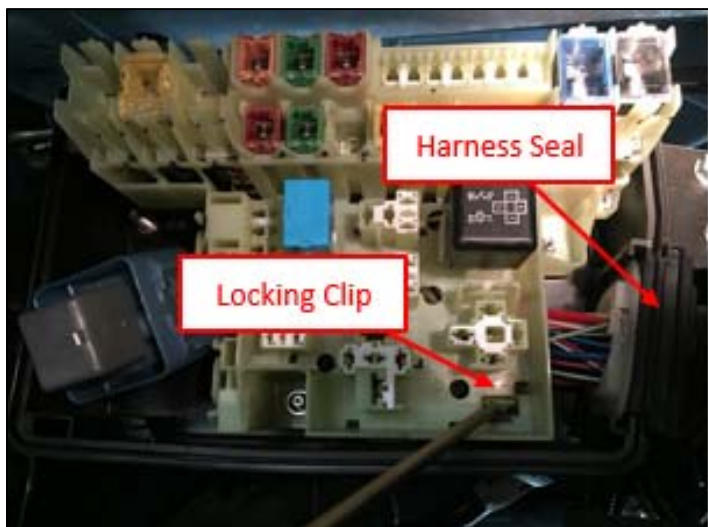
7. Release the fuse block locking clip that secures the fuse block to the fuse box.

**NOTICE:** Care should be taken to ensure the harness seal for the fuse block is not damaged during fuse block repositioning.

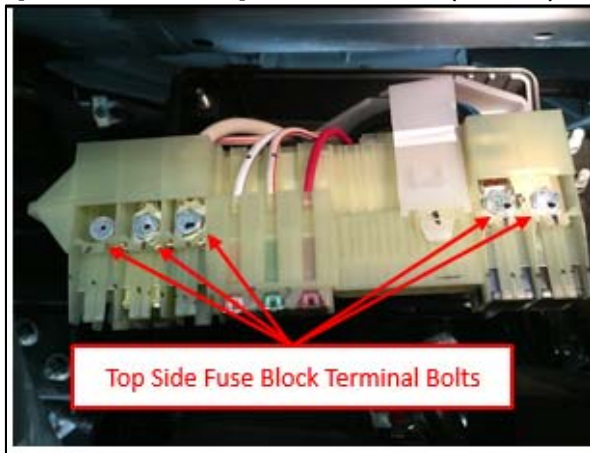
8. On the top side of the fuse block you will find (5) 10mm terminal bolts. The fastening torque for these terminal bolts needs to be confirmed. Using a torque wrench tighten each terminal bolt to the specified torque.

**Specified Torque: 55 in-lb (5 Nm)**

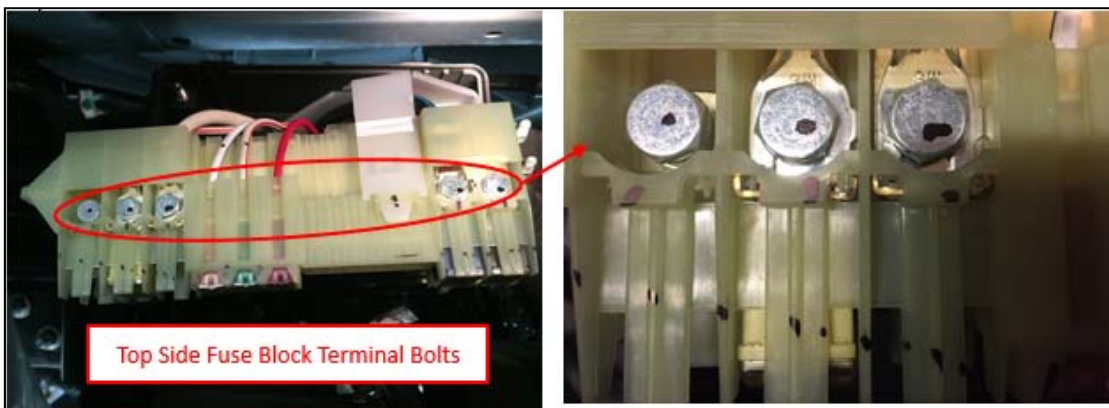
9. If any of the 10mm terminal bolts were found loose, the corresponding electrical connection needs to be visually inspected for damage. Was damage found to the electrical connection, harness or fuse block? **If damage was found, contact TechAssist with documentation of the damage before replacing the harness.**

**Yes** – Proceed to **step 16** of the repair procedure. Replacement of the fuse block wiring harness is required.

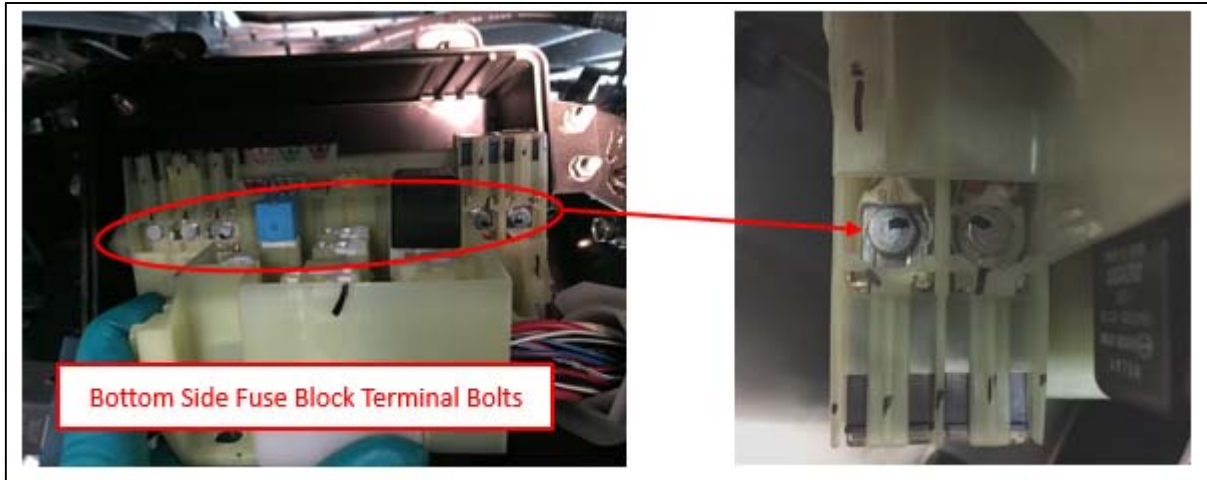
**10.** On the bottom side of the fuse block you will find (5) 8mm terminal bolts. The fastening torque for these terminal bolts needs to be confirmed. Using a torque wrench tighten each terminal bolt to the specified torque.

**Specified Torque:** 27 in-lb (3 Nm)

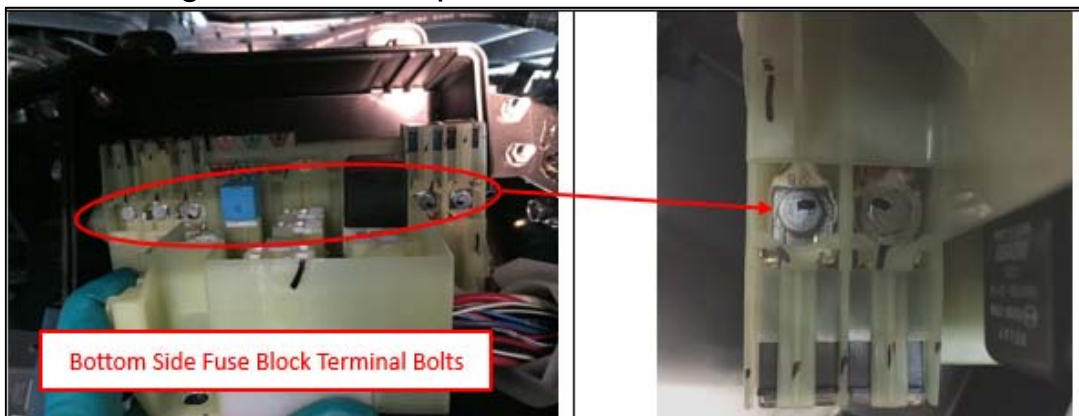
**11.** If any of the 8mm terminal bolts were found loose, the corresponding electrical connection needs to be visually inspected for damage. Was damage found to the electrical connection, harness or fuse block? **If damage was found, contact TechAssist with documentation of the damage before replacing the harness.**

**Yes** – Proceed to **step 16** of the repair procedure. Replacement of the fuse block wiring harness is required.

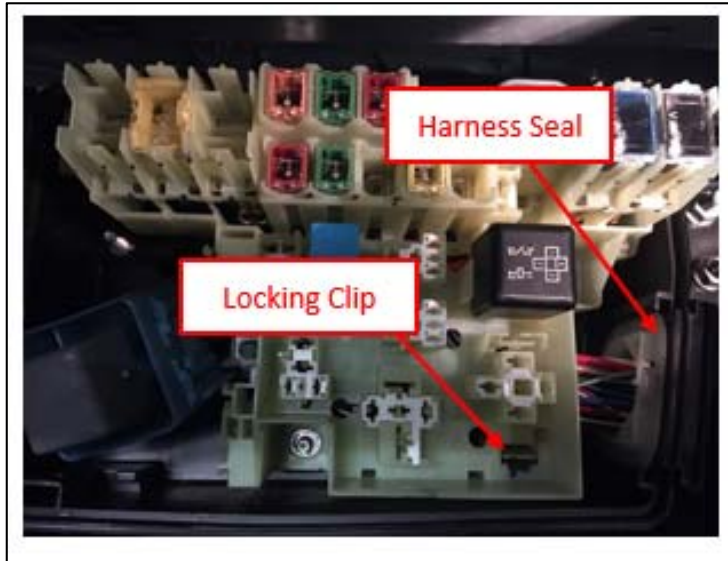
**12.** Install the fuse block in to the fuse box and make certain the locking clip is engaged.

**NOTICE:** Care should be taken to ensure the harness seal is correctly repositioned in the fuse box and no visual damage is present to the seal. Failure to do this can cause water intrusion into the fuse box with subsequent damage.

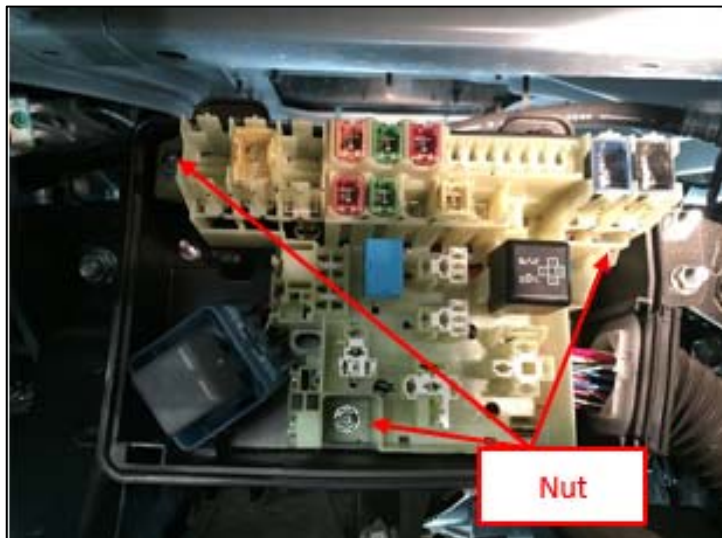
**13.** Install the (3) 10mm nuts securing the fuse block to the fuse box. Torque these nuts to the specified torque.

**Specified Torque:** 55 in-lb (5 Nm)

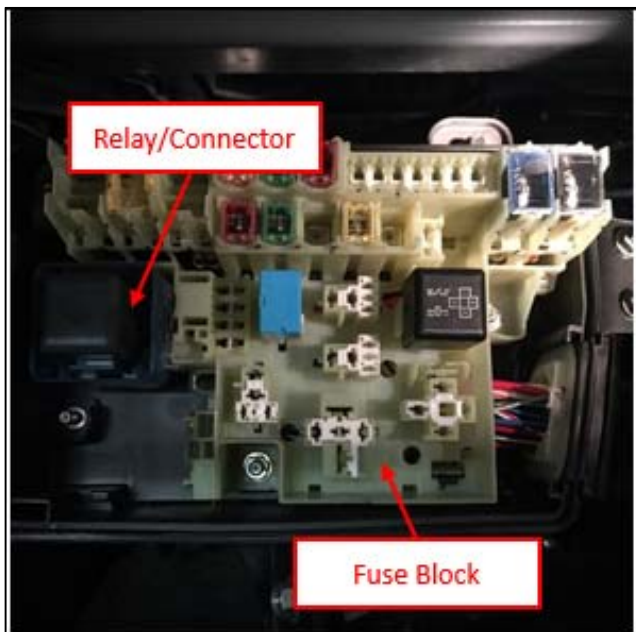
**14.** Clip the relay/connector assembly back onto the side of the fuse block and ensure it is securely latched to the locking clip.

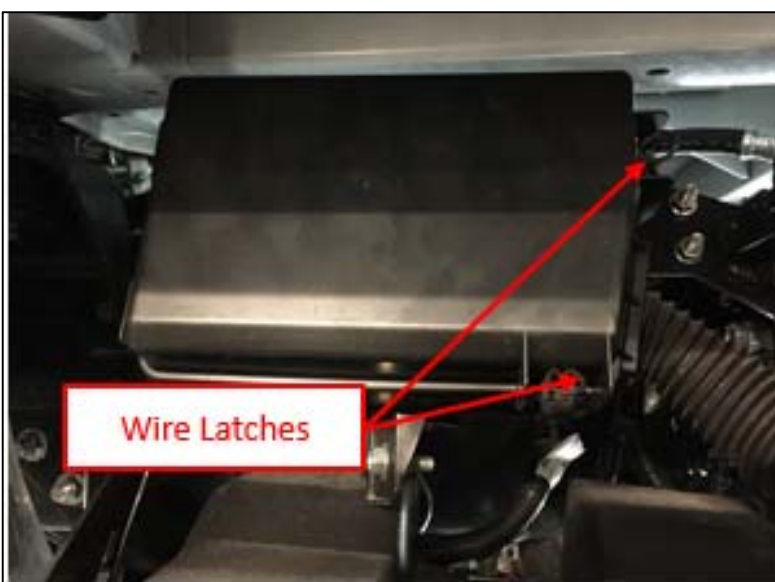
**15.** Install the fuse box cover and engage the (2) wire latches.

**NOTICE:** Care should be taken to ensure the fuse box cover is correctly repositioned and secured. Failure to do this can cause water intrusion into the fuse block with subsequent damage.

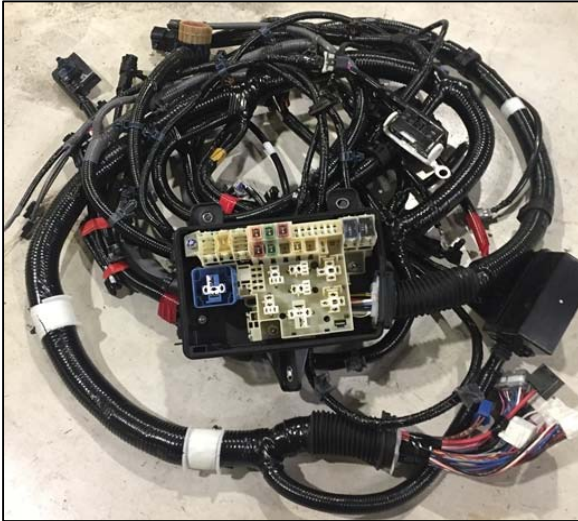
**16.** Reference the part section and select the correct fuse block harness based on your vehicle application. Replace the fuse block harness.

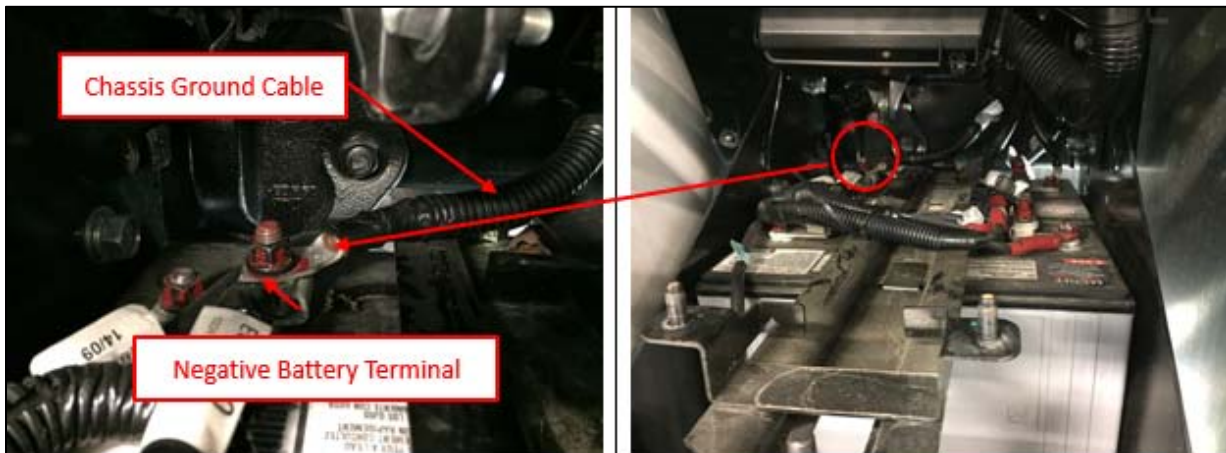
18. Remove the electrical tape from the negative battery cable (chassis ground). Reconnect to the battery ground cable to the negative battery terminal. Install the negative battery terminal nut and tighten to the specified torque.

**Specified Torque:** 98 in-lb (11 Nm)

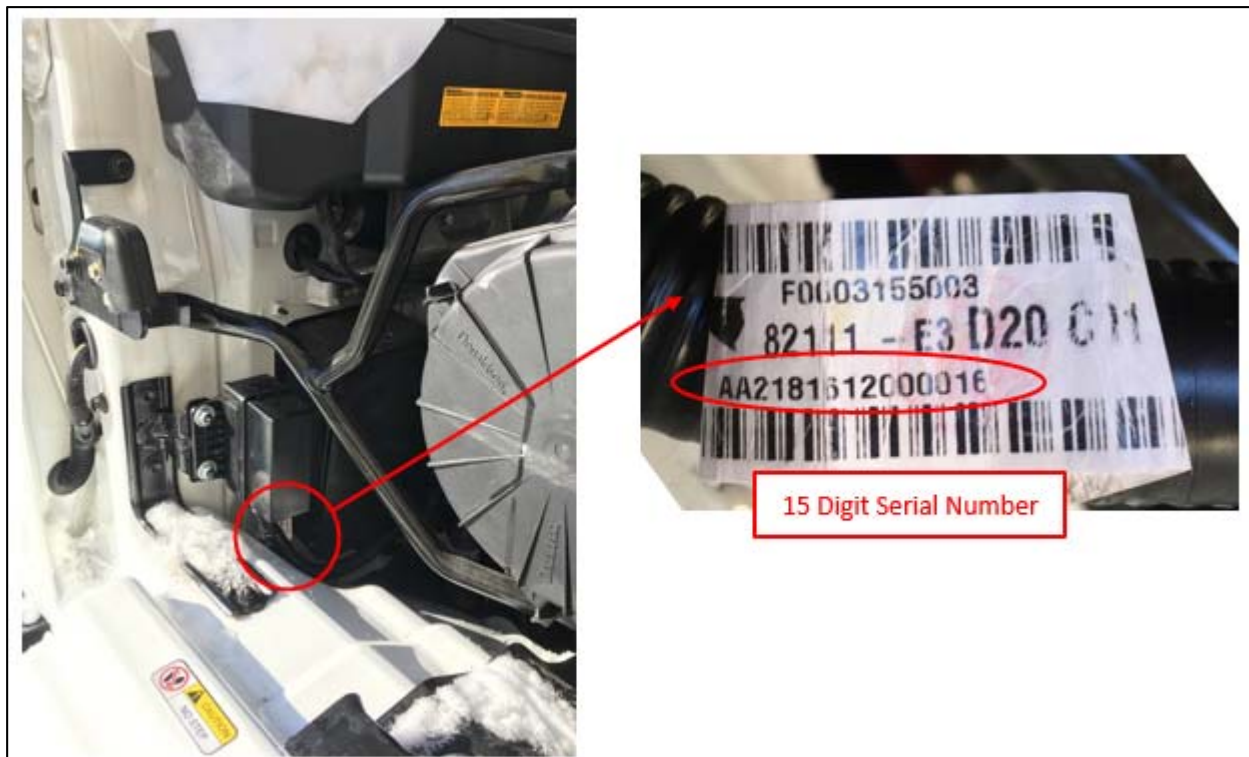
**21.** Locate the fuse block harness part number tag. The following information will need to be documented in the comment section of the warranty claim:

- The (15) digit serial number of the chassis harness.
- Please make a note of the (10) terminal bolts found in the fuse block, were any found to be missing or finger tight (Yes or No)?
