Thor Motor Coach Recall Repair Instructions

Recall #	18V-120 2018-101		
Description/Title:	29J Outlaw Seat Belt Bracket		
Affected Product Line(s):	Certain MY 2018 & 2019 29J Outlaw motorhomes		
Service Campaign # :	RC000151	Released Date:	04/02/2018
Repair Code:	TMCRC80472V	Document Date:	04/02/2018
Time Allowed:	0.67	Document Revision:	A

It has been discovered that on Certain MY 2018/2019 29J Outlaws, the sofa seat belt bracket does not meet the strength requirements of FMVSS/CMVSS 210.

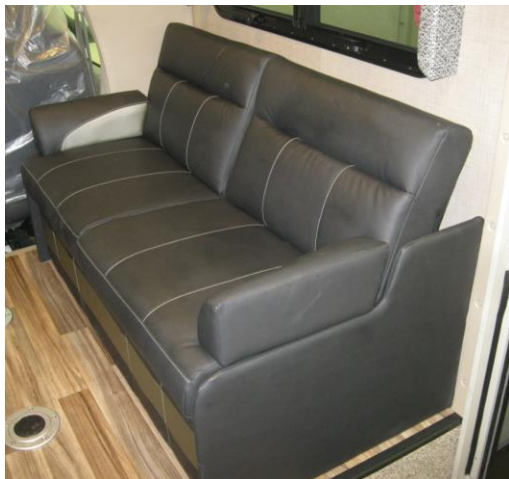
1. Locate the sofa on the passenger side of the motorhome.

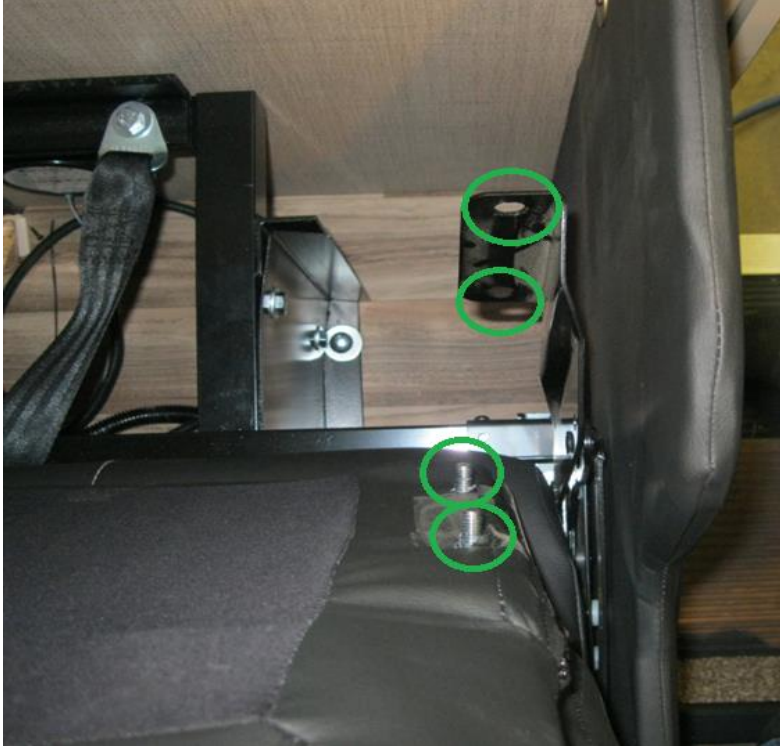
3. Remove the 4 nuts (2 per side) that secure the seat back to the sofa framing.

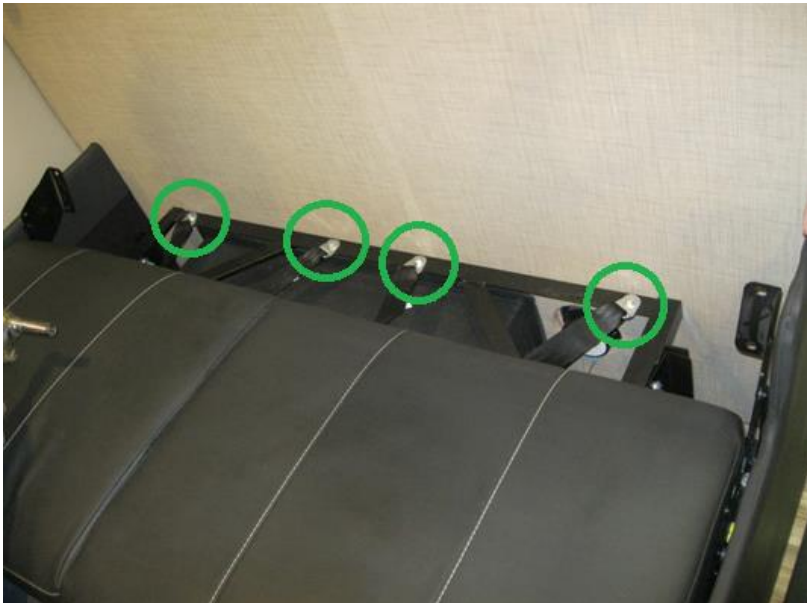
4. Remove and discard the 4 seatbelt bolts from the seatbelt bracket.

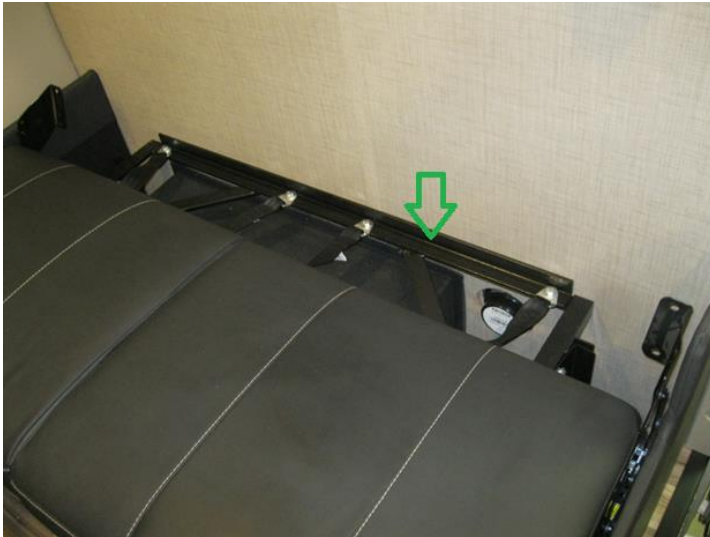
5. Add the Frame Reinforcement Angle (print TFM5493) on top of the seatbelt bracket with the bolt holes aligned. Position the vertical leg of the angle so it's against the sidewall. Reinstall the 2 seatbelts with 4 3/8"-16 x 1 1/2" grade 5 bolts as specified on the assembly drawing (print TFM5491). Use 3/8"-16 grade 5 nuts, flat washers, and lock-washers. Torque the 4 bolts to 18-25 ft-lbs. **(NOTE: nut, bolts, flat washers, and lock-washers are not included in recall kit. Please obtain and claim as shop supplies with recall.)**

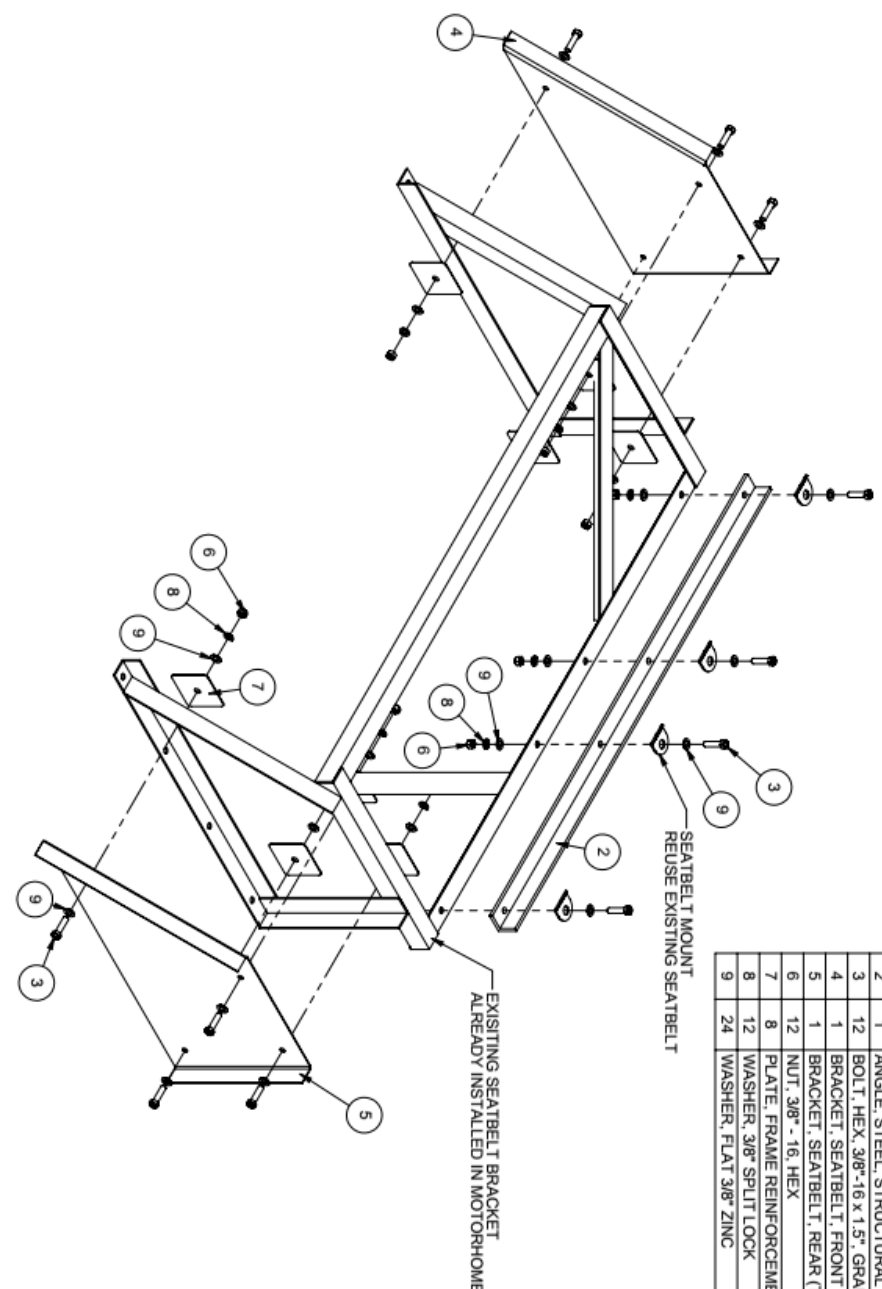
BOM	
NO	DESCRIPTION - W x L (GRAIN)
1	ANGLE FRAME REINFORCEMENT (TFM5493)
2	ANGLE STEEL STRUCTURAL 1 1/2 x 1 1/2 x 1/4
3	BOLT, HEX, 3/8"-16 x 1.5" GRADE 5
4	BRACKET, SEATBELT, FRONT (TFM5492)
5	BRACKET, SEATBELT, REAR (TFM5489)
6	NUT, 3/8" - 16, HEX
7	PLATE, FRAME REINFORCEMENT (TFM5490)
8	WASHER, 3/8" SPLIT LOOK
9	WASHER, FLAT 3/8" ZINC

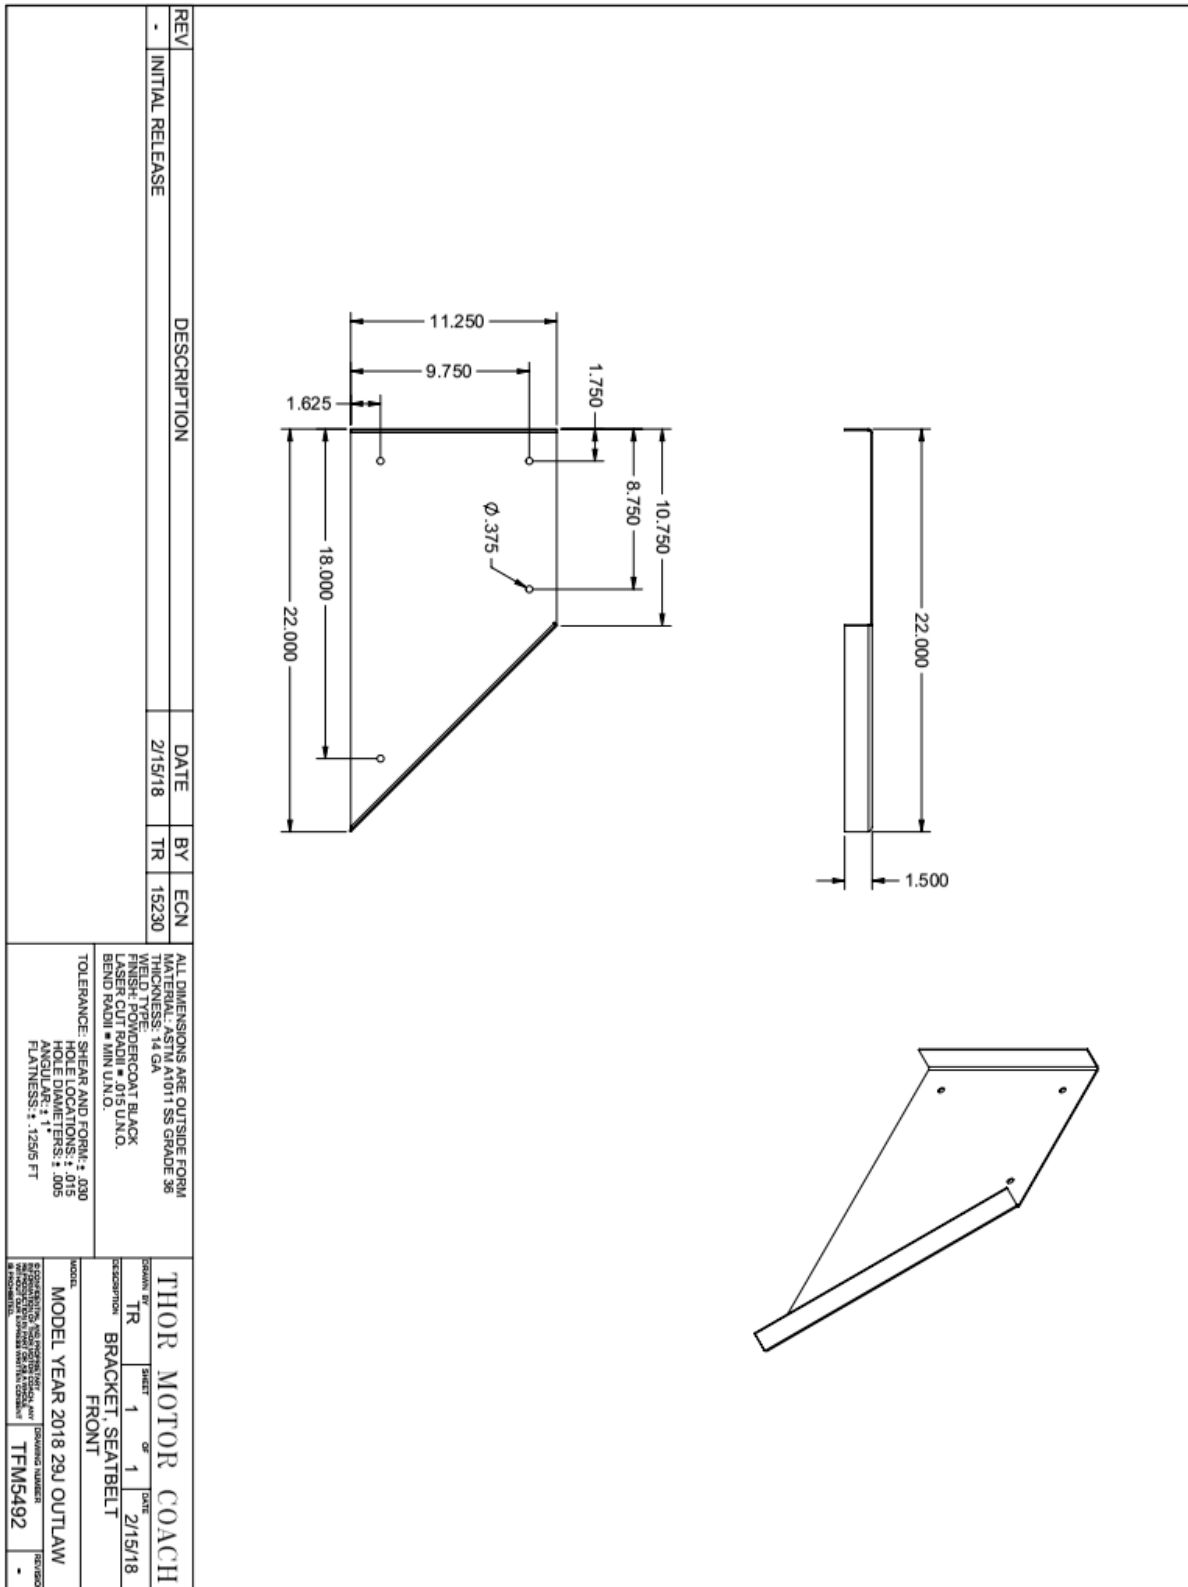
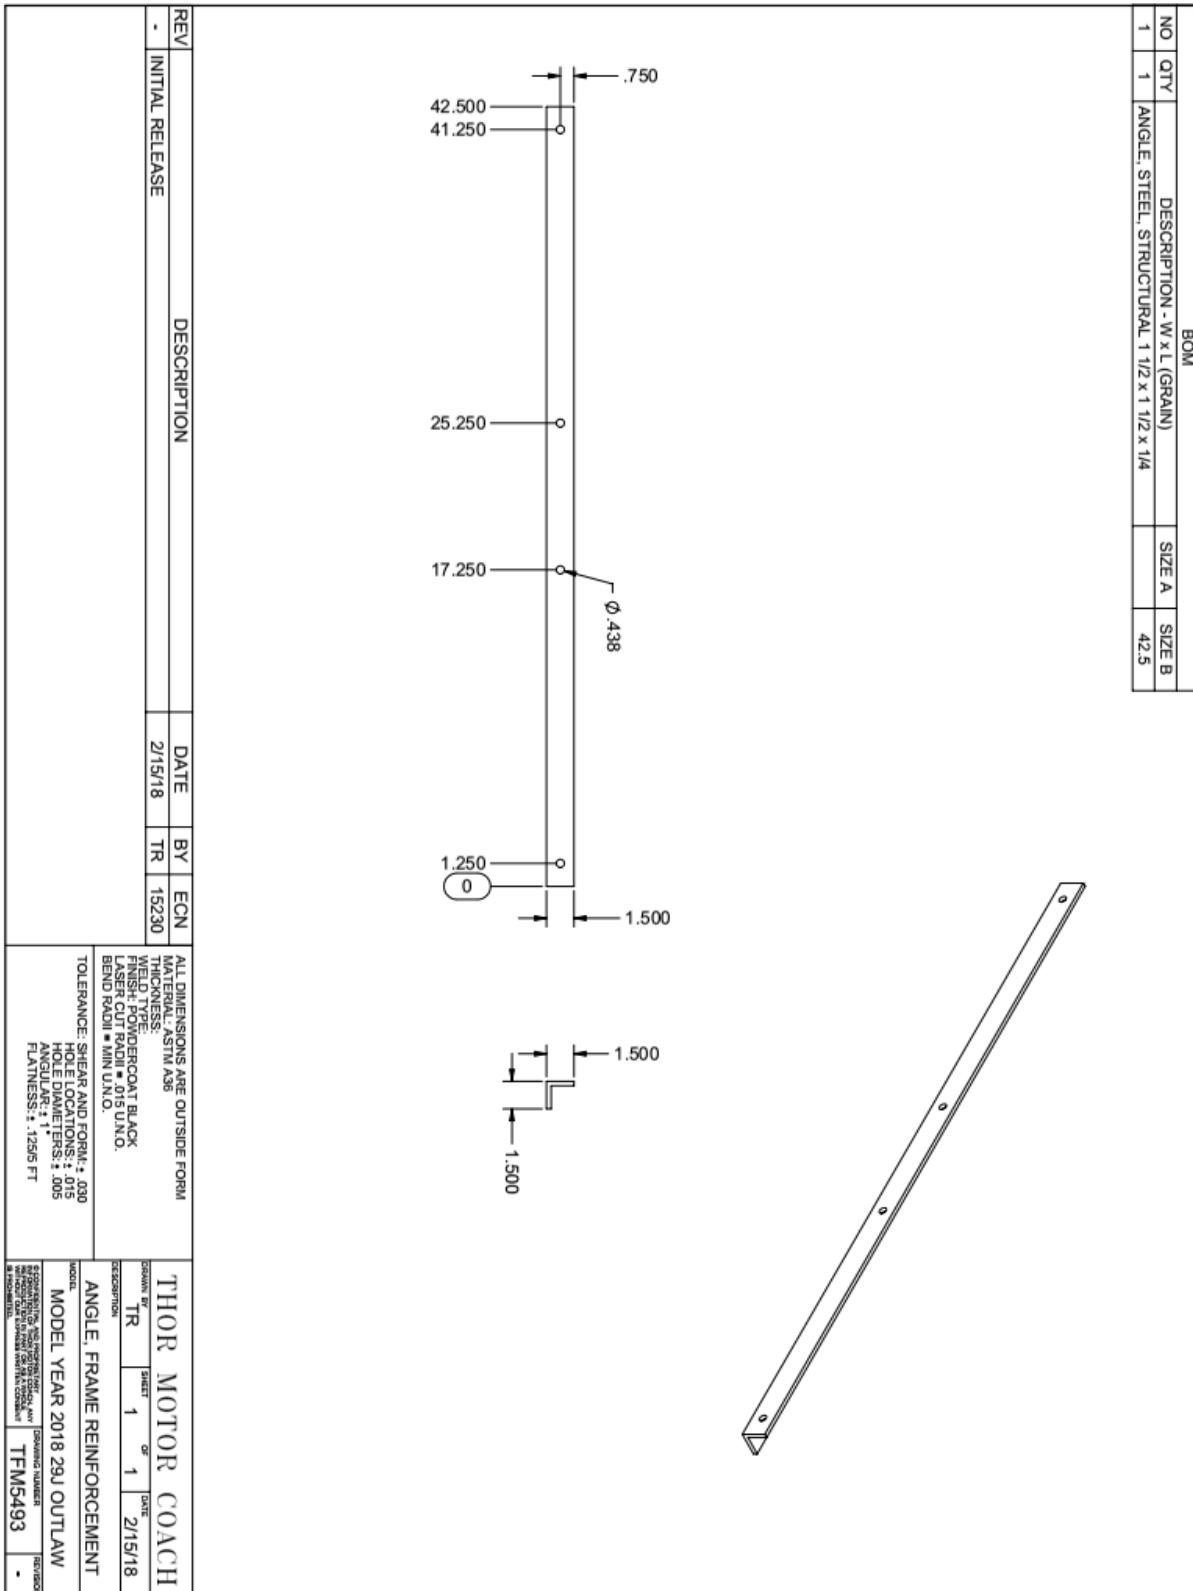
<p>THOR MOTOR COACH</p> <p>DRAWN BY: TR</p> <p>SHEET 1 OF 1</p> <p>DATE: 2/16/18</p> <p>DESCRIPTION: ASSEMBLY SEATBELT BRACKET INSTALLATION</p> <p>MODEL: MODEL YEAR 2018 29J OUTLAW</p> <p>DATE: 2/16/18</p> <p>REVISION: -</p>	<p>DESIGNED BY: TR</p> <p>DATE: 2/16/18</p> <p>DESCRIPTION: ASSEMBLY SEATBELT BRACKET INSTALLATION</p> <p>MODEL: MODEL YEAR 2018 29J OUTLAW</p> <p>DATE: 2/16/18</p> <p>REVISION: -</p>
---	---
