TECHNICAL INSTRUCTIONS

SAFETY RECALL J0I

REAR SEAT LOW TORQUE

CERTAIN 2017 Tundra

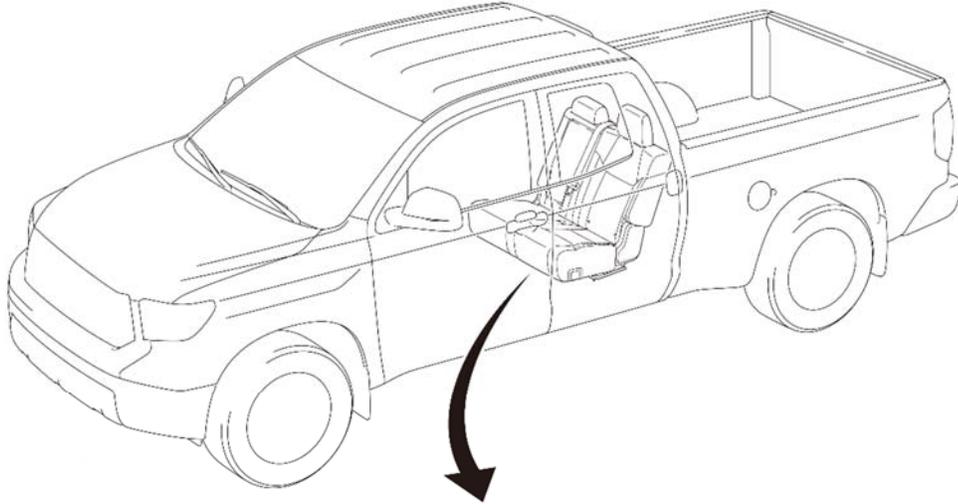
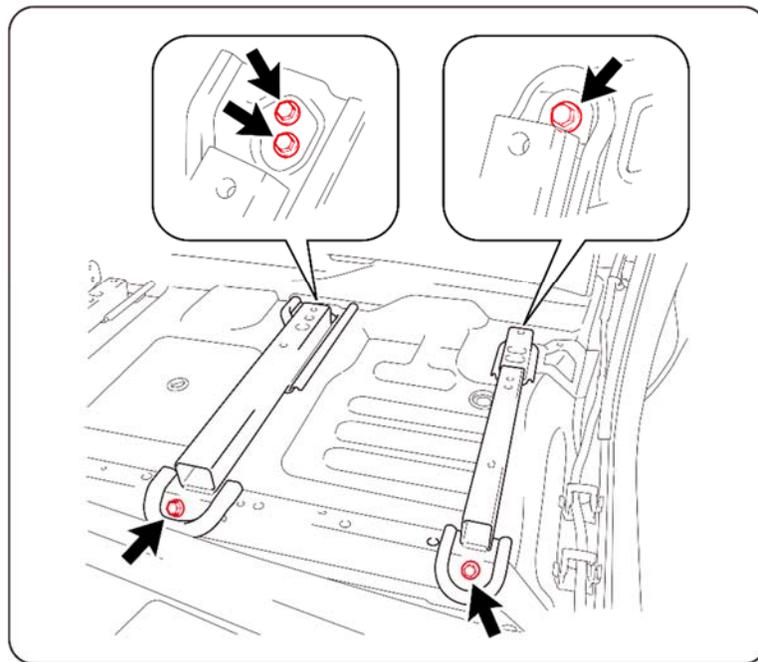
S97004aS

In the involved vehicles with second row seats, there is a possibility that one or more of the bolts attaching the left rear seat to the floor may not have been properly fastened. A seat with improperly fastened bolts may lead to an increased risk of injury in the event of a crash.

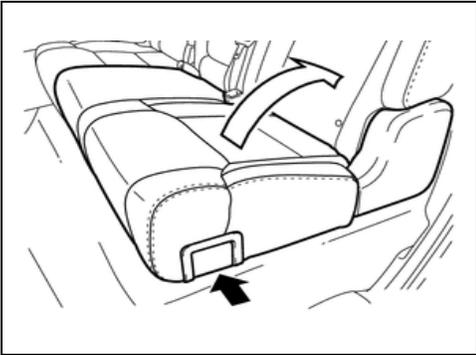
1. REMOVE REAR SEAT ASSEMBLY LH

a. Tilt the lower seat cushion upward.

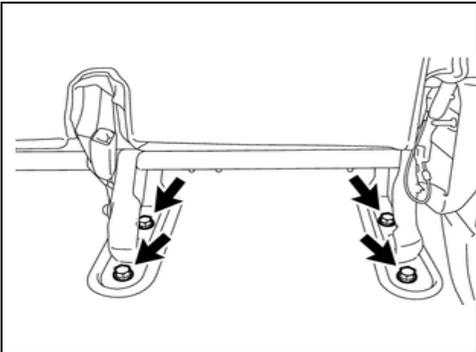
b. Remove the 4 seat mounting bolts.

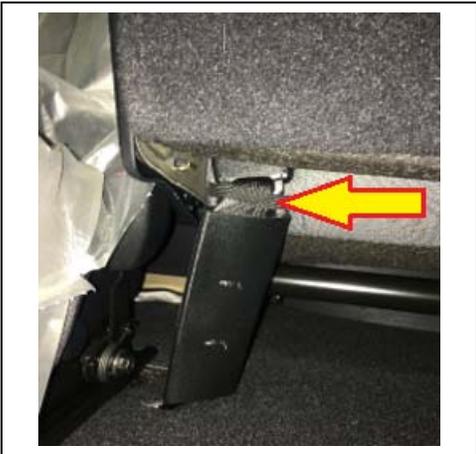
c. Pull the rear seat belt latch through the strap.

d. Remove the LH rear seat assembly from the vehicle.

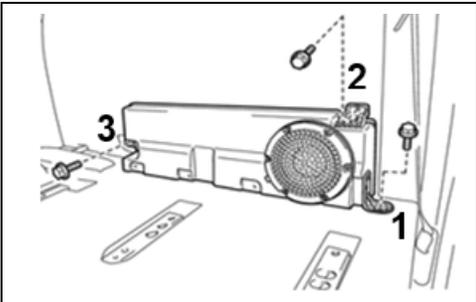
2. REMOVE SPEAKER ASSEMBLY (if equipped)

a. Remove the 3 bolts.

b. Disconnect the wire harness connector.

c. Remove the speaker assembly from the vehicle.

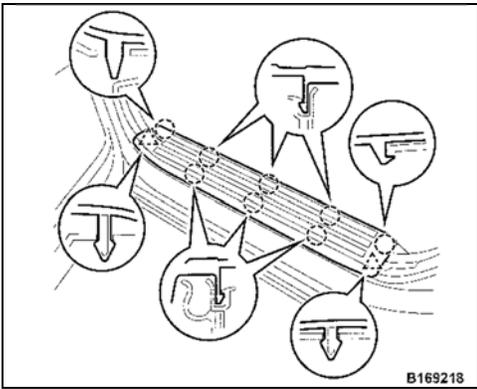
3. **REMOVE REAR DOOR SCUFF PLATE LH**
 - a. Detach the 8 claws and 2 clips.

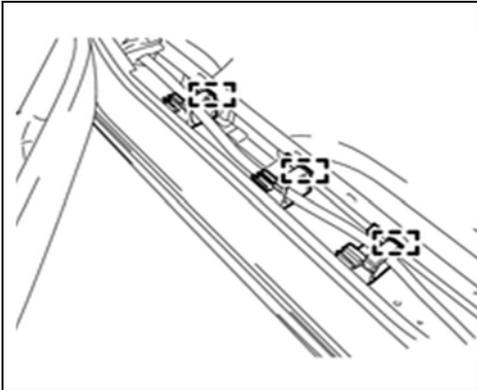
4. **ROLL CARPET FORWARD**
 - a. Detach the 3 outside carpet clips.
 - b. Pull the carpet out from the lower edges of the C-Pillar trim panel.
 - c. Roll the carpet forward enough to expose the seat mounting area.

STOP Be careful to not fold or crush the carpet that may create fold lines.

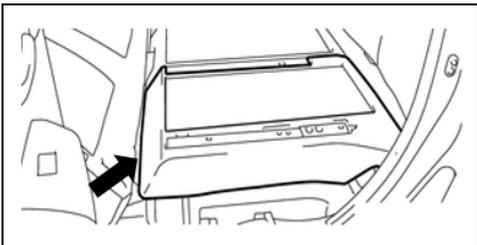
5. **REMOVE FLOOR BOARD SPACER LH**
 - a. Lift upward to separate the floor board spacer.

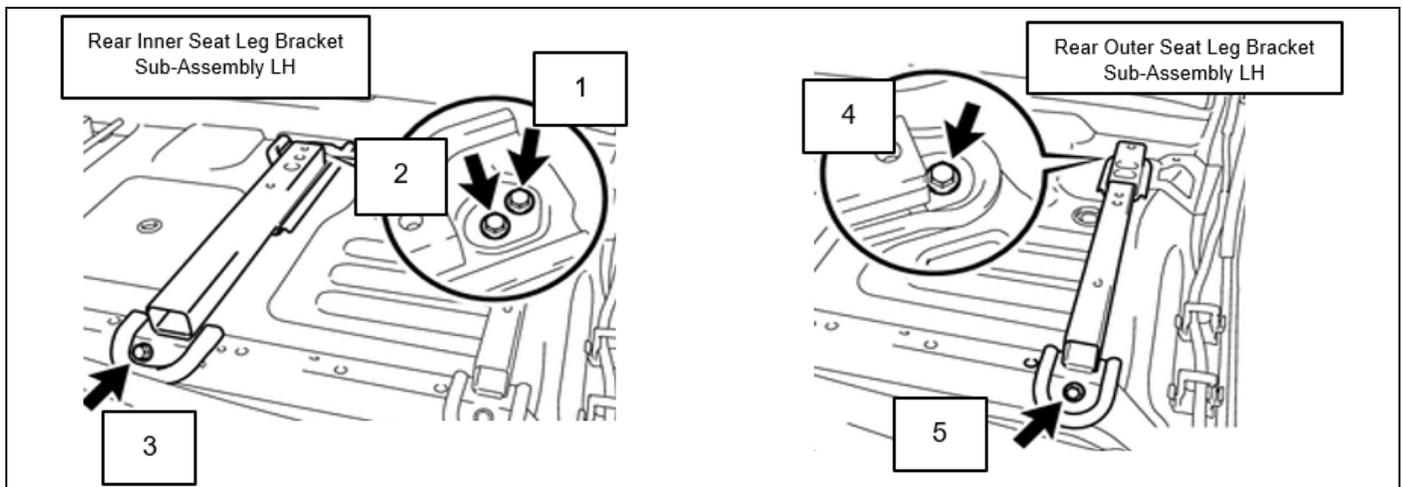
1. **TORQUE SEAT LEG BRACKET BOLTS LH**
 - a. Torque the 5 bolts in the sequence shown in the illustration.

Torque: 31 ft.lbs {42 N·m, 428 kgf·cm}

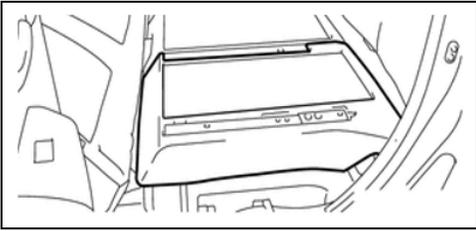
- 1. REINSTALL FLOOR BOARD SPACER LH**
 - a. Place the floor board spacer into place.

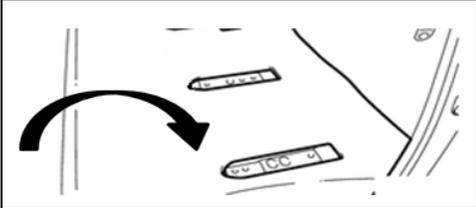
- 2. REINSTALL CARPET LH**
 - a. Roll the carpet back into place.
 - b. Tuck the carpet under the C-pillar trim.

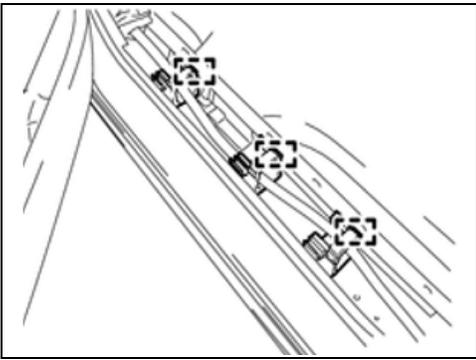
- c. Attach the carpet to the 3 outside mounting clips.

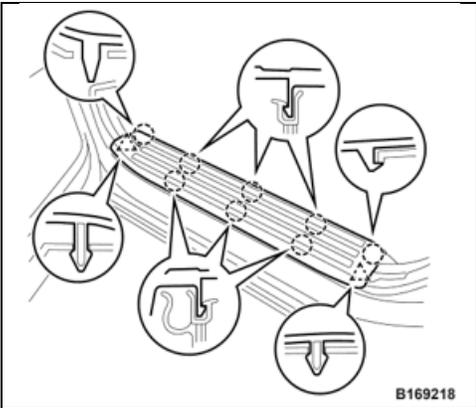
- 3. INSTALL REAR DOOR SCUFF PLATE LH**
 - a. Attach the 8 claws and 2 clips.

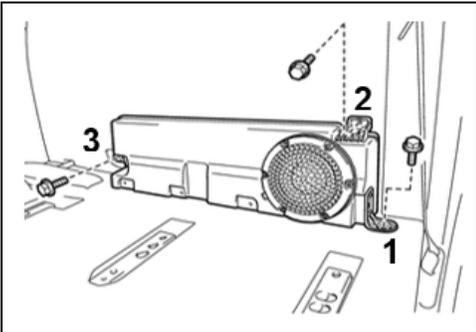
- 4. INSTALL SPEAKER ASSEMBLY (if equipped)**
 - a. Plug in the electrical connection.
 - b. Install the 3 bolts.
Torque: 71 in.lbs {8.0 N·m, 82 kgf·cm}

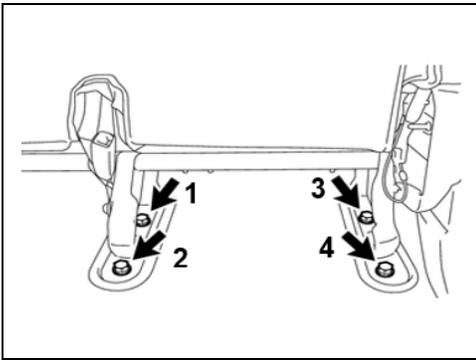
5. INSTALL REAR SEAT ASSEMBLY LH

- a. Place the rear seat into the vehicle.
- b. Install the 4 mounting bolts.
Torque: 31 ft.lbs {42 N·m, 428 kgf·cm}

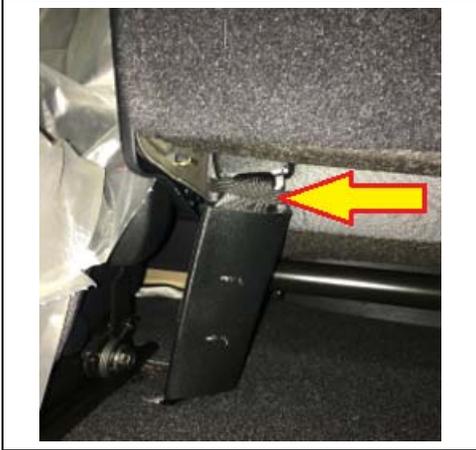
- c. Push the seat belt latch through the strap.
- d. Fold the lower seat cushion down to the sitting position.
