Safety Recall Code: 69Q9

TAKATA SDI Driver Frontal Airbag Inflator

U.S.A. & CANADA: Certain 2007-2014 MY Volkswagen vehicles equipped with a Takata SDI driver frontal airbag

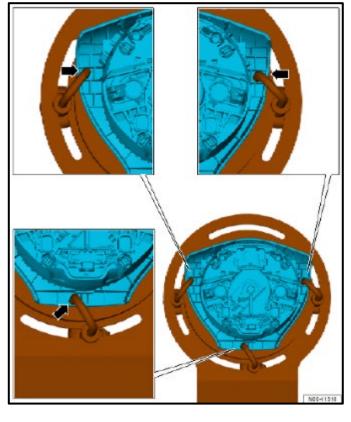
Clamp airbag centrally in airbag support. There are securing points on the sides <arrows>, parallel, opposite each other, and below.

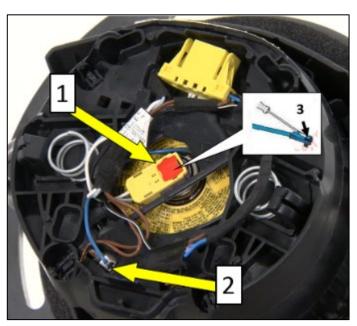
- Disengage connector lock <3> using a small flat bladed screwdriver.
- Remove connector <1> using needle nose pliers.

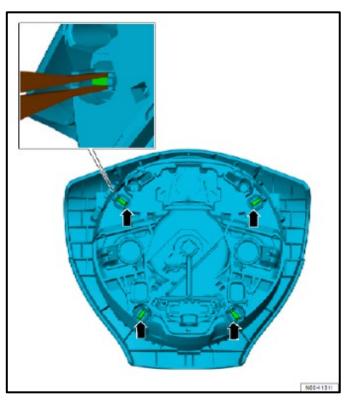
Remove locking pins <arrows> for horn ring with aid of longnose pliers.

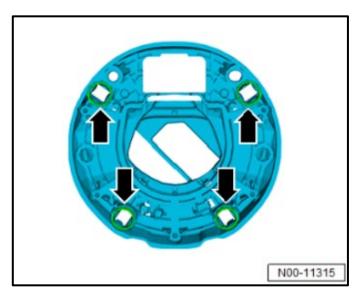
• Remove horn ring with springs <arrows>.

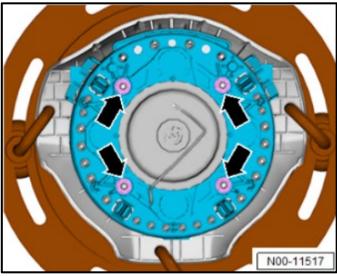
- Remove and discard nuts <arrows>.
- Remove cover for inflator.

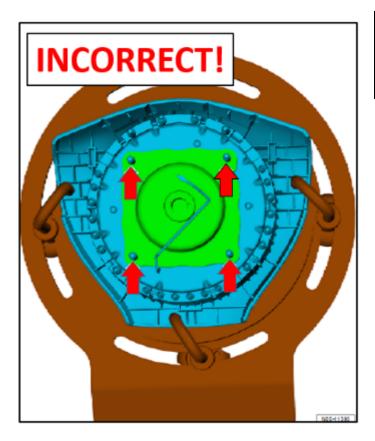
The inflator must ${f NOT}$ be placed on the studs <arrows>.

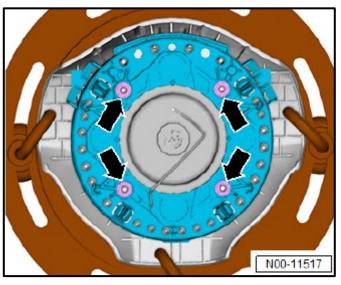
Fit cover for inflator and tighten 4 nuts <arrows> to 5 Nm ± 0.4 Nm.

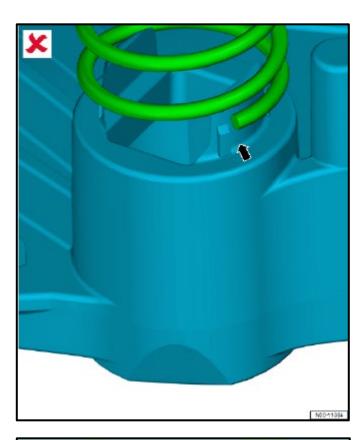
- If one of the springs is damaged or has been lost, it can be replaced with a spring from the bag of spares included.
- Note the examples shown for reference of proper spring seating.
- Spring seated **incorrectly** <arrow>.

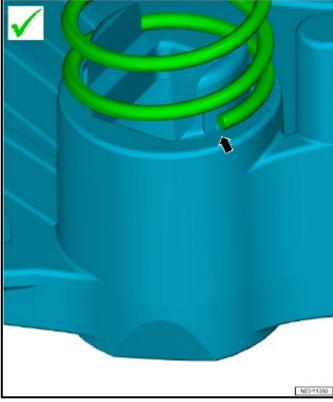
Spring seated correctly <arrow>.

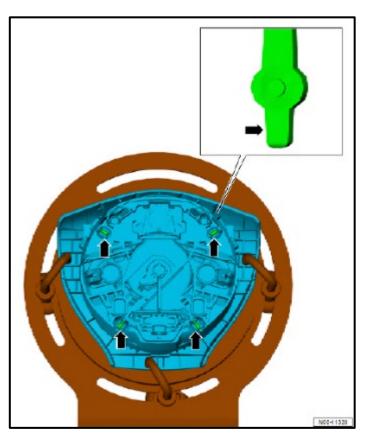
Using long-nose pliers, insert four locking pins in retaining lugs with narrow side facing downwards <arrow in magnification>. Pins must engage audibly.

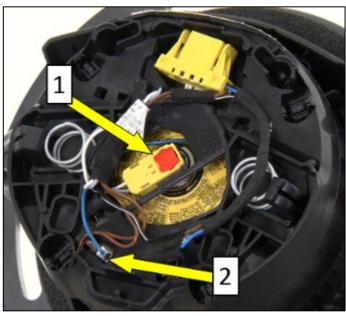
• Connect central connector <1> on inflator.

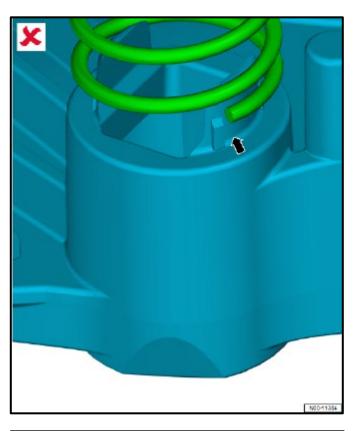
- If one of the springs is damaged or has been lost, it can be replaced with a spring from the bag of spares included.
- Note the examples shown for reference of proper spring seating.
- Spring seated incorrectly <arrow>.

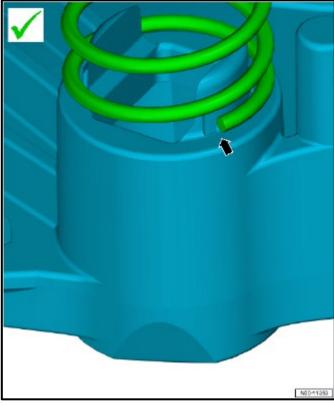
Spring seated correctly <arrow>.

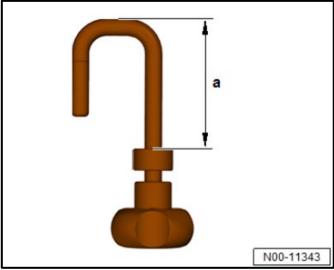
- The four spoke steering wheel has two mounting points.
- Tighten mounting by hand to prevent damage.
- Adjust three knurled nuts of securing hooks to <dimension a> 50mm.

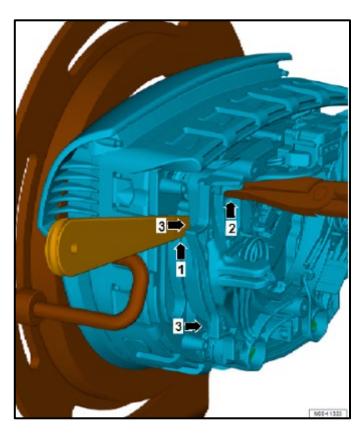
Apply removal wedge -3409- between horn ring and inflator <1> and press together locking elements using longnose pliers <2>.
 Lever off horn ring at plastic lugs <3>.

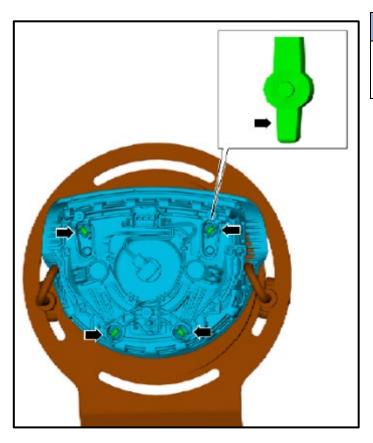
Position horn ring with springs on securing clips and press firmly in place. Ensure that springs are seated correctly on both sides <arrows>.

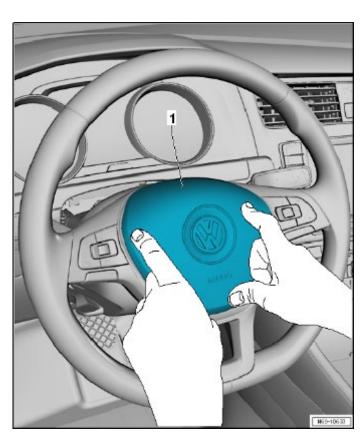
- Press on the edge of the airbag unit <1> with both hands until it locks into place.
- Gently pull on the airbag unit to make sure the airbag unit is secured correctly at all three attachment points in the steering wheel.
