**NEW FLYER**

## **INSTRUCTION TO SERVICE**

<b>ITS: 6807</b>	
<b>SECTION:</b>	219 ENGINE & TRANSMISSION
<b>WRITTEN BY:</b>	Curtis Matthews
<b>SUBJECT:</b>	Driveshaft P/N: (451210) Inspection and Replacement

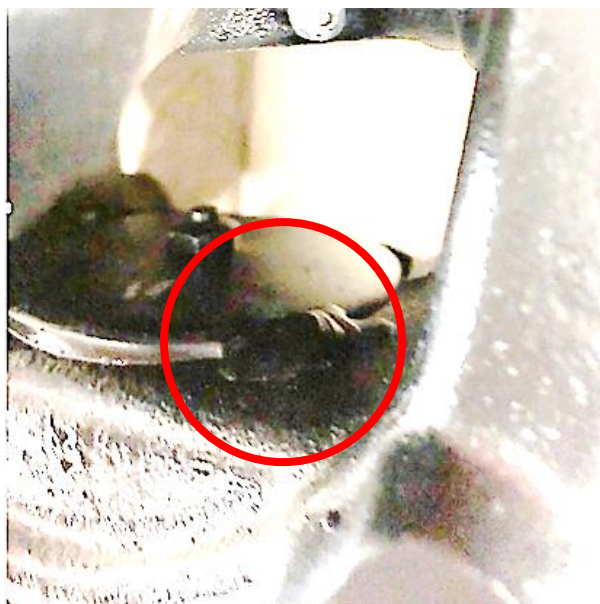
- Ways to identify if the cap is metal:
  - Tack welds on the top of the cap. See figures 2 and 3.
  - There are no raised letters on the top of the cap.
  - The cap attracts a magnet.
- If the cap is metal, then the driveshaft is **APPROVED**. Record that the cap is metal on the inspection sheet and proceed to step nine of this instruction.
- If the cap is plastic, proceed to step six.

Figure 3: Side view of metal cap with tack welds

Item	Inspection Item	Result
1.	Dust cap material. See figures 2 and 3.	Metal - <b>APPROVED</b> <input type="checkbox"/>
		Plastic - Go to item 2 <input type="checkbox"/>
2.	Driveshaft style. (See figures 4 through 9. Caps are not approved only if they are plastic)	Style A - <b>NOT APPROVED</b> <input type="checkbox"/>
		Style B - <b>NOT APPROVED</b> <input type="checkbox"/>
		Style C - <b>NOT APPROVED</b> <input type="checkbox"/>
		Style D - <b>APPROVED</b> <input type="checkbox"/>
		Style E - <b>APPROVED</b> <input type="checkbox"/>
		Style F - <b>APPROVED</b> <input type="checkbox"/>
3.	Date code from sticker (If legible). See figure 10 and 11.	Date Code:  WO#:
4.	Inspect the yokes for cracks, see figure 12. Are cracks visible?	Yes <input type="checkbox"/> No <input type="checkbox"/>
