INSTRUCTION TO SERVICE

ITS: 6778	
SECTION:	219 ENGINE & TRANSMISSION
WRITTEN BY:	Curtis Matthews
SUBJECT:	Driveshaft P/N: (458521) Inspection and Replacement

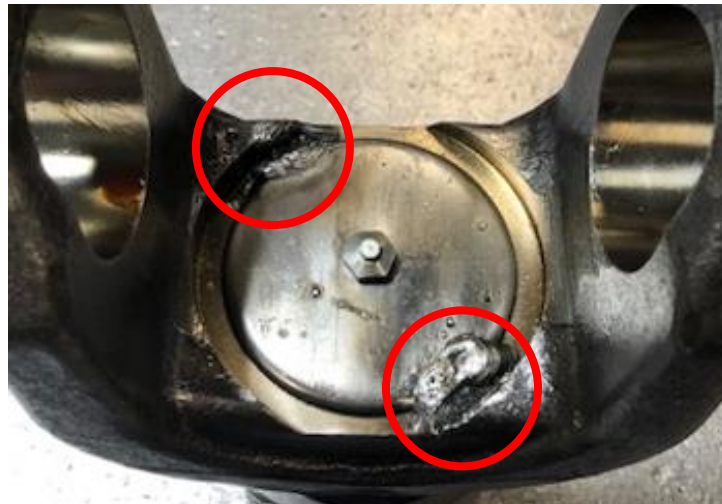
- Ways to identify if the cap is metal:
 - Tack welds on the top of the cap. See figures 2 and 3.
 - There are no raised letters on the top of the cap.
 - The cap attracts a magnet.
- If the cap is metal, then the driveshaft is **APPROVED**. Record that the cap is metal on the inspection sheet and proceed to step nine of this instruction.
- If the cap is plastic, proceed to step six.

Figure 2: Top view of metal cap with tack welds

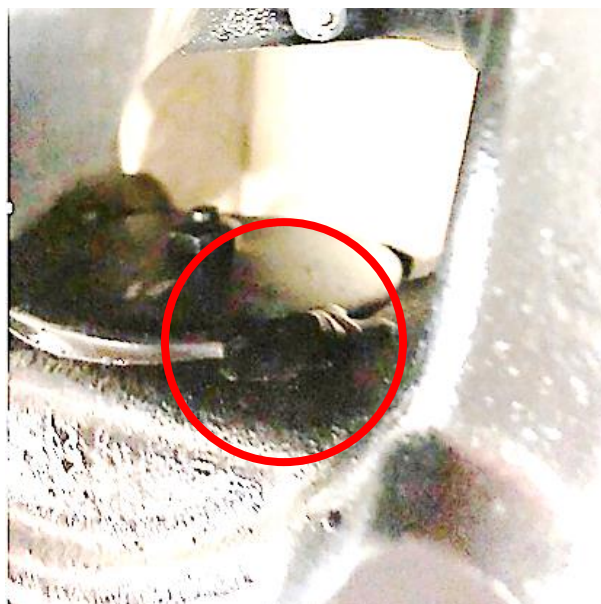
Figure 3: Side view of metal cap with tack welds

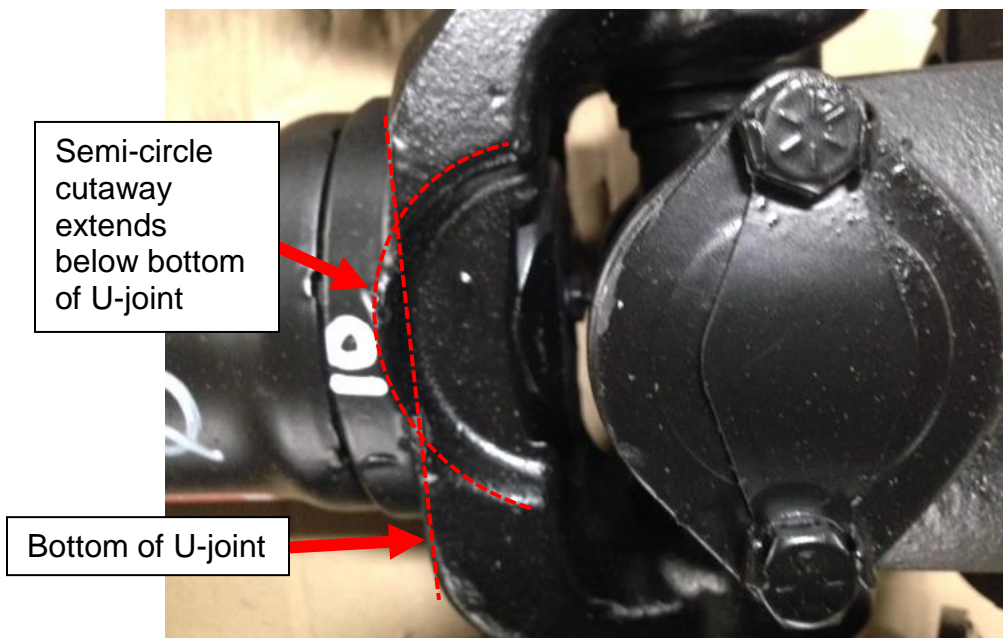
- Style B – Plastic Dust Cap and extended cutaway. **NOT APPROVED**

Figure 5: Style B driveshaft

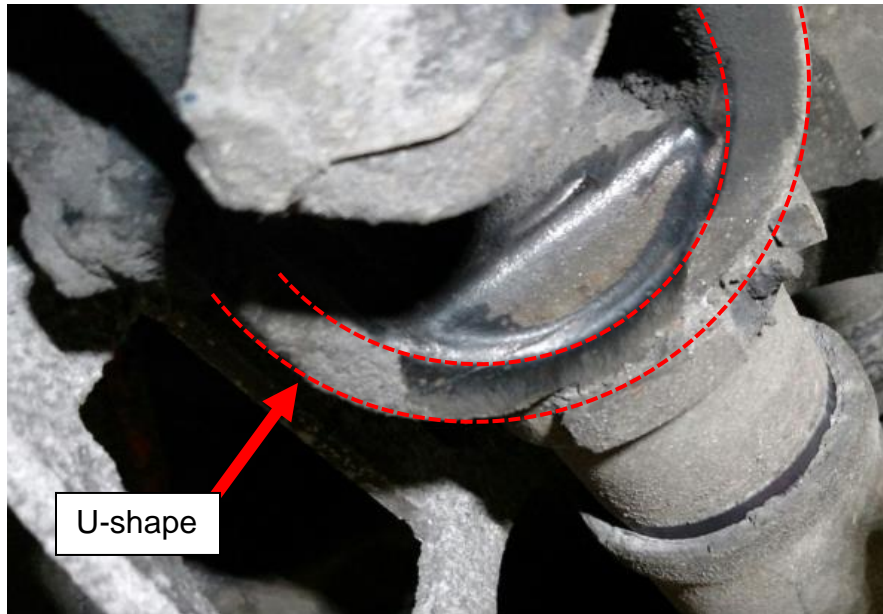
- Style C – Plastic dust cap, and U-shaped yoke. **NOT APPROVED**

Figure 6: Style C driveshaft

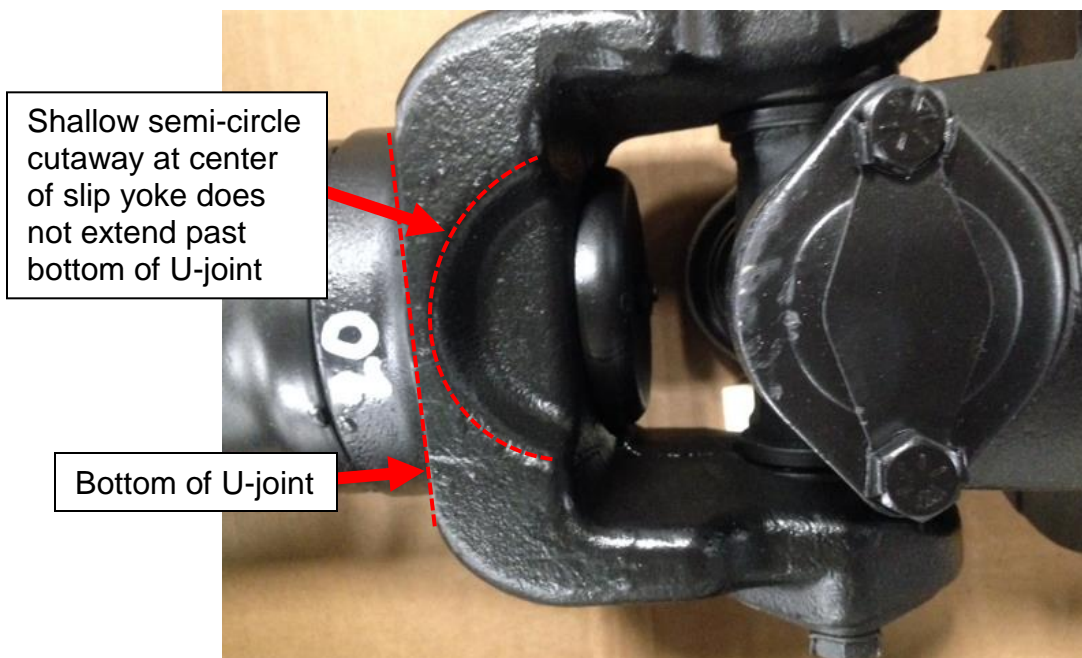
- Style D – Plastic dust cap and shallow cutaway. **APPROVED**

Figure 7: Style D driveshaft

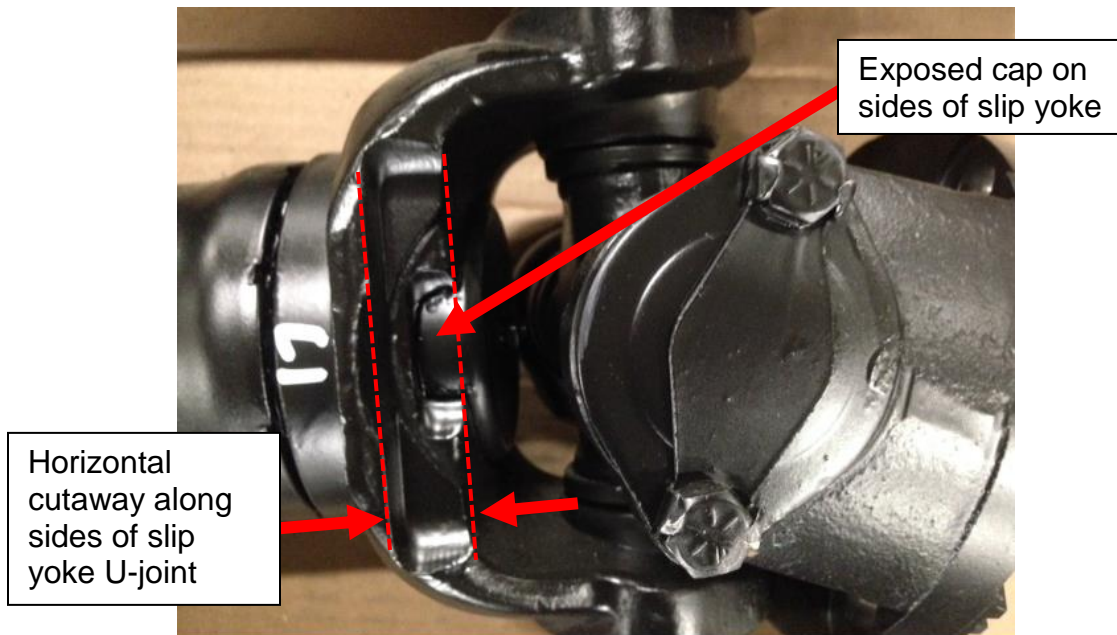
- Style E – Plastic dust cap and horizontal cutaway. **APPROVED**

Figure 8: Style E driveshaft

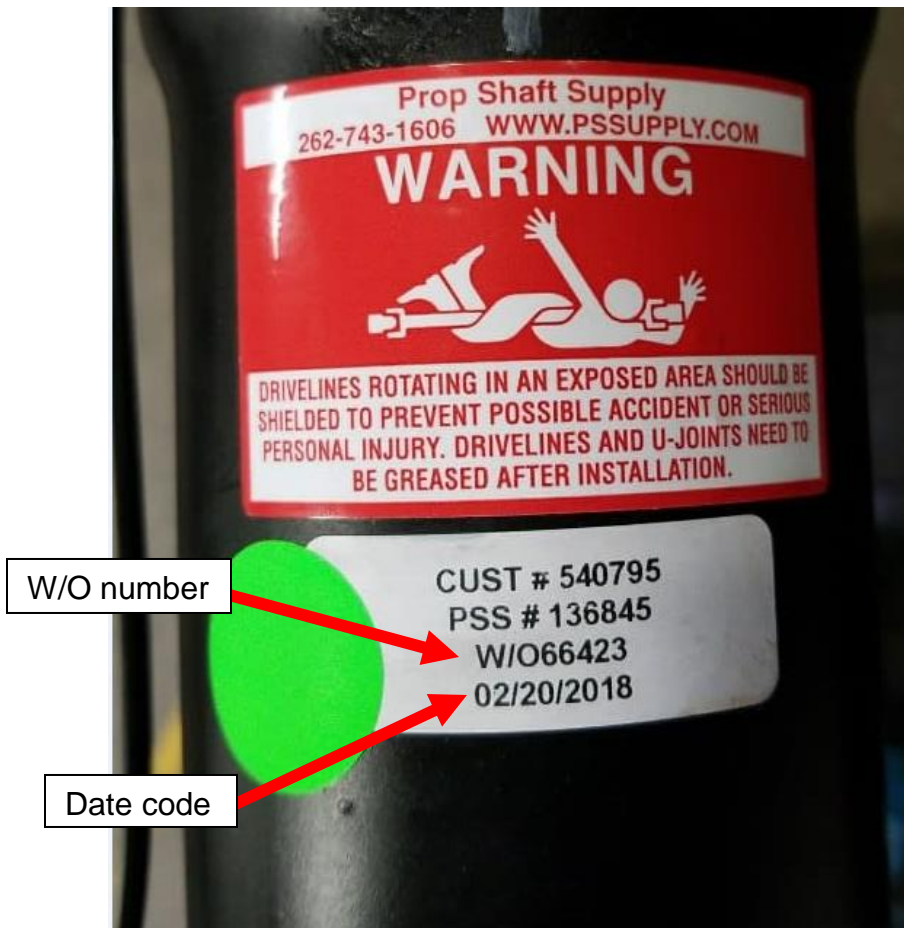
7. Record the date code and work order (W/O) number seen in figures 10 and 11 (if legible).

Figure 11: Close-up of date code sticker

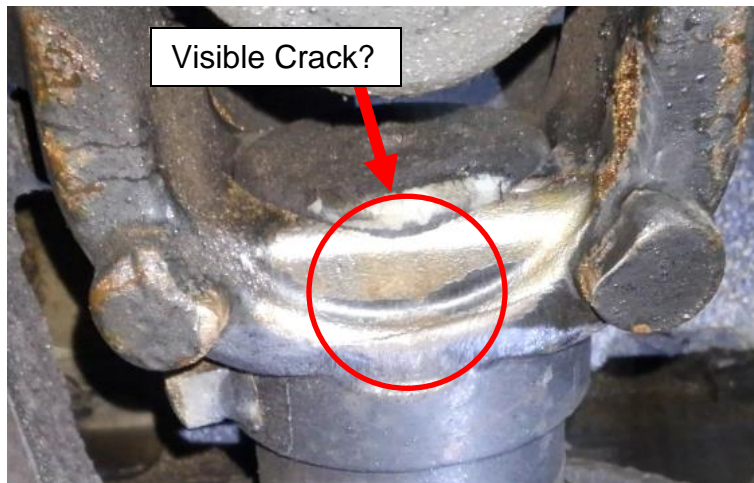
8. If the driveshaft is **NOT APPROVED**, inspect the slip yoke for cracks at the center of the U-joint as seen figure 12.

Figure 12: Driveshaft area of concern for cracks

- ☞ **NOTE:** If the driveshaft is **NOT APPROVED** but has no visible crack, it can continue to be used in service until a replacement driveshaft is available. If it is visibly cracked, the bus is to be held from service until a replacement driveshaft can be installed.
9. When the attached inspection sheet has been completed, forward it to your New Flyer Regional Support Manager to arrange for replacement parts and return shipping.
 10. If the driveshaft is **APPROVED**, proceed to Part 3 – Return Bus to Service. If the driveshaft is not approved, proceed to Part 2 – Remove and Replace Driveshaft.

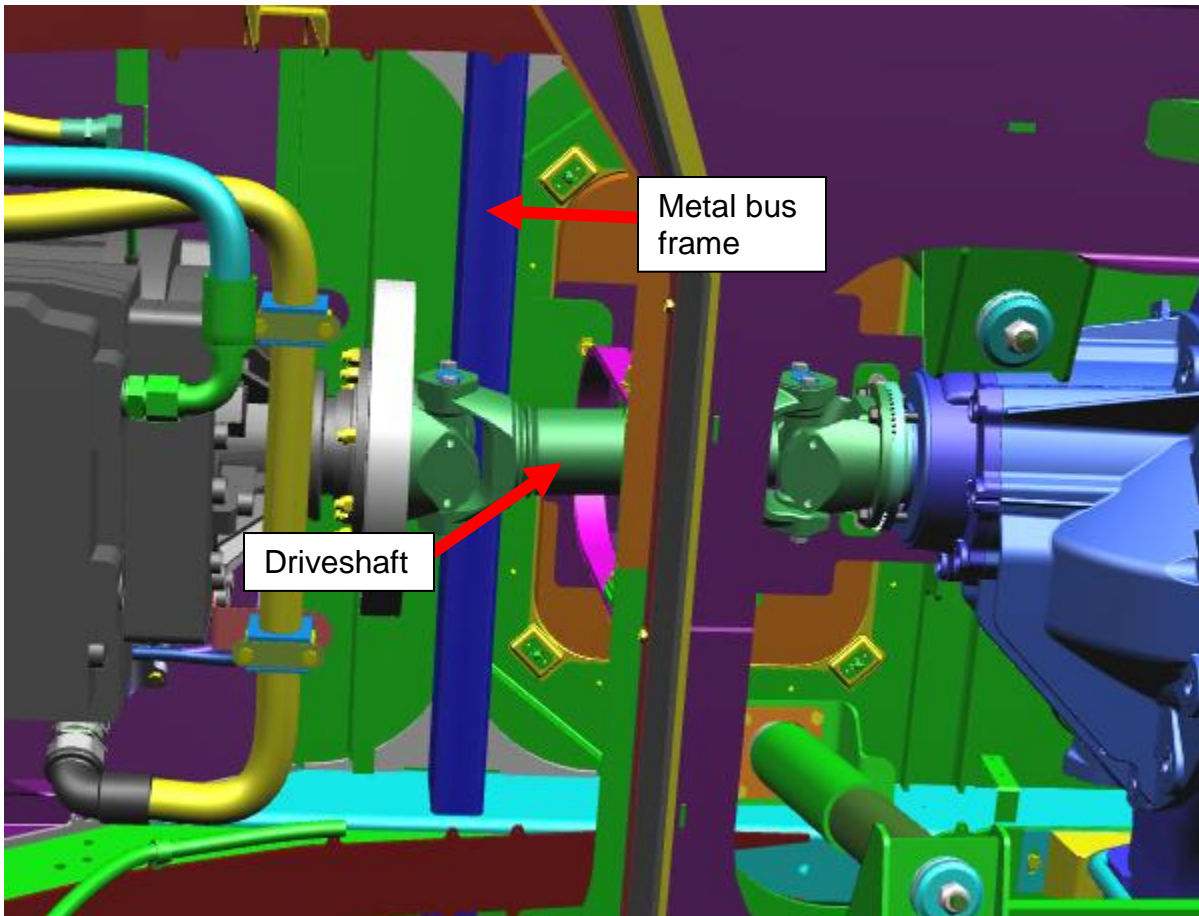
1. Raise bus in accordance with the New Flyer Service Manual.
2. Support the driveshaft weight with ratchet straps to the bus frame as indicated in figure 13.

Figure 13: Original driveshaft underside

⚠ WARNING: For safety, two technicians are required anytime a driveshaft is being suspended or lifted.

7. Support the weight of the new driveshaft using ratchet straps similar to note 2 and figure 13.

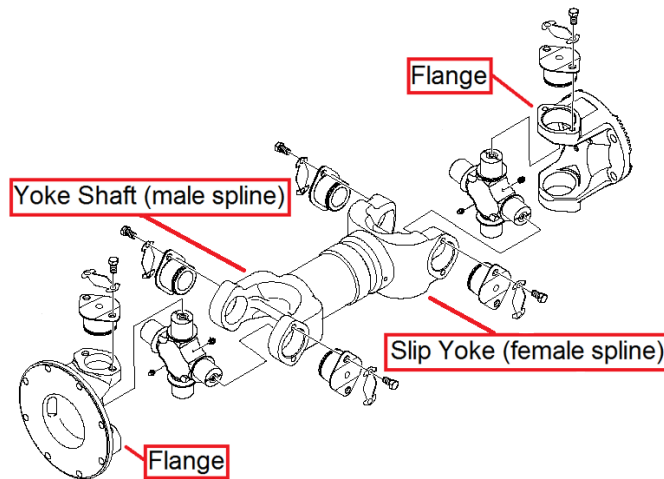
3. Refer to figure 14 for driveshaft part identification.

Figure 14: Exploded view of driveshaft parts

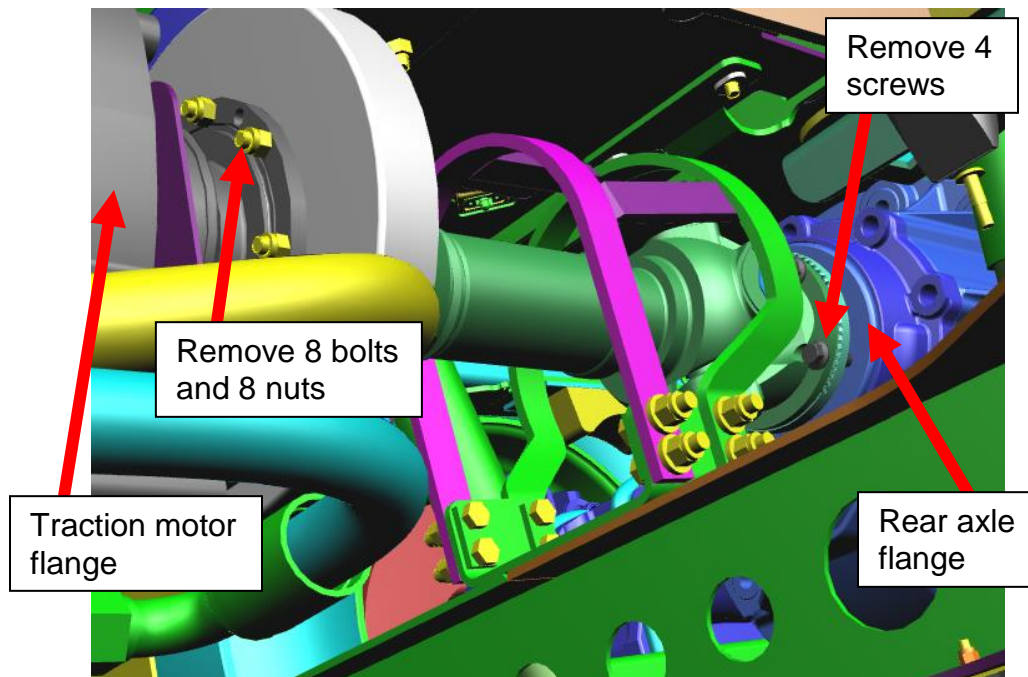
4. Remove hardware that fastens the driveshaft flanges to the traction motor and the rear axle. Rotate pinion for better visibility of hardware on driveshaft. See figure 15.
 - a) Remove 4 screws P/N: (6312877) from the rear axle flange on slip yoke side.
 - b) Remove 8 bolts P/N: (11B07028) and 8 nuts P/N: (41N07000) from traction motor flange on yoke shaft side.
5. Safely lower the driveshaft.
6. Discard old driveshaft hardware and tag/paint the old driveshaft.

Figure 15: Original driveshaft

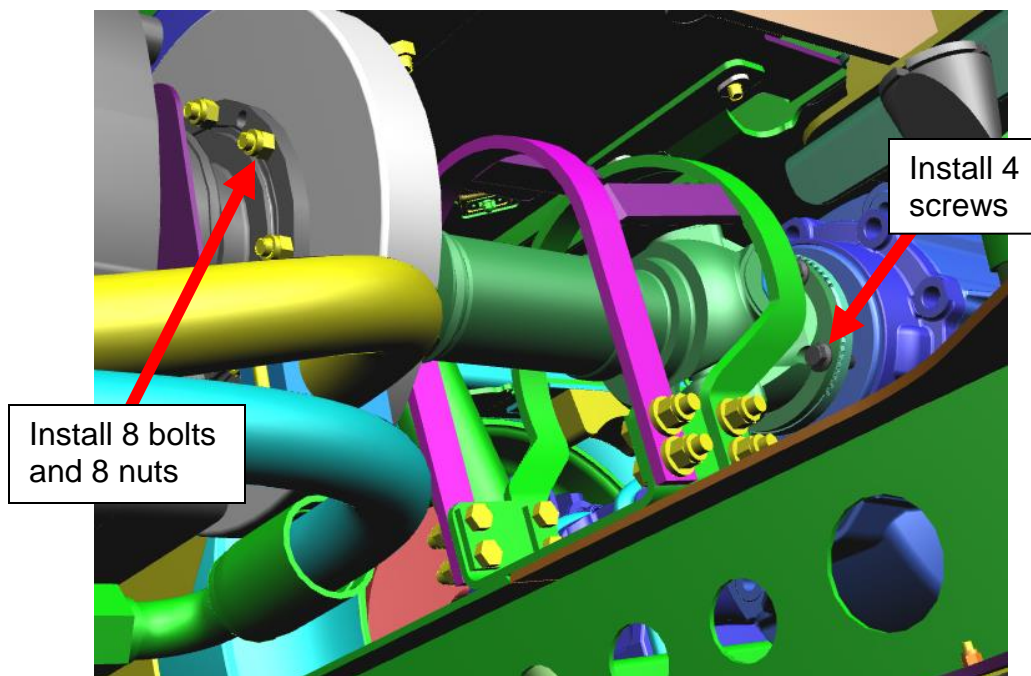
9. Mount driveshaft flanges to the traction motor flange and the rear axle flange. Rotate axle for better visibility of hardware. See figure 16.

a) Fasten the slip yoke to the rear axle with 4 screws P/N: (6312877). Torque screws to 81 ± 3 FT-LBS DRY.

b) Fasten the yoke shaft flange to the traction motor flange with 8 bolts P/N: (11B07028) and 8 nuts P/N: (41N07000). Torque screws to 75-77 FT-LBS DRY.

Figure 16: New installed driveshaft on Bus# 1252

10. Lubricate the slip joint and universal joints of the driveshaft using grease P/N: (507257) in accordance with the New Flyer Service Manual.
