Dealer Service Instructions for:

Safety Recall U04 / NHTSA 18V-160 Frame Bracket

2009 - 2012 (DS) RAM 1500 Pickup

The front fuel tank strap on about 218,000 of the above vehicles may detach due to the frame bracket corroding. Detachment of the front fuel tank strap could potentially allow the front of the fuel tank to make contact with the ground, increasing the risk of a fuel leak. A fuel leak in the presence of an ignition source could result in a fire.

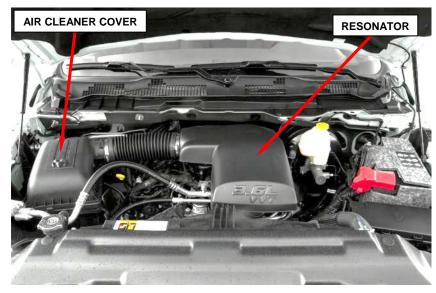
Figure 4 – 3.6L Resonator and Air Cleaner Cover

e. Pull the front of the resonator with air intake tube away from the throttle body while lifting from the rear of the resonator to separate from the ball stud mounts (Figure 4).

- b. Install the resonator to the throttle body inlet. Push the resonator down onto the two locating ball studs until the rubber mount sockets are fully seated. (Figure 4).

- e. Align the air cleaner cover to the lower air cleaner cover.
- f. Secure the air cleaner cover latches (Figure 4).
- 63. <u>5.7L engines only</u>, perform the following steps to install the air duct system:

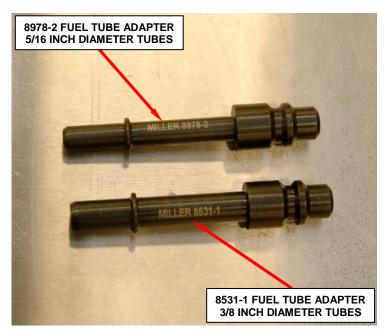
Figure 8 – Fuel Tube Adapter Fittings

NOTE: Tool number 8978-2 is used on 5/16 inch diameter fuel tubes while tool number 8531-1 is used on 3/8 inch diameter fuel tubes (Figure 8).
