March 30, 2018

Version 3

Safety Recall: Left (Driver Side) Second Row Seat Recliner Does Not Lock

Year	Model	Trim	VIN Range
2014-16	Odyssey	ALL	Check the iN VIN status for eligibility.

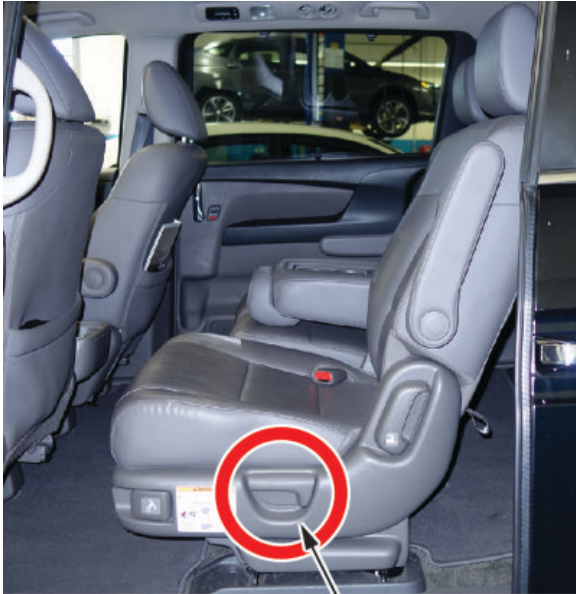
SEAT-BACK ANGLE
ADJUSTMENT LEVER

1. Remove any child or booster seats that are installed in the second row center and left seats, and place them in the cargo area for the customer to install. Note which position the seat is installed; Standard (inner) or Wide (outer) position. If the seat is removed from the vehicle during the repair, reinstall it in the same position before returning the vehicle to the customer for their convenience.
2. Start with the seat-back in an upright position.

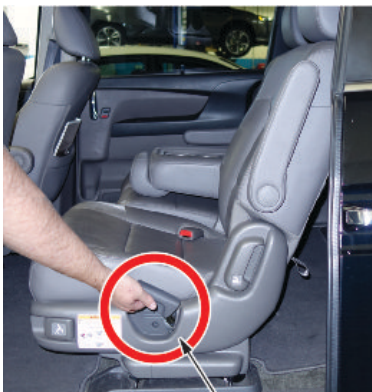
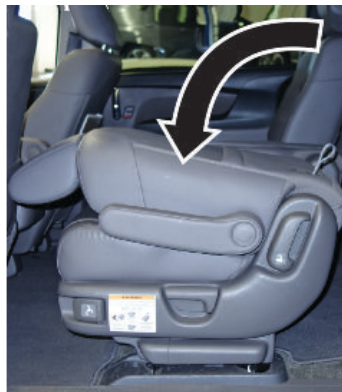
SEAT-BACK ANGLE
ADJUSTMENT LEVER

3. Check the seat-back angle adjustment lever function.
 - 3.1. Pull the seat-back angle adjustment lever, and allow the seat-back to fold.

- If the seat-back does not fold, folds slowly, or requires assistance to fold it down, the recliner mechanism must be replaced. Go to **REPAIR PROCEDURE - SEAT-BACK FRAME REPLACEMENT**.
- If the seat folds normally, go to step 3.2.

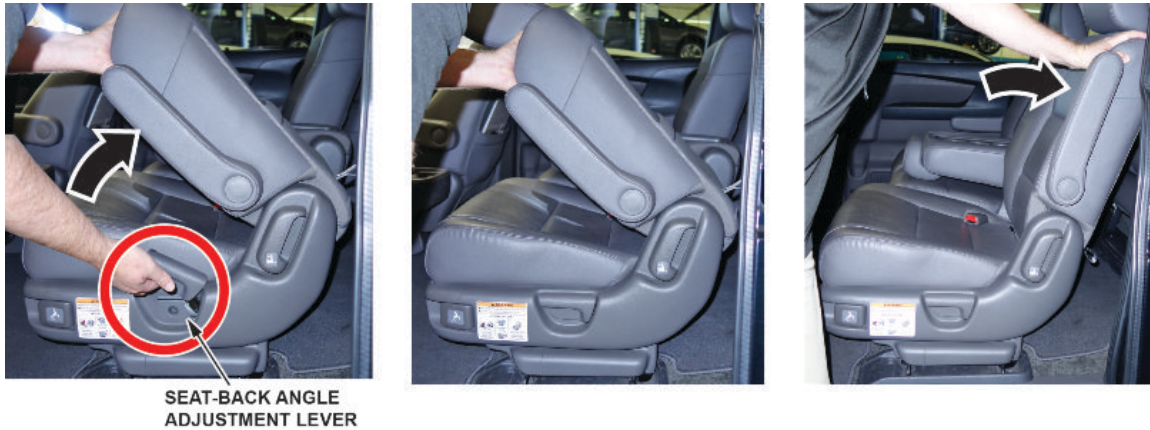
- 3.2. Pull the seat-back adjustment lever, and lift up on seat-back to release it from the folded position. Release the adjustment lever, and continue to push the seat-back until it locks in the upright position.

- If the seat-back does not lift up easily, binds, or requires significant effort to lift it up and push it back to the upright position, the recliner mechanism must be replaced. Go to REPAIR PROCEDURE - SEAT-BACK FRAME REPLACEMENT.
 - If the seat-back lifts up and locks normally in the upright position, go to step 4.
4. Sit in the seat, lift the slide lever, and slide the seat all the way forward. Using your arms and legs, push against the seat-back to confirm that the seat recliner mechanism holds its position and doesn't recline when a rearward force is applied.

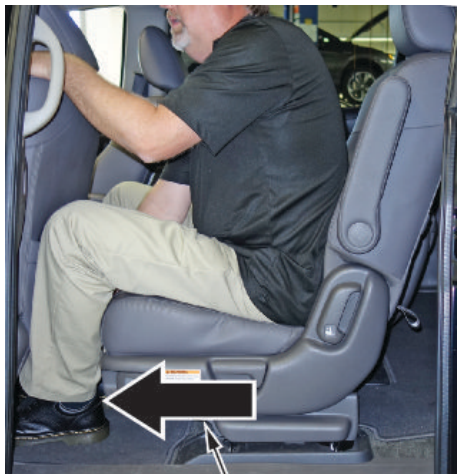
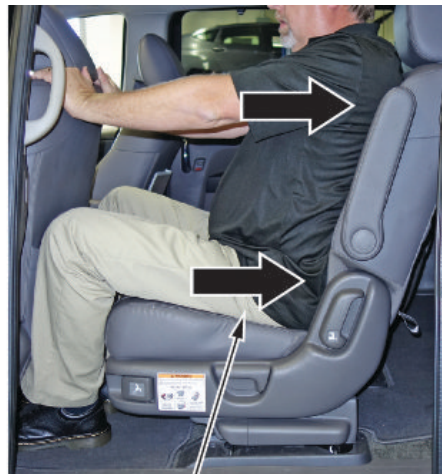
Slide all the way forward.

Push back with both arms and legs.

- If the seat-back does not hold its position and/or there is a ratcheting sound, the recliner mechanism must be replaced. Go to REPAIR PROCEDURE - SEAT-BACK FRAME REPLACEMENT.
- If the seat-back holds its position and there is no ratcheting sound, go to step 5.

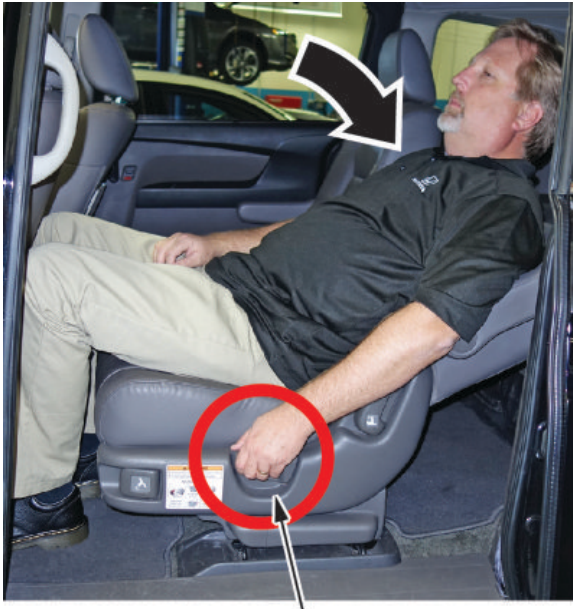
SEAT-BACK ANGLE ADJUSTMENT LEVER

5.1. While seated, pull the seat-back angle adjustment lever, lean back until the seat is fully reclined, then release the lever.

- If the seat-back recliner binds or requires significant effort to recline, the recliner mechanism must be replaced. Go to REPAIR PROCEDURE - SEAT-BACK FRAME REPLACEMENT.
- If the recliner function operates normally, go to step 5.2.

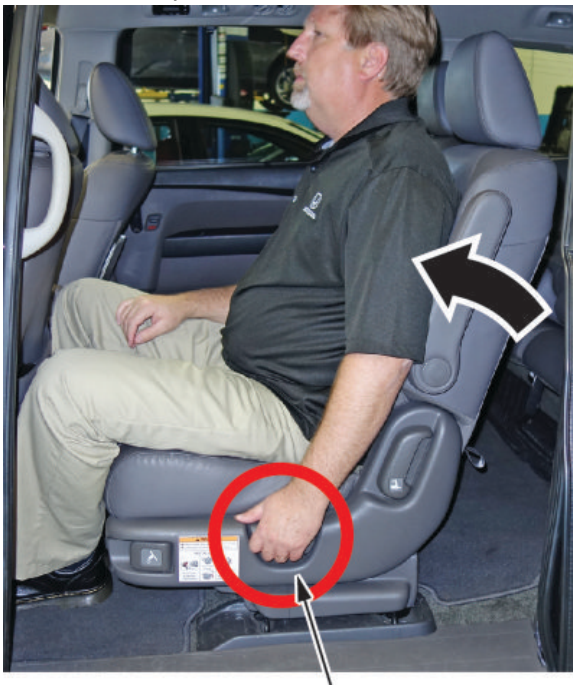
SEAT-BACK ANGLE ADJUSTMENT LEVER

5.2. While seated, pull the recliner handle, return the seat to the upright position, and exit the seat.

- If the seat-back recliner does not fold, folds slowly, and/or requires assistance to fold forward, the recliner mechanism must be replaced. Go to REPAIR PROCEDURE - SEAT-BACK FRAME REPLACEMENT.
- If the seat-back returns to the upright position normally, go to step 6.

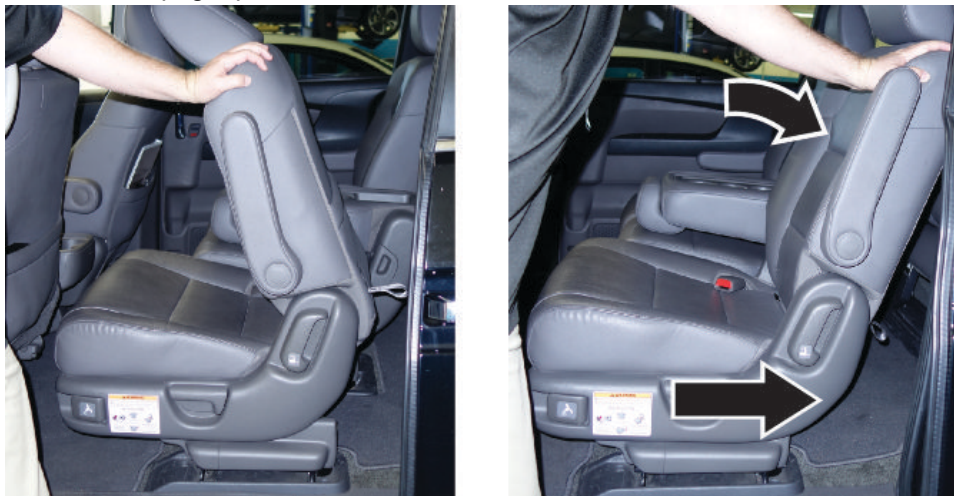
- If the seat-back does not fold forward by itself, binds, and/or requires assistance to fold forward, the recliner mechanism must be replaced. Go to REPAIR PROCEDURE - SEAT-BACK FRAME REPLACEMENT.
 - If the seat-back folds forward normally, go to step 6.2.
- 6.2. Push the seat-back toward the rear of the vehicle until the seat slider locks into position and the seat-back locks in the upright position.

- If the seat-back does not lock in the upright position normally, the recliner mechanism must be replaced. Go to REPAIR PROCEDURE - SEAT-BACK FRAME REPLACEMENT.
- If the seat-back locks in the upright position normally, **repeat steps 2 through 6.2 a second time**. If all of the seat recliner operation checks test normal, go to REPAIR PROCEDURE - RECLINER BRACKET KIT.

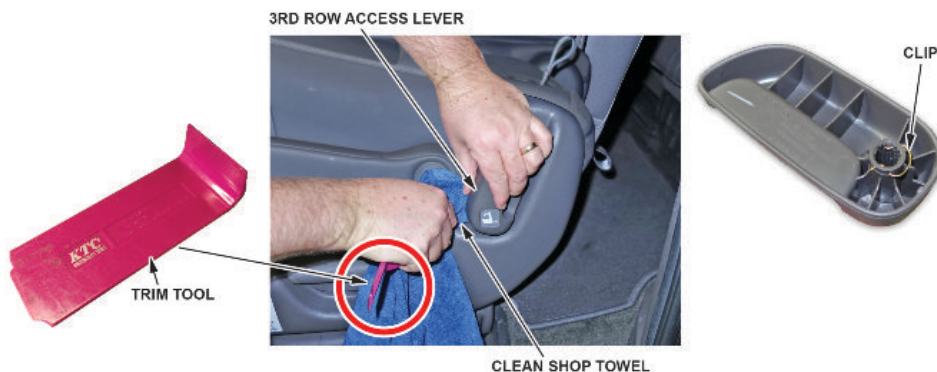
- Put on gloves to protect your hands.
 - Take care not to tear or damage the seat covers.
 - Use the appropriate tool from the KTC trim tool set to avoid damage when removing components.
1. Remove the recliner cover.
 - 1.1. Make sure the seat-back is in an upright position. Using a trim tool and a clean shop towel as shown, remove the 3rd row access lever.

- Use a clean shop towel to make sure the recliner cover and 3rd row access lever are not damaged.
- Be careful not to lose the clip on the back of the 3rd row access lever. If the clip is lost, the handle will not lock when you install it.

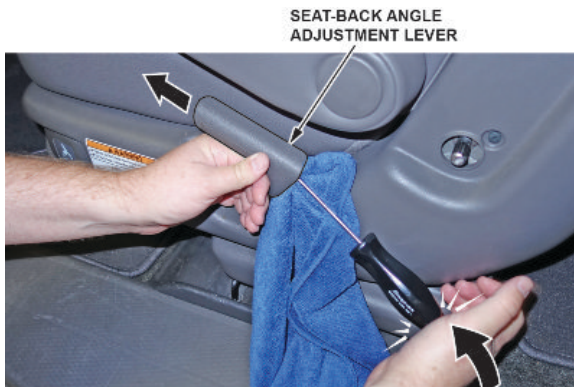
- 1.2. Lower the seat-back to the folded position.
- 1.3. Remove the seat-back angle adjustment lever handle by inserting a medium length Phillips screwdriver into the handle, then striking the screwdriver handle with your hand to slide the adjustment lever handle off.

- Place a clean shop towel between the screwdriver and the recliner cover to avoid damaging the recliner cover.
- To avoid damaging the recliner cover, do not strike the screwdriver with a hammer .
- Make sure the recliner lever is pulled up slightly so the handle doesn't hit the recliner cover when it comes off.

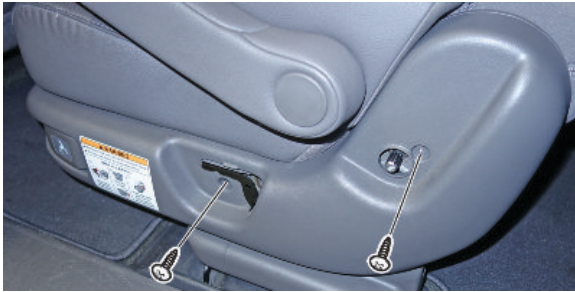
1.4. Remove the screws.

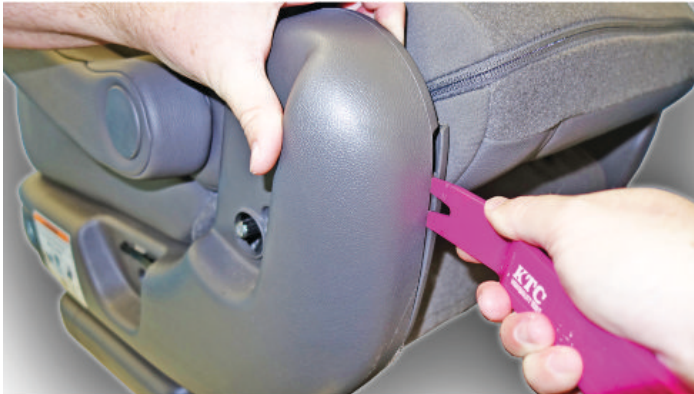
1.5. Starting at the back of the recliner cover, insert a trim tool as shown to separate the outer and inner covers.

1.6. Move toward the front of the recliner cover using the trim tool to separate the inner and outer covers.

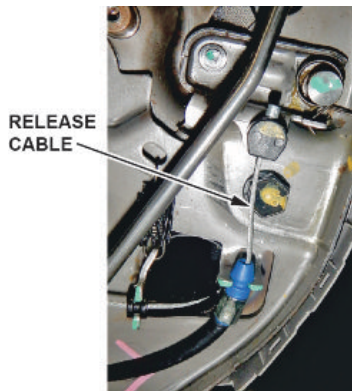
2. Disconnect the release cable.

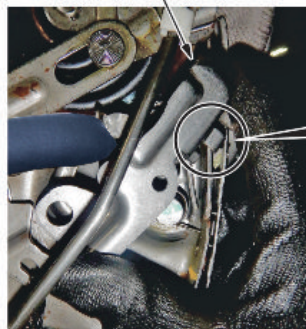
4. Lift the lever and hold it as shown, then install the bracket, starting at an angle with center tab 2 and lower tab 3 positioned as shown.

Push the lever clockwise, and hold it there.

Install the new bracket on the seat frame..

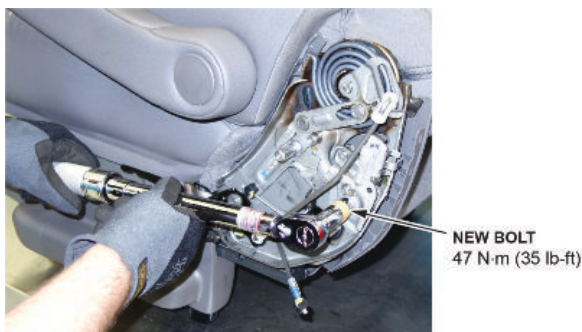
7. Torque the new bolt to **47 N·m (35 lb-ft)**.

The bolt is coated with thread lock, which allows bolt adjustment for up to 10 minutes after it is initially torqued. After 10 minutes, the thread lock sets. If the bolt needs adjustment after 10 minutes, replace it with a new one.

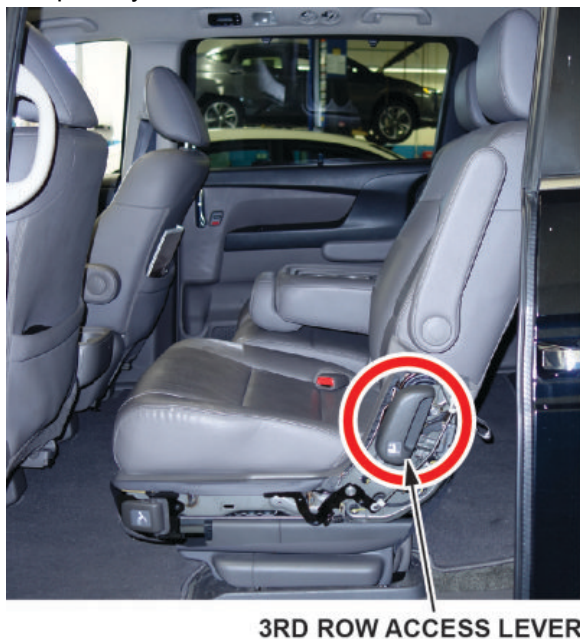
9. Temporarily install the 3rd row access lever. Install the seat if it was removed from the vehicle.

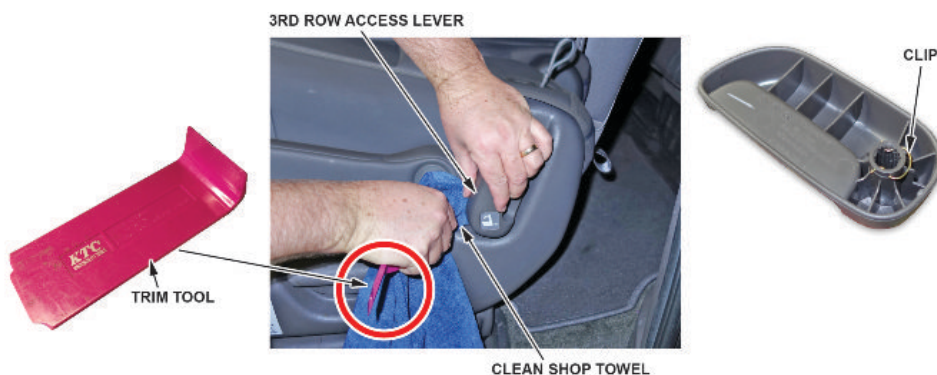
- Put on gloves to protect your hands.
 - Take care not to tear or damage the seat covers.
 - Use the appropriate tool from the KTC trim tool set to avoid damage when removing components.
1. Note which position the seat is installed; Standard (inner) or Wide (outer) position so that you can reinstall the seat in the same position after the repair.
 2. Remove the second row seat.
 3. If not already done, remove the recliner cover.
 - 3.1. Make sure the seat-back is in an upright position. Using a trim tool and a clean shop towel as shown, remove the 3rd row access lever.

- Use a clean shop towel to make sure the recliner cover and 3rd row access lever are not damaged.
- Be careful not to lose the clip on the back of the 3rd row access lever. If the clip is lost, the lever will not lock when you install it.

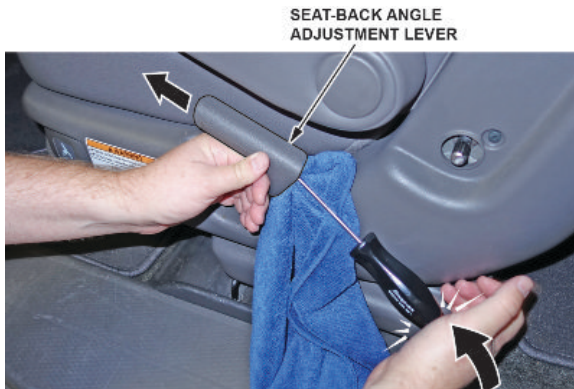
- 3.2. Lower the seat-back to the folded position.
- 3.3. Remove the seat-back angle adjustment lever handle by inserting a medium length Phillips screwdriver into the handle, then striking the screwdriver handle with your hand to slide the adjustment lever handle off.

- Place a clean shop towel between the screwdriver and the recliner cover to avoid damaging the recliner cover.
- To avoid damaging the recliner cover, do not strike the screwdriver with a hammer.
- Make sure the recliner lever is pulled up slightly so the handle doesn't hit the recliner cover when it comes off.

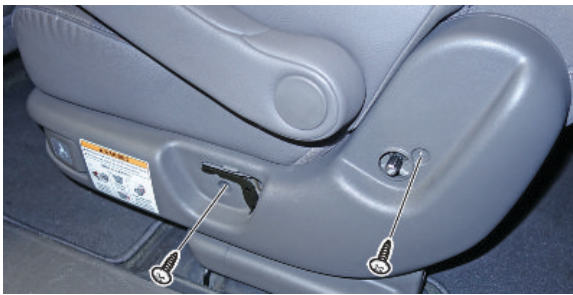
- 3.4. Remove the screws.

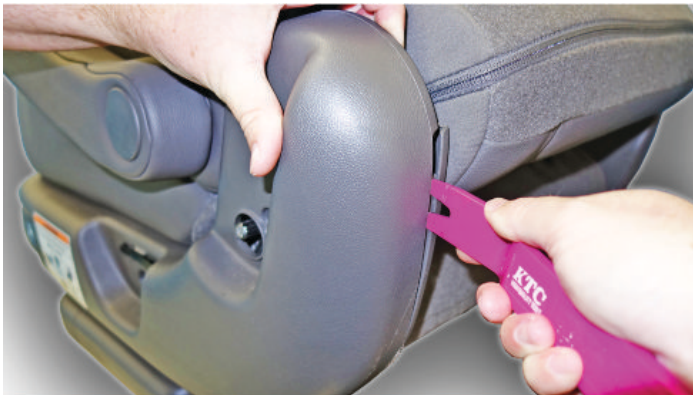
- 3.5. Starting at the back of the recliner cover, insert a trim tool as shown to separate the outer and inner covers.

- 3.6. Move toward the front of the recliner cover using the trim tool to separate the inner and outer covers.
- 3.7. Remove the recliner cover.

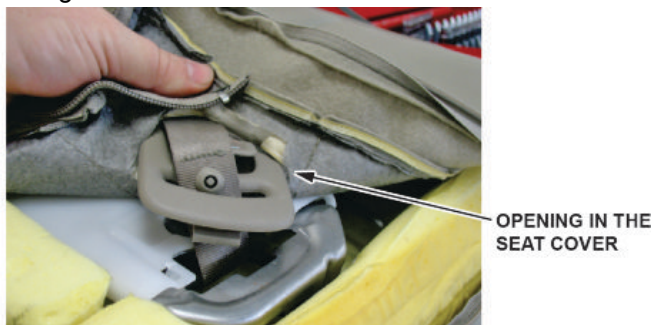
10. Feed the walk-out strap trim through the opening in the seat cover.

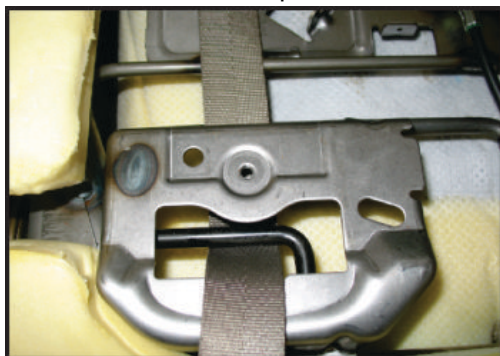
- Route the walk-out strap under the metal bar as shown.

- Install the walk-out strap using a new 6 mm push nut.

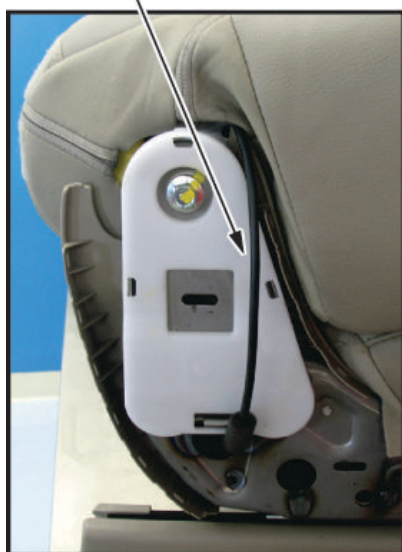
WALK-OUT CABLE ROUTING

17. Install the seat-back onto the base.

The bracket **does not** need to be installed on a new seat-back frame.

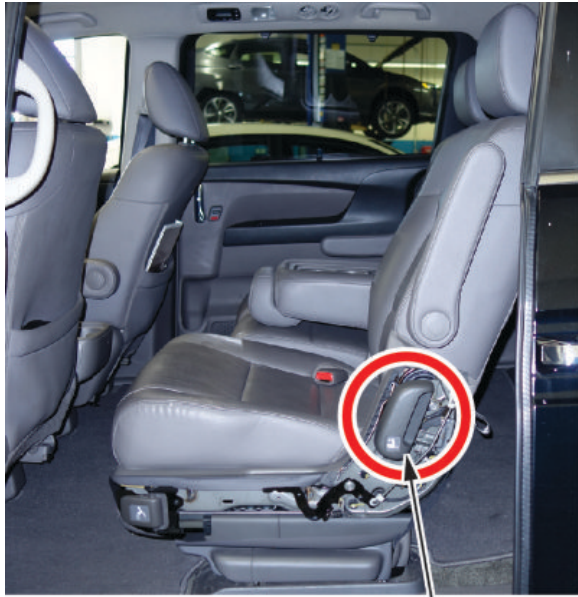
3RD ROW ACCESS LEVER

18. Temporarily install the 3rd row access lever. Install the seat if it was removed from the vehicle.
