April 24, 2018

Version 5

Safety Recall: Left (Driver Side) Second Row Seat Recliner Does Not Lock

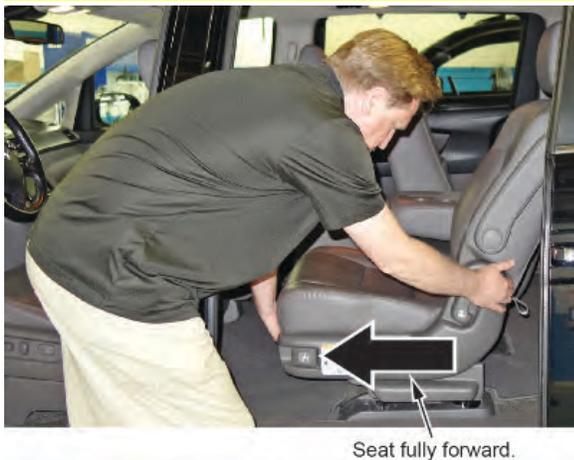
4. **Lift the slide lever and slide the second row seat all the way forward.**

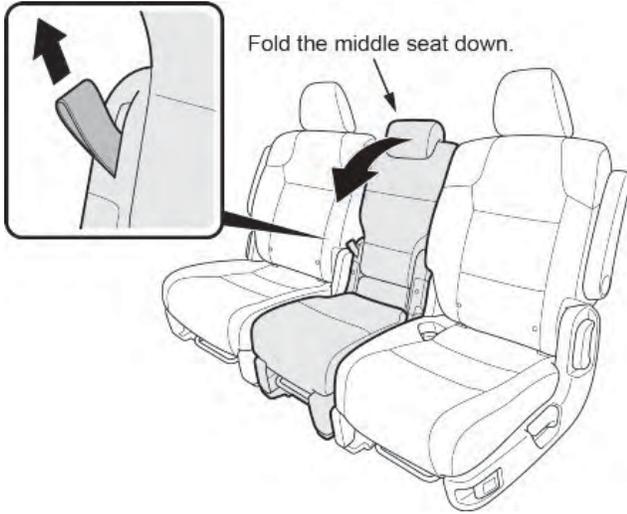
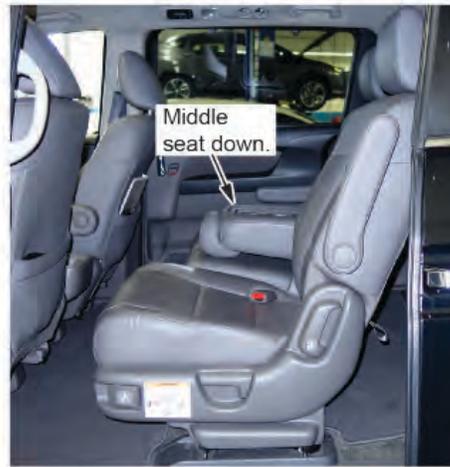
5. **Fold down the second row middle seat.**

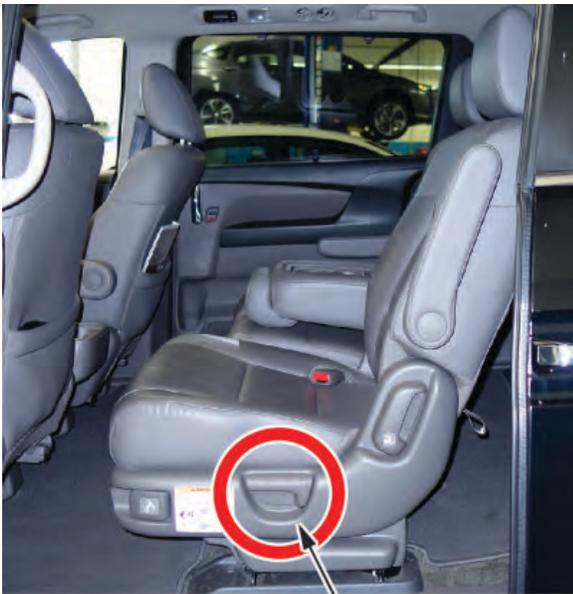
**SEAT-BACK ANGLE
ADJUSTMENT LEVER**

6. Start with the seat-back in an upright position.

7. Check the seat-back angle adjustment lever function.

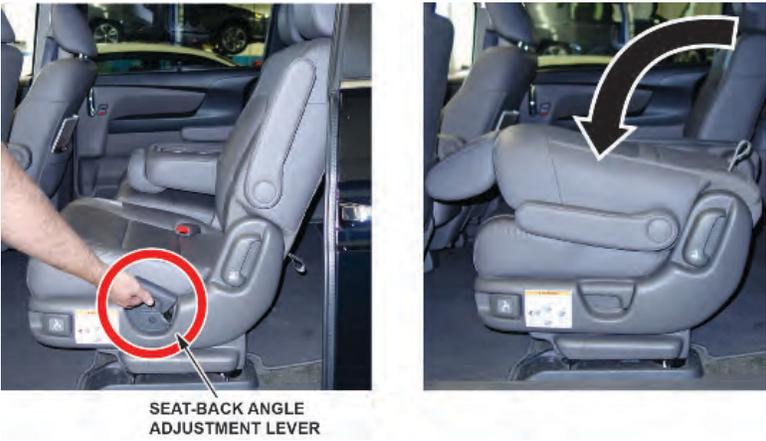
7.1. Pull the seat-back angle adjustment lever, and allow the seat-back to fold.

Don't let the seat-back slam down.

- If the seat-back does not fold, folds slowly, or requires assistance to fold it down, the recliner mechanism must be replaced. Go to REPAIR PROCEDURE - SEAT-BACK FRAME REPLACEMENT.
- If the seat folds normally, go to step 7.2.

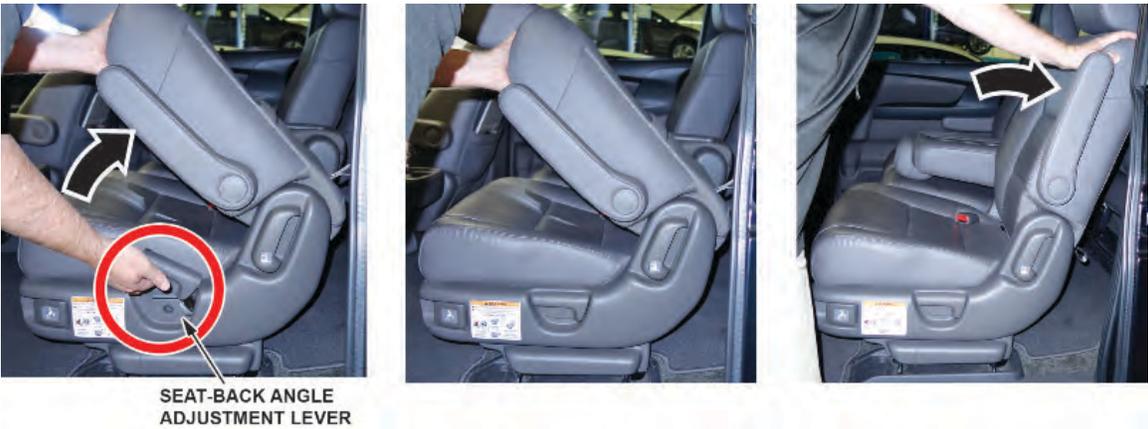
7.2. Pull the seat-back adjustment lever, and lift up on seat-back to release it from the folded position. Release the adjustment lever, and continue to push the seat-back until it locks in the upright position.

- If the seat-back does not lift up easily, binds, or requires significant effort to lift it up and push it back to the upright position, the recliner mechanism must be replaced. Go to REPAIR PROCEDURE - SEAT-BACK FRAME REPLACEMENT.
- If the seat-back lifts up and locks normally in the upright position, go to step 8.

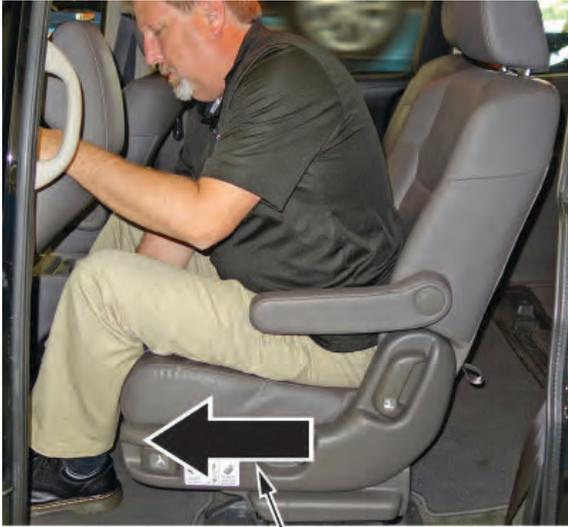
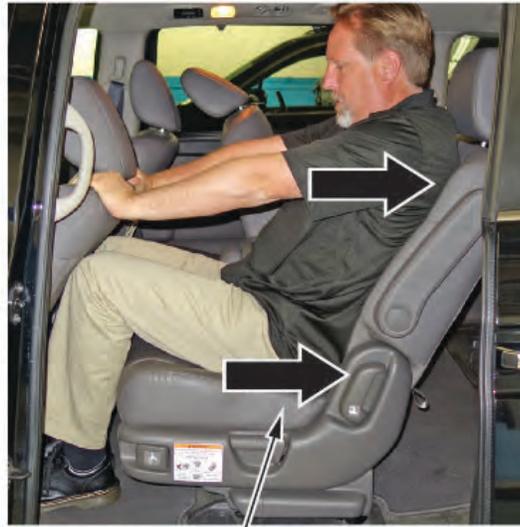
8. Sit in the seat, lift the slide lever, and make sure the seat is all the way forward. Using your arms and legs, push against the seat-back to confirm that the seat recliner mechanism holds its position and doesn't recline when a rearward force is applied.

Slide fully forward.

Push back with both arms and legs.

- If the seat-back does not hold its position and/or there is a ratcheting sound, the recliner mechanism must be replaced. Go to REPAIR PROCEDURE - SEAT-BACK FRAME REPLACEMENT.
 - If the seat-back holds its position and there is no ratcheting sound, go to step 9.
9. Check the seat-back angle adjustment lever while sitting in the seat.
- 9.1. While seated, pull the seat-back angle adjustment lever, lean back until the seat is fully reclined, then release the lever.

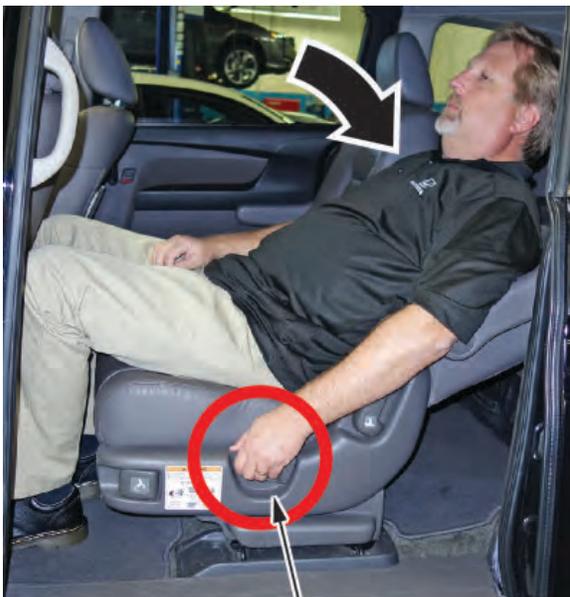
SEAT-BACK ANGLE ADJUSTMENT LEVER

- If the seat-back recliner binds or requires significant effort to recline, the recliner mechanism must be replaced. Go to REPAIR PROCEDURE - SEAT-BACK FRAME REPLACEMENT.
- If the recliner function operates normally, go to step 9.2.

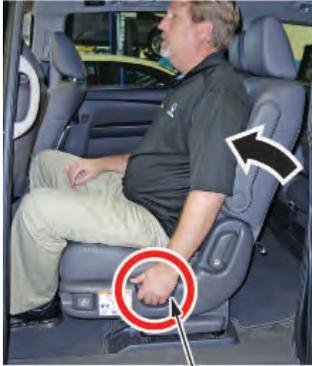
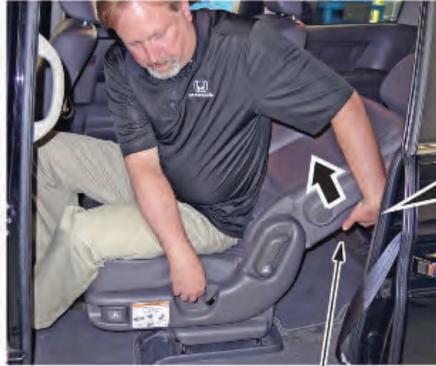
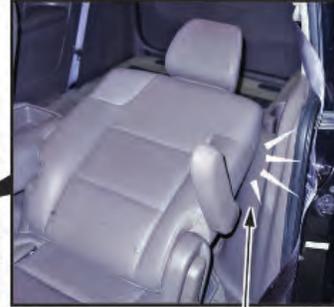
SEAT/TRIM PANEL CONTACT POINT

When the seat-back is fully reclined, it contacts the rear side trim panel near the 3rd row cup holder. This may prevent the seat-back from freely returning to the upright position. If this occurs, lift the seat-back until it is not contacting the trim panel and allow the recliner to return to the upright position unassisted.

Lift the seat-back to free it from the trim panel if necessary.

- After the seat-back is free from the side trim panel, if the seat-back recliner does not fold, binds, or requires continuous assistance to return the seat to the upright position, the recliner mechanism must be replaced. Go to REPAIR PROCEDURE - SEAT-BACK FRAME REPLACEMENT.
- If the seat-back returns to the upright position normally, go to step 10.

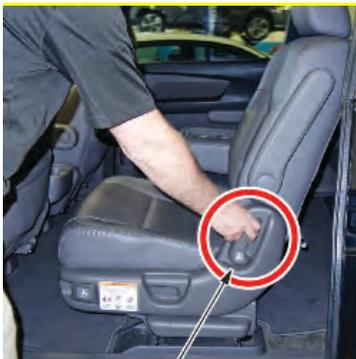
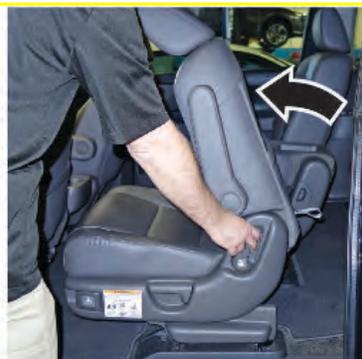
3RD ROW ACCESS LEVER

10.1. Pull the 3rd row access lever, and allow the seat-back to fold forward.

The seat-back should fold forward as shown. It will not fold flat.

- If the seat-back does not fold forward by itself, binds, and/or requires assistance to fold forward, the recliner mechanism must be replaced. Go to REPAIR PROCEDURE - SEAT-BACK FRAME REPLACEMENT.
- If the seat-back folds forward normally, go to step 10.2.

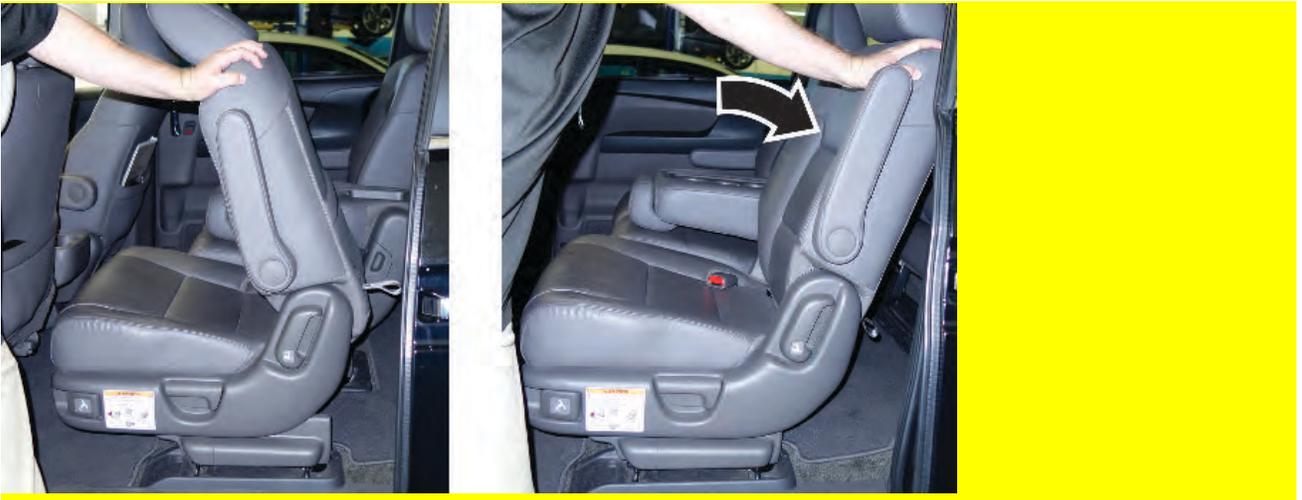
10.2. Push the seat-back toward the rear of the vehicle until the seat-back locks in the upright position.

- If the seat-back does not lock in the upright position normally, the recliner mechanism must be replaced. Go to REPAIR PROCEDURE - SEAT-BACK FRAME REPLACEMENT.
- If the seat-back locks in the upright position normally, go to REPAIR PROCEDURE - RECLINER BRACKET KIT.

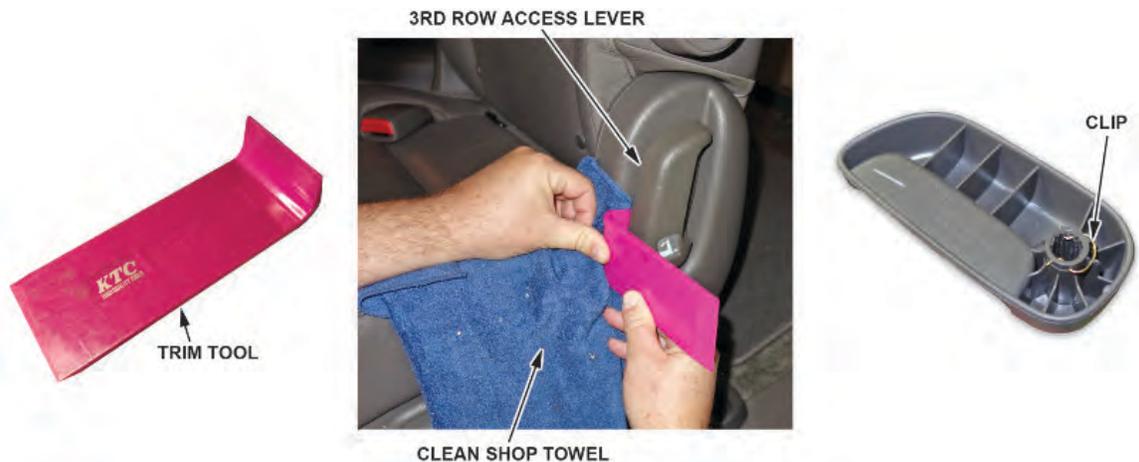
- Put on gloves to protect your hands.
 - Take care not to tear or damage the seat covers.
 - Use the appropriate tool from the KTC trim tool set to avoid damage when removing components.
1. Remove the recliner cover.
 - 1.1. Make sure the seat-back is in an upright position. Using a trim tool and a clean shop towel as shown, remove the 3rd row access lever.

- Use a clean shop towel to make sure the recliner cover and 3rd row access lever are not damaged.
- Be careful not to lose the clip on the back of the 3rd row access lever. If the clip is lost, the handle will not lock when you install it.

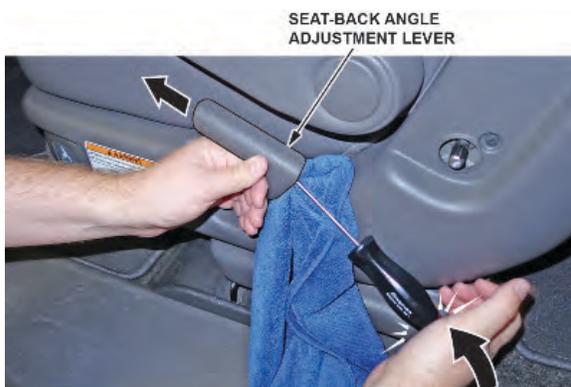
- 1.2. Lower the seat-back to the folded position.
- 1.3. Remove the seat-back angle adjustment lever handle by inserting a medium length Phillips screwdriver into the handle, then striking the screwdriver handle with your hand to slide the adjustment lever handle off.

- Place a clean shop towel between the screwdriver and the recliner cover to avoid damaging the recliner cover.
- To avoid damaging the recliner cover, do not strike the screwdriver with a hammer .
- Make sure the recliner lever is pulled up slightly so the handle doesn't hit the recliner cover when it comes off.

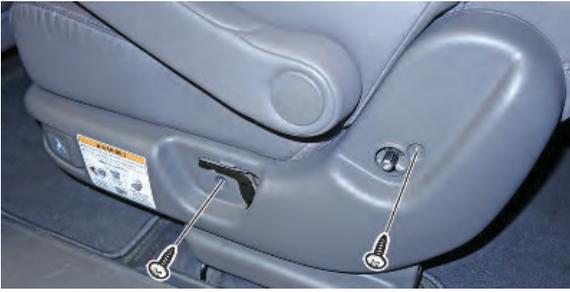
1.4. Remove the screws.

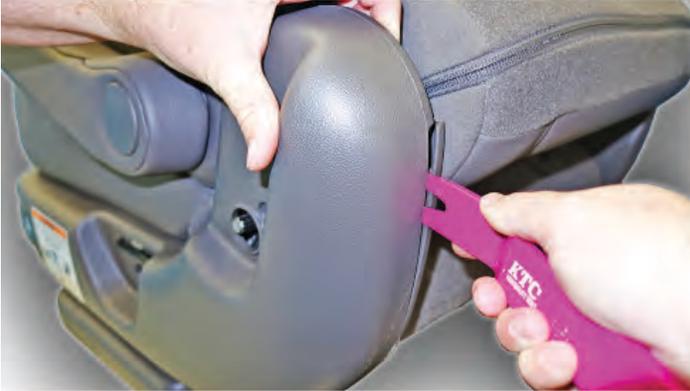
1.5. Starting at the back of the recliner cover, insert a trim tool as shown to separate the outer and inner covers.

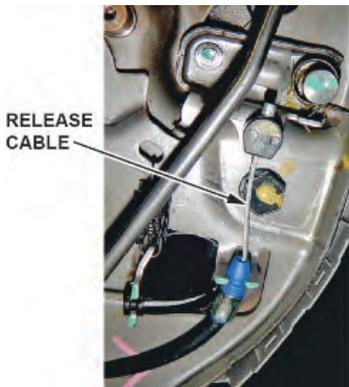
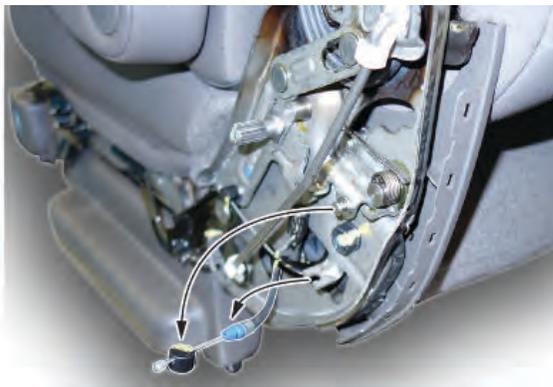
2. Disconnect the release cable.

- Remove the bolt. **Do not reuse it. It must be replaced with the new bolt included in the kit.**

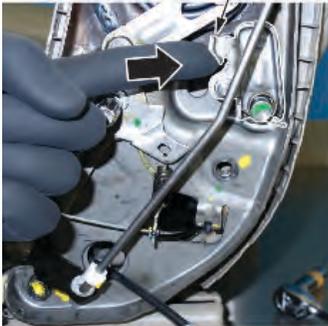
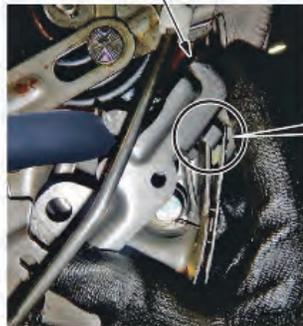
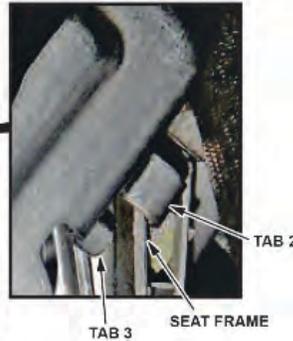
- Lift the lever and hold it as shown, then install the bracket, starting at an angle with center tab 2 and lower tab 3 positioned as shown.

Push the lever clockwise, and hold it there.

Install the new bracket on the seat frame..

- Rotate the bracket counterclockwise into position until the bolt hole on the new bracket aligns with the bolt hole in the seat frame.

Hook the new bracket onto the seat frame.

Rotate the bracket counterclockwise until the hole in the bracket and the hole in the seat frame line up.

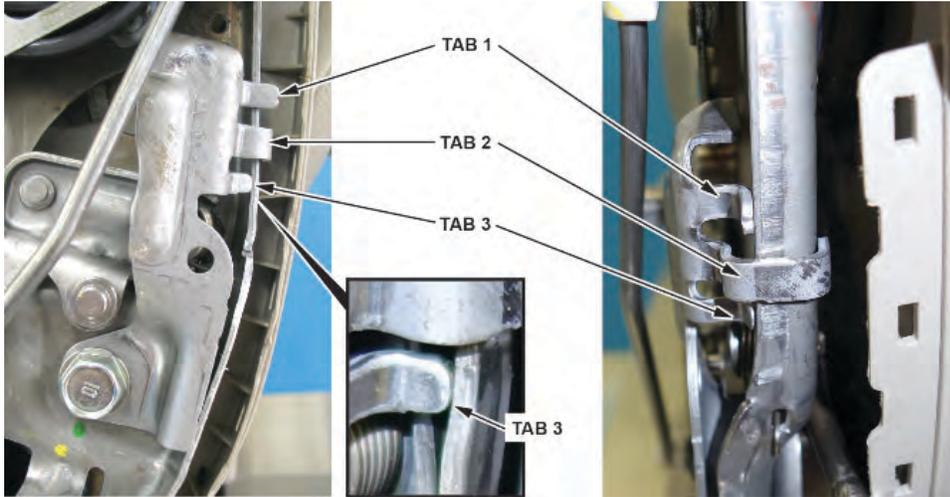
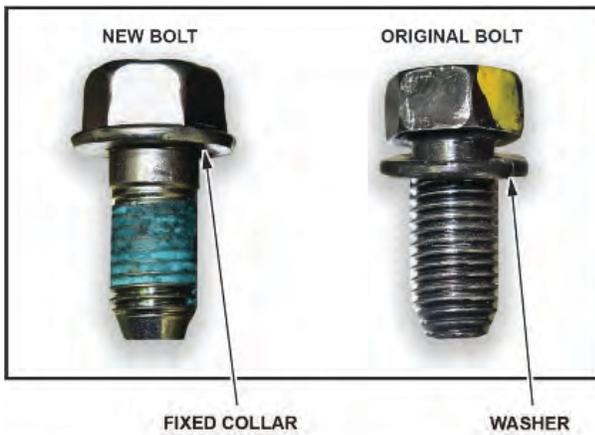
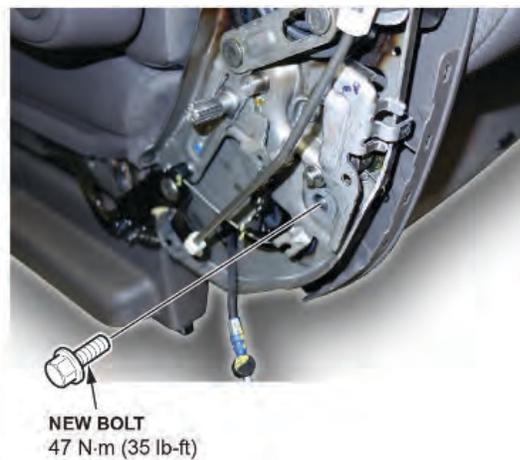
6. Check to make sure the three tabs are in position, install and hand tighten the **new bolt from the kit**.

- Tab 1 sits on the edge of the seat frame, tab 2 wraps around the seat frame, and tab 3 is on the inside of the frame.
- **The new bolt has a fixed collar and is coated with threadlock and must be used to install the bracket. Do not use the original bolt.**

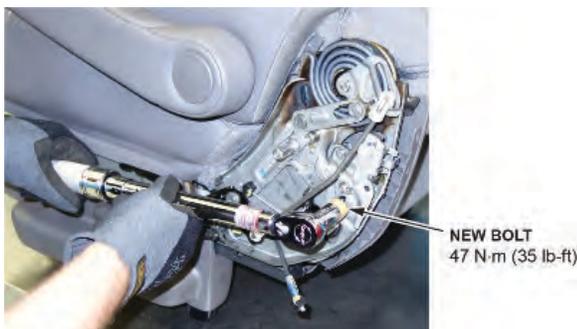
7. Torque the new bolt to **47 N·m (35 lb-ft)**.

The bolt is coated with thread lock, which allows bolt adjustment for up to 10 minutes after it is initially torqued. After 10 minutes, the thread lock sets. If the bolt needs adjustment after 10 minutes, replace it with a new one.

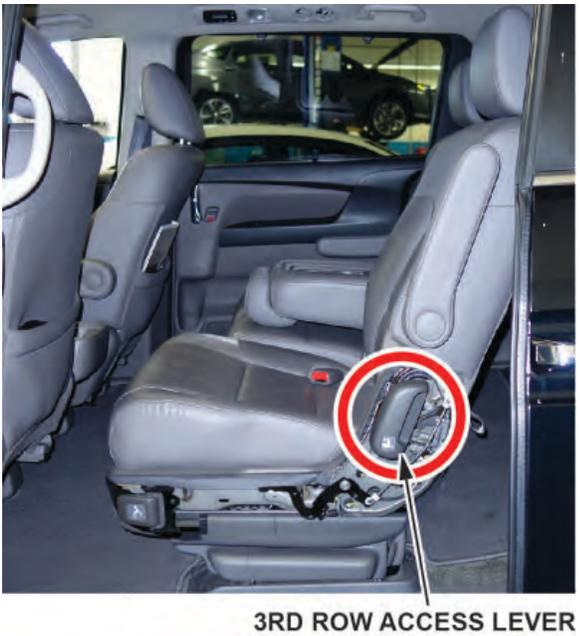
9. Temporarily install the 3rd row access lever. Install the seat if it was removed from the vehicle.

10. Confirm the seat-back recliner function activates using the seat-back angle adjustment lever, the 3rd row access lever and the release strap.

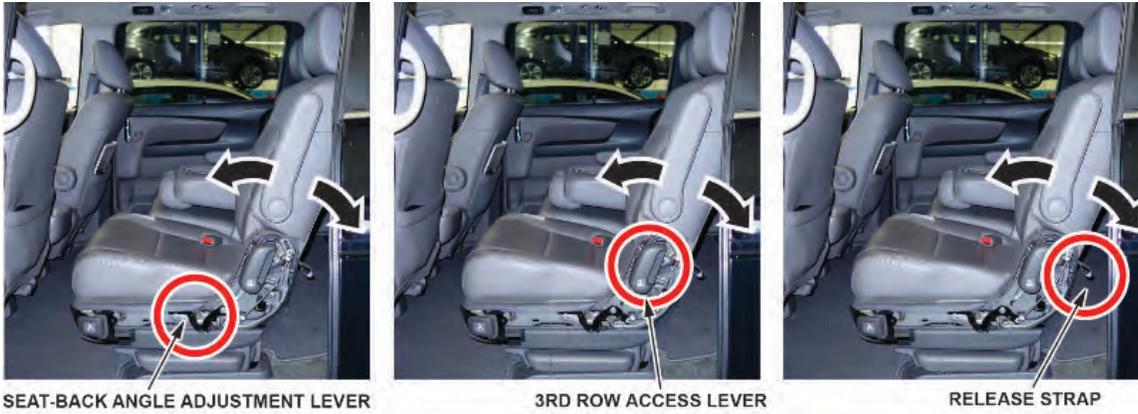
- If the seat-back recliner does not activate with the seat-back angle adjustment lever, the 3rd row access lever and the release strap, replace the recliner mechanism. Go to SEAT-BACK FRAME REPLACEMENT.
 - If the seat-back recliner activates using the seat-back angle adjustment lever, the 3rd row access lever and the release strap, go to step 11.
11. Remove the 3rd row access lever and install the recliner cover in the reverse order of removal.
12. If the second row seat was installed in the wide (outer) position noted in step 1 of the INSPECTION PROCEDURE, move it to the wide (outer) position and do the following to make sure it is properly secured.

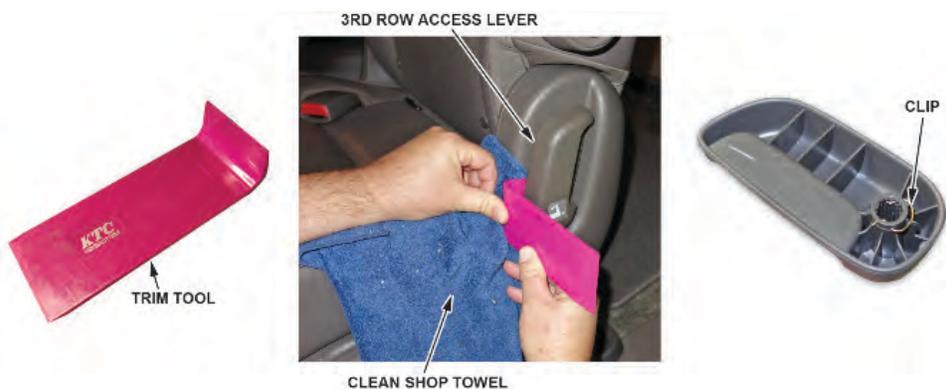
- Put on gloves to protect your hands.
 - Take care not to tear or damage the seat covers.
 - Use the appropriate tool from the KTC trim tool set to avoid damage when removing components.
1. Note which position the seat is installed; Standard (inner) or Wide (outer) position so that you can reinstall the seat in the same position after the repair.
 2. Remove the second row seat.
 3. If not already done, remove the recliner cover.
- 3.1. Make sure the seat-back is in an upright position. Using a trim tool and a clean shop towel as shown, remove the 3rd row access lever.

- Use a clean shop towel to make sure the recliner cover and 3rd row access lever are not damaged.
- Be careful not to lose the clip on the back of the 3rd row access lever. If the clip is lost, the lever will not lock when you install it.

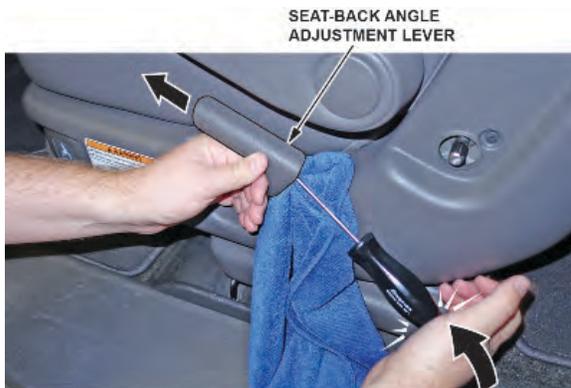
- 3.2. Lower the seat-back to the folded position.
- 3.3. Remove the seat-back angle adjustment lever handle by inserting a medium length Phillips screwdriver into the handle, then striking the screwdriver handle with your hand to slide the adjustment lever handle off.

- Place a clean shop towel between the screwdriver and the recliner cover to avoid damaging the recliner cover.
- To avoid damaging the recliner cover, do not strike the screwdriver with a hammer.
- Make sure the recliner lever is pulled up slightly so the handle doesn't hit the recliner cover when it comes off.

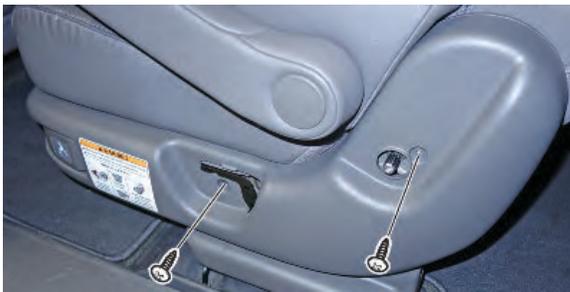
- 3.4. Remove the screws.

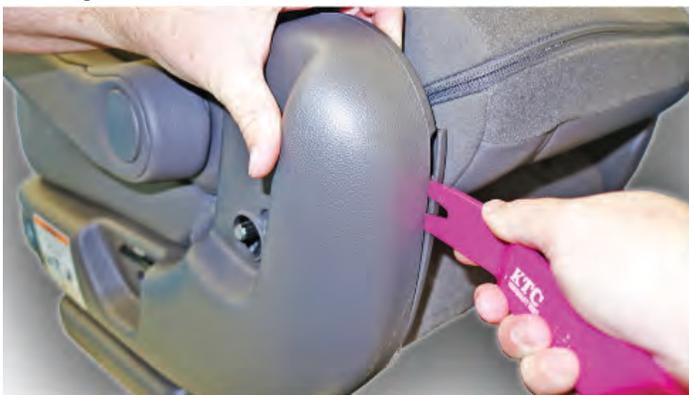
- 3.5. Starting at the back of the recliner cover, insert a trim tool as shown to separate the outer and inner covers.

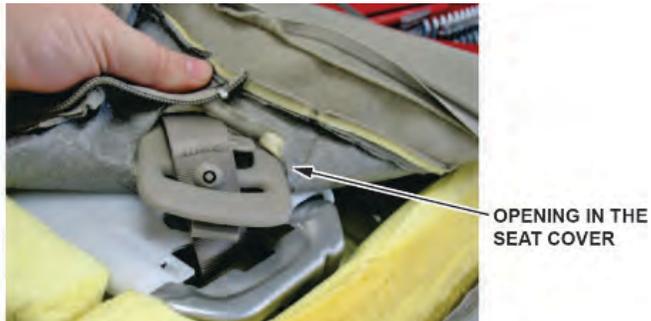
10. Feed the walk-out strap trim through the opening in the seat cover.

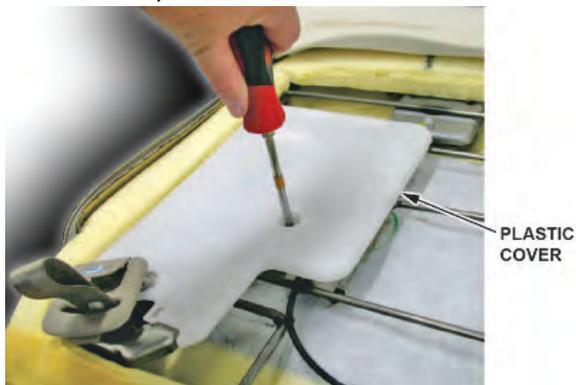
11. Remove the plastic cover.

12. Remove the push nut, then remove the walk-out strap.

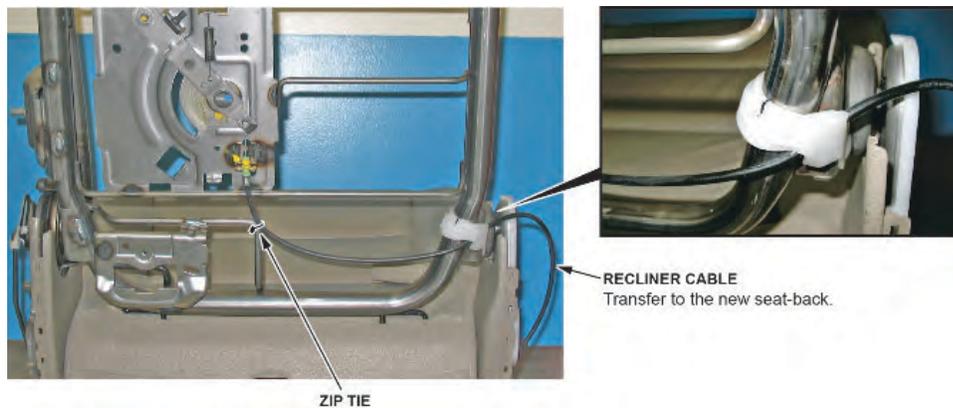
15. Cut the zip tie, and disconnect the plastic clamp. Then disconnect the recliner cable and install it onto the new seat-back recliner mechanism.

Use a new zip-tie to secure the recliner cable when reassembling the seat.

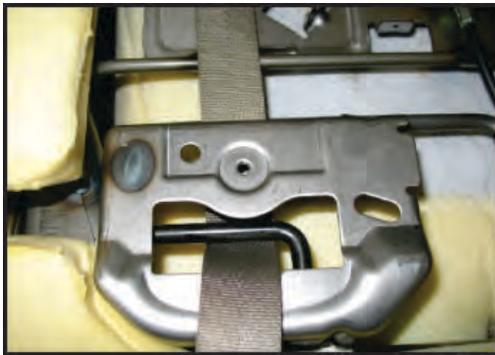
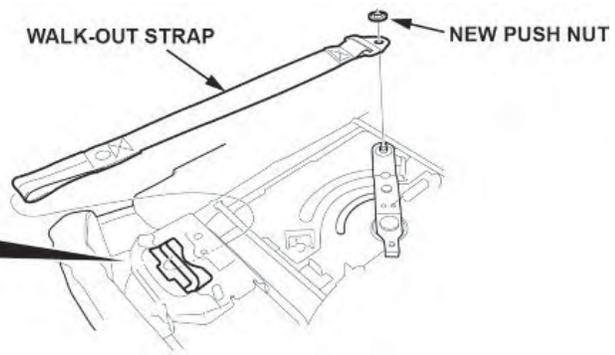
- Route the walk-out strap under the metal bar as shown.

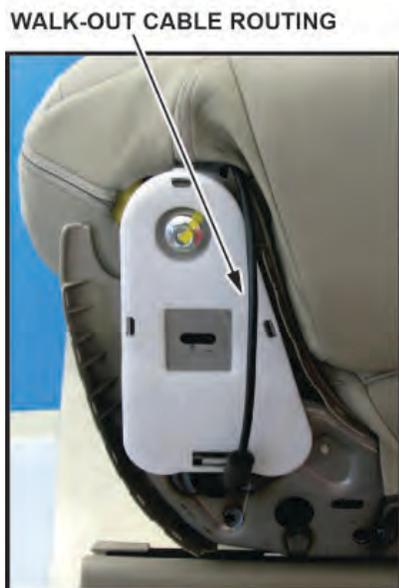
The bracket kit **does not** need to be installed on a new seat-back frame.

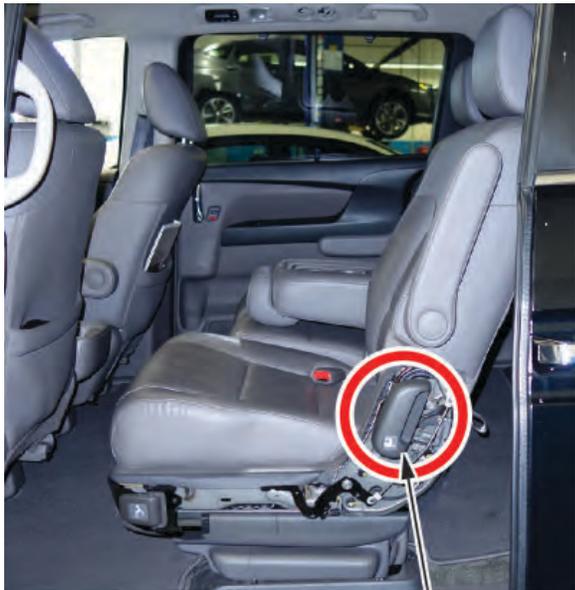
3RD ROW ACCESS LEVER

18. Install the seat, and temporarily install the 3rd row access lever.

19. Confirm the seat-back recliner function activates using the seat-back angle adjustment lever, the 3rd row access lever, and the release strap.
