TECHNICAL INSTRUCTIONS

SAFETY RECALL J0K

VACUUM PUMP

CERTAIN 2017 TACOMA

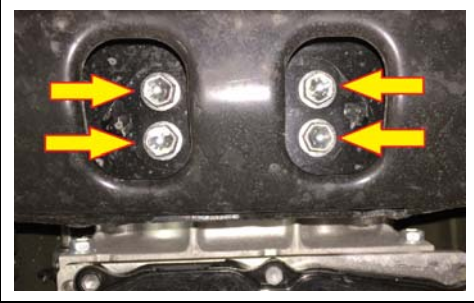
1. **REMOVE THE TRANSMISSION MOUNT BOLTS**
 - a. Remove the 4 bolts securing the transmission mount to the crossmember.

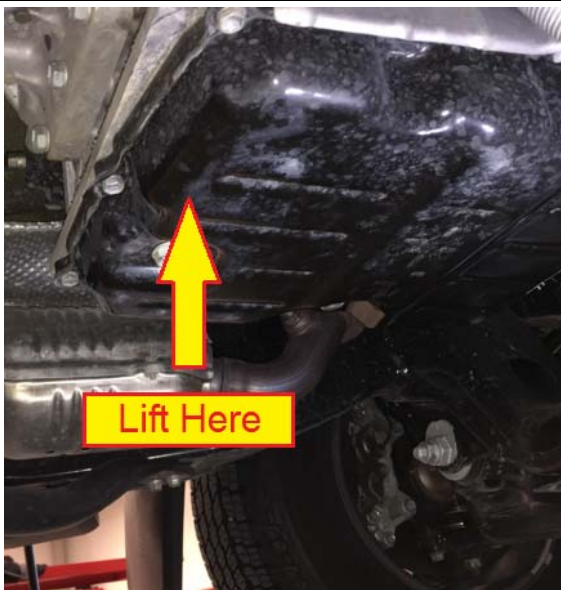
4x2 Automatic

4x2: Lift under the rear edge of the oil pan.

Note: Lift only on the rear most edge of the pan. Lifting in the center of the pan may cause damage.

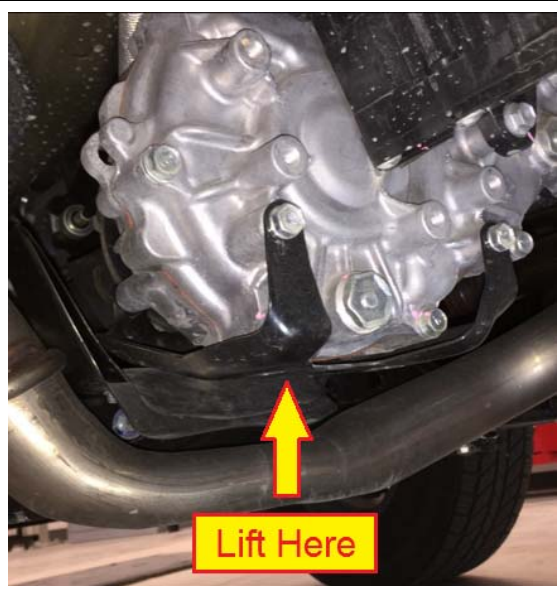
4x4 Automatic

4x4: Lift under the skid plate of the transfer case

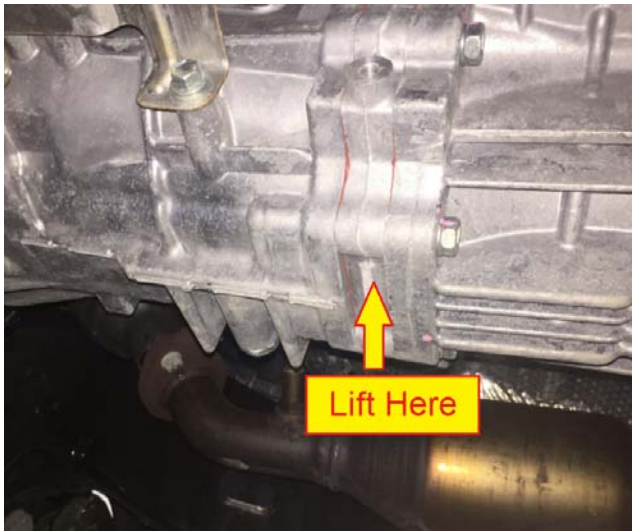
4x2 Manual

4x2: Lift under the transmission case

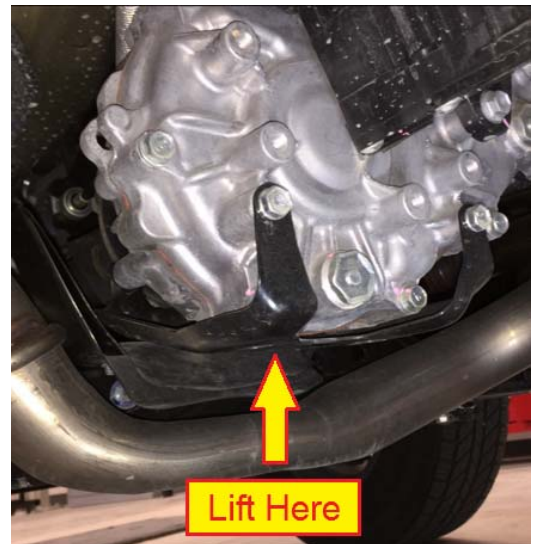
4x4 Manual

4x4: Lift under the skid plate of the transfer case

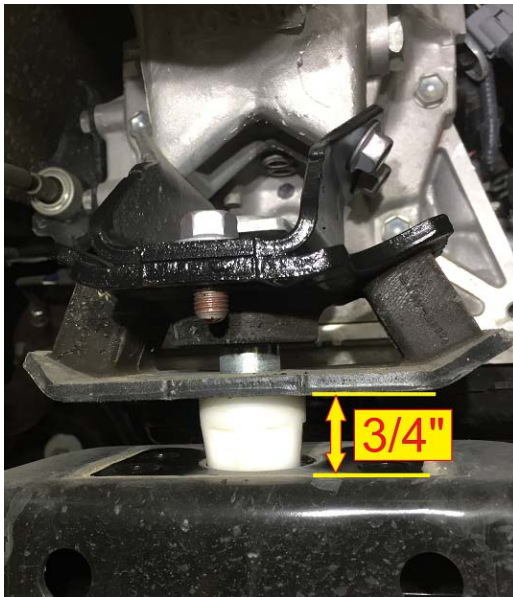
4x2 Automatic

- a. Using the previously positioned floor jack, lift the transmission so that $\frac{3}{4}$ " (19mm) of clearance is achieved between the transmission mount and the crossmember.

Lifting the transmission more than the specified amount can cause damage.
