2018 Panigale V4 Fuel Tank Updates - CR148 Recall Service Bulletin SRV-RCL-18-002 Panigale V4 (All Models and Country Versions)

Date: Thursday, March 29th, 2018

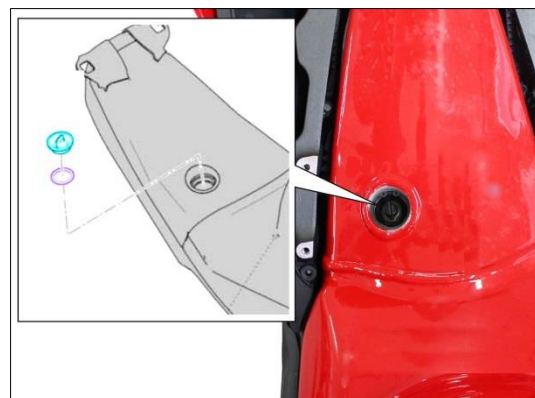
b) Replacement of the fuel tank filling/compensating valve and of the relevant O-ring:

In some remote cases, a fuel leak may occur from the fuel tank filler valve plug due to an incorrect fitting procedure of the plug itself; this leak could occur both while riding or when the bike is parked.

We have therefore decided to replace the fuel tank filling valve plug with a new reshaped plug and O-ring in order to avoid the problem mentioned above.
