L73X-
R.01.18

To: Official after-sales network.
Subject: Replacement of homologation label.
Date: 25/05/2018
Pages: 7

Replacement of homologation label.

Centenario Coupé And Roadster

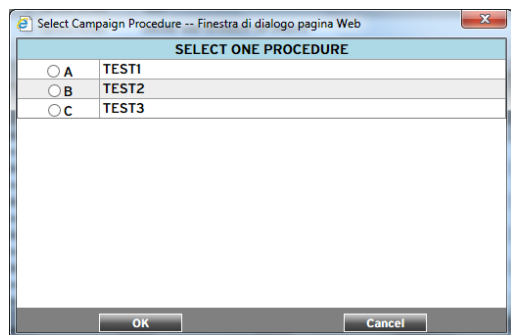
Select the desired campaign and go on with the claim insertion, read carefully the windows message content and choose the option button corresponding to the operation performed .

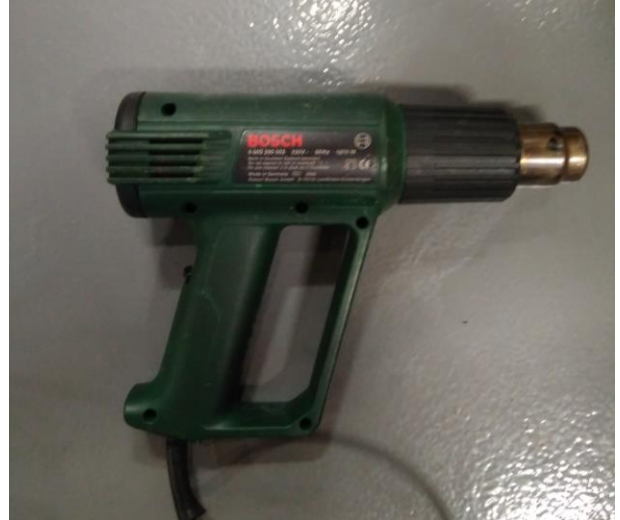
- Heat gun.

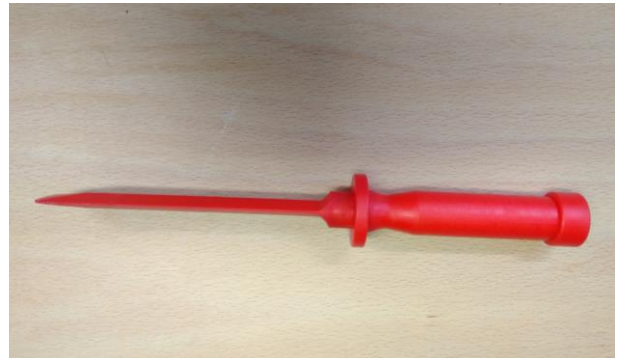
- Plastic bodywork tool.

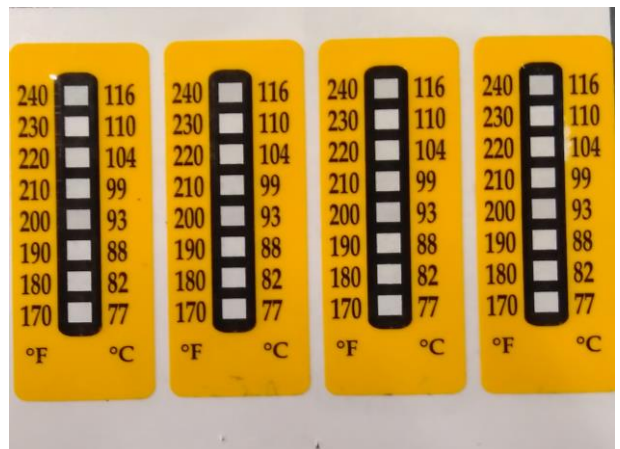
- Heat reading stickers (graduated °C/°F, with full scale 116°C/240°F).

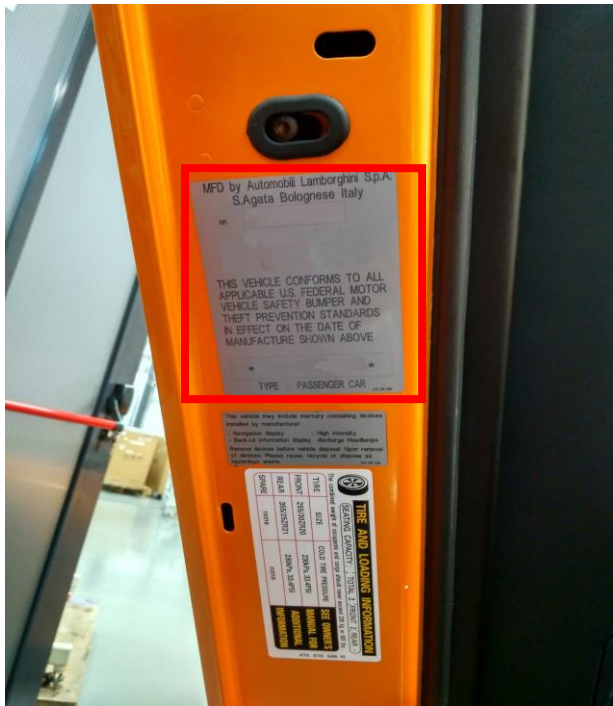
1. Identify the label to remove in the lower part of the driver door (see image).

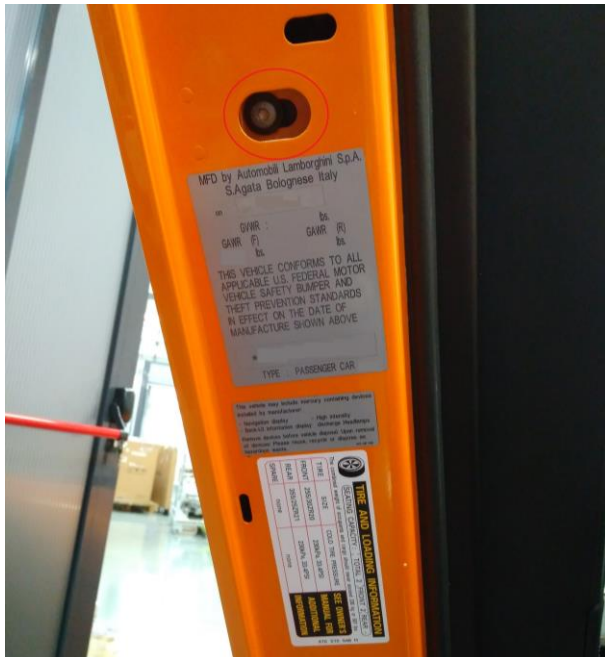
2. Remove the upper seal.

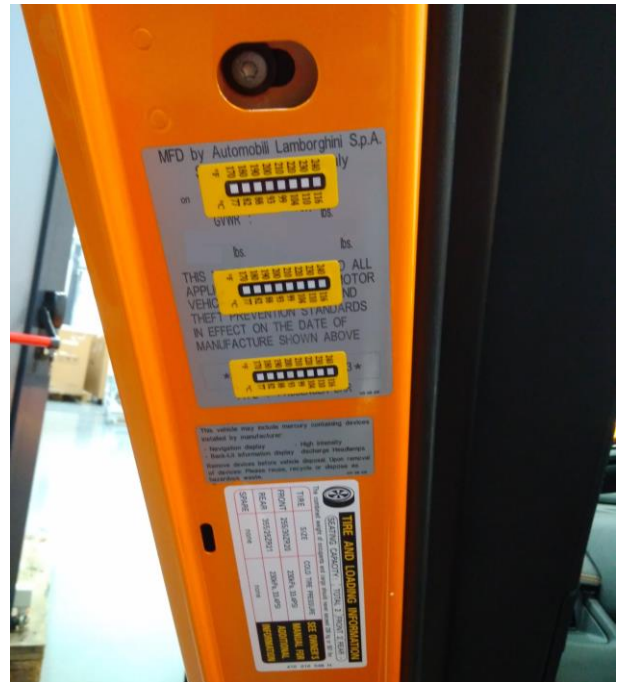
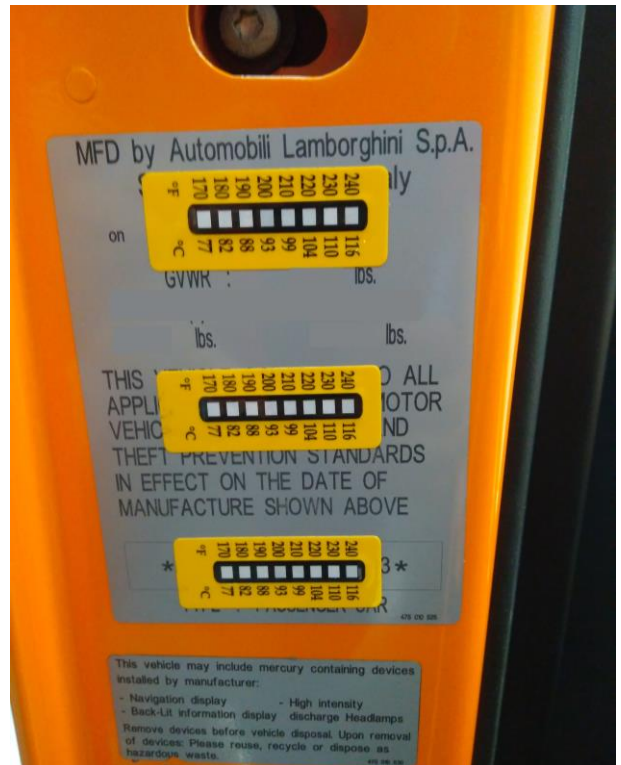
3. Apply three heat reading stickers to monitor the temperature on the entire surface of the label.

- Heat the adhesive label using the heat gun. Stand about 10-15 cm away and perform even circular movements over the entire surface in order to uniformly heat the entire label do not focus on one particular point for more than 2 seconds; otherwise the paint may become damaged. Consequently, by making use of a removing plastic bodywork tool, gently remove the sticker by scratching and continuously applying heat.

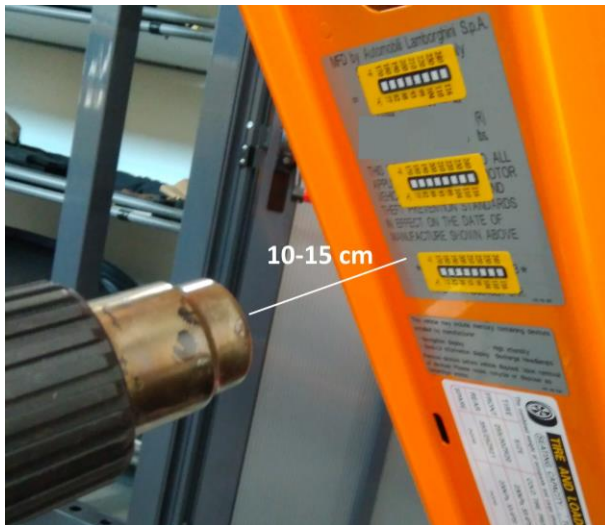
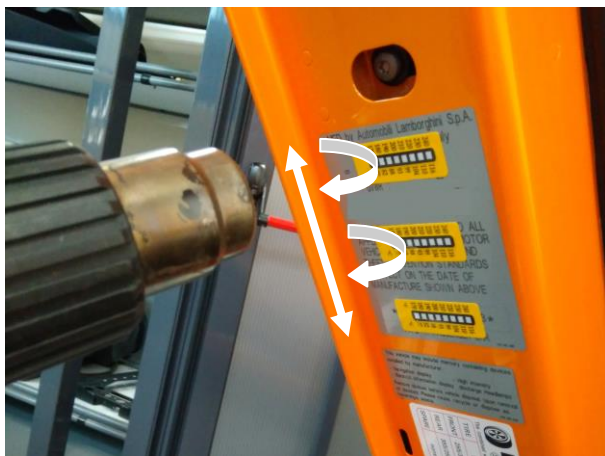
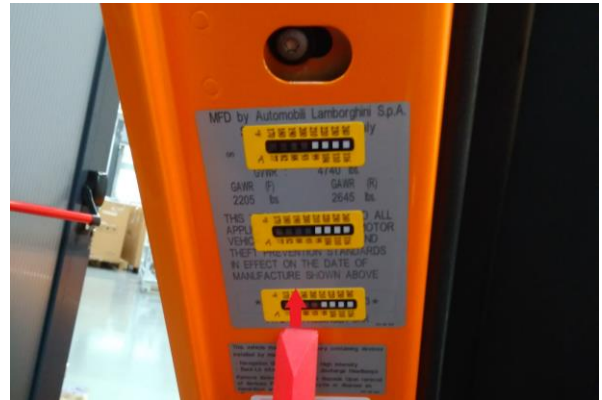
Removal starting from the bottom makes the job easier.

Do not cross the temperature of 93°C (210°F) as the paint could come off near and under the identification label.

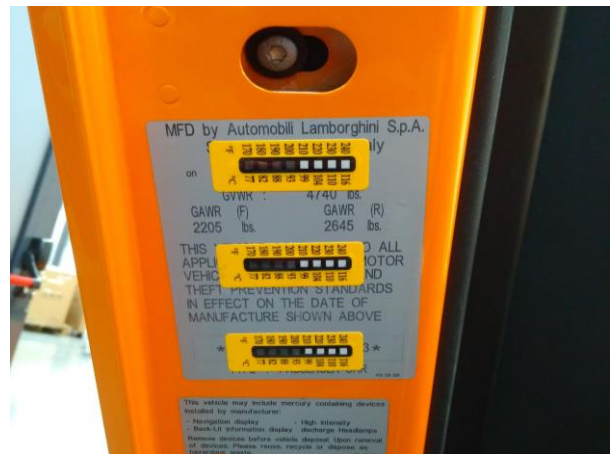
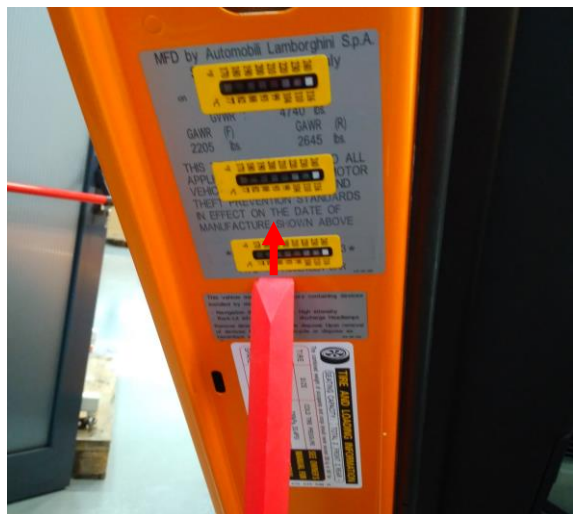
In case of crossing the limit temperature of 93°C (210°F), stop the operation and let the label's surface cool down for a couple of minutes to guarantee its proper cooling.

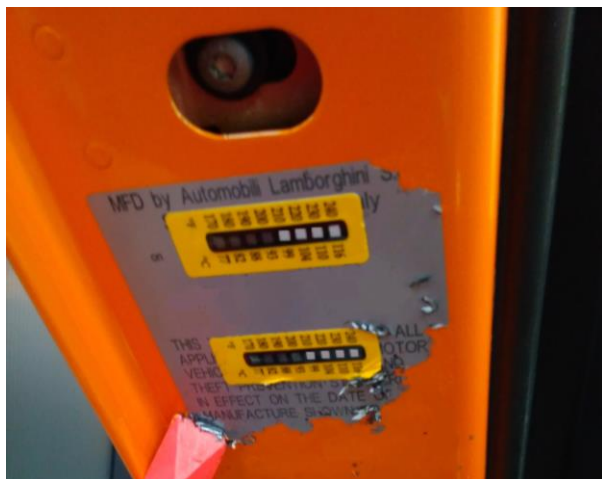
It is normal if the homologation label comes off in fragments, as shown in the picture below.

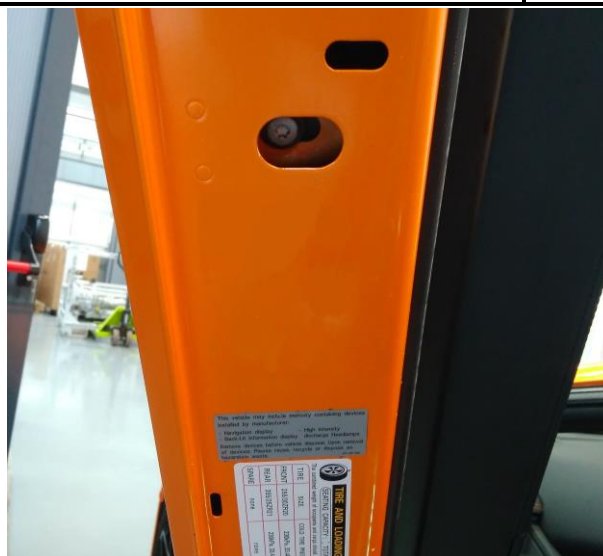
5. Completely remove the label and clean the surface with a soft cloth and a degreaser to eliminate all glue residue.

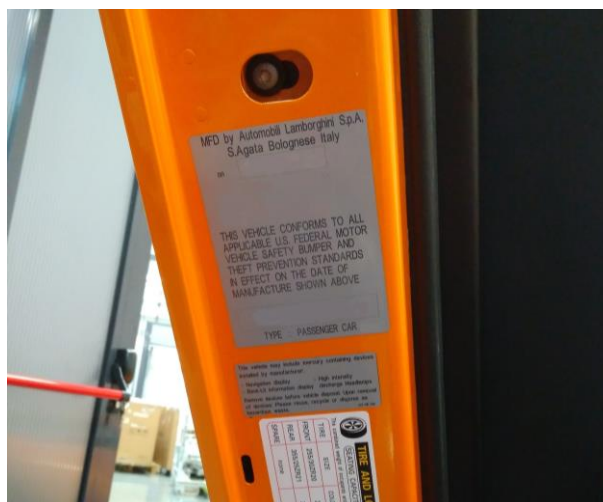
6. Glue on the new label

For an accurate label alignment take as reference the edge of the door. In order to avoid any bubble under the surface of the label, please gently apply pressure from top to bottom with the plastic bodywork tool.

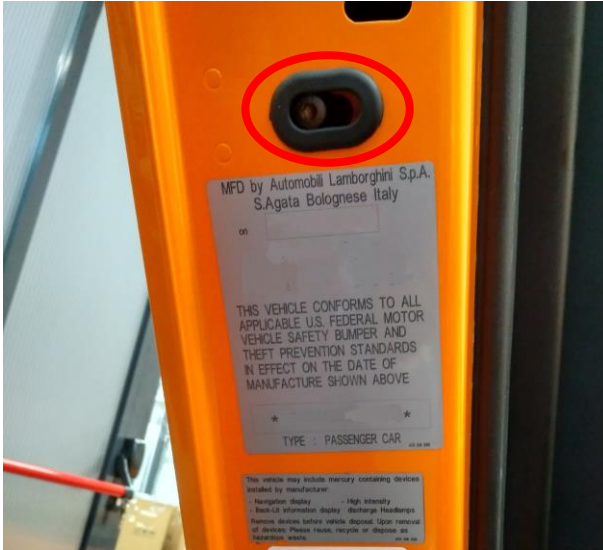
7. Install the seal.
