Subject: Meritor Brake Caliper Orientation

Models Affected: Specific Business Class M2 vehicles manufactured November 11, 2015, through February 9, 2018, and equipped with a single axle spring suspension with Meritor EX-H air disc brakes.

June 2018 FL767A NHTSA #18V-251

Inspect Rear Brake Calipers

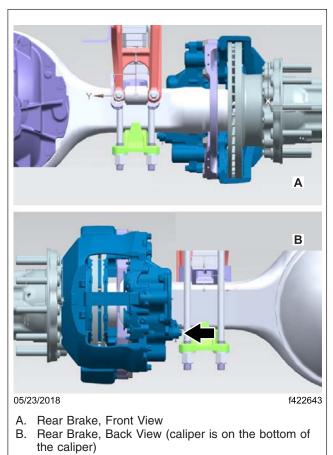
Fig. 1, Correct Caliper Position, Left Side

- 1. Check the base label (Form WAR259) for a completion sticker for FL767 (Form WAR260) indicating this work has been completed. The base label is usually located on the passenger-side door, about 12 inches (30 cm) below the door latch. If a completion sticker is present, no work is needed. If a completion sticker is not present, proceed to the next step.
- 2. Park the vehicle on a level surface, shut down the engine, and set the parking brake. Chock the tires.
- 3. Inspect the rear disc brake calipers for proper installation. Correctly installed calipers will have the fixed pin positioned at the bottom of the caliper. See **Fig. 1** and **Fig. 2**.

If the calipers are not installed correctly, go to step 4 on page 9.

If the calipers are installed correctly, no further work is needed. Clean a spot on the base label (Form WAR259). Write the campaign number, FL767, on a blank red completion sticker (Form WAR260), to indicate the work has been completed, and attach it to the base label.

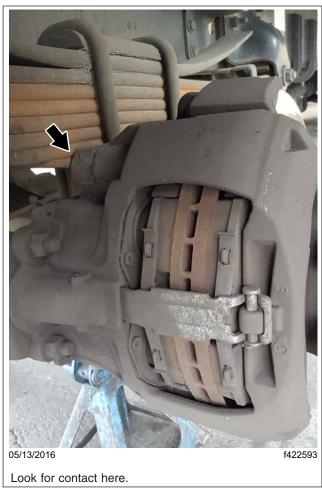
Fig. 3, Contact Area

4. On each axle end, inspect the spring and caliper for evidence of contact. See Fig. 3, Fig. 4, and Fig. 5.

If there is no evidence of contact between the caliper and spring, go to "Caliper Orientation Procedure" on page 10.

If there is evidence of contact between the caliper and leaf spring, go to "Caliper and Rotor Replacement," and inspect calipers once they are removed from the vehicle.

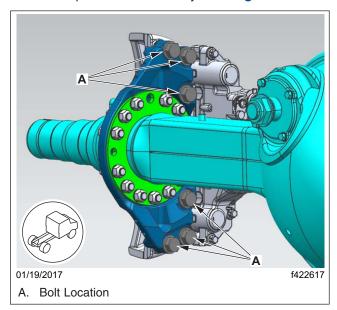
Fig. 6, Caliper Bolts, Rear Axle

- 4. Cage the rear brake chambers so that the springs cannot actuate during disassembly.
- 5. Disconnect the supply and return air lines from the brake chamber.
- 6. Back off the manual brake adjuster 1/4 turn.
- 7. Remove the brake pads.
- 8. With the caliper/carrier assembly securely supported, remove and discard the six bolts attaching the carrier to the anchor plate. Remove the caliper/carrier assembly. See **Fig. 6**.

- 9. With the caliper/carrier assembly securely supported, remove and discard the six bolts attaching the carrier to the anchor plate. Remove the caliper/carrier assembly. See **fig. 6** on page 11.
- 10. Remove the brake rotors. For instructions, refer to Group 42 of the vehicle's workshop manual.
- 11. Install the new brake rotors. For instructions, refer to Group 42 of the vehicle's workshop manual.
- 12. Position the new carrier/caliper assembly, and attach it to the anchor plate with new bolts. Hand tighten the

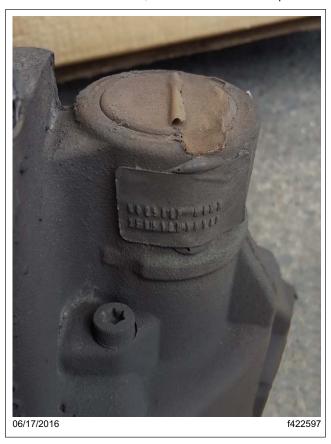
Fig. 7, Caliper Damage

9. Inspect the caliper for damage due to contact with the spring.

If contact between the caliper and spring was noted during the inspection procedure, and the caliper shows evidence of contact similar that shown in **Fig. 7** and **Fig. 8**, replace both sets of brake calipers, rotors, brake chambers, and pads on the affected axle. Follow the procedure in "Caliper and Rotor Replacement" on page 13. Refer to PartsPro with the vehicle serial number for rotor part numbers. If there is no evidence of contact, continue with the caliper reorientation.

If a caliper is found damaged during the inspection, or if it is not functioning correctly while performing the "Caliper Orientation Procedure," replace both sets of brake calipers, rotors, brake chambers, and pads on the affected axle as follows. Some steps may already be completed.
