| | GROUP<br><b>Safety Recall Campaign</b> | MODEL<br><b>2017MY Niro (DE HEV)</b> |
| | NUMBER<br><b>SC163</b> | DATE<br><b>June 2018</b> |
| <b>SUBJECT: HYDRAULIC CLUTCH ACTUATOR (HCA) INSPECTION, REPAIR OR REPLACEMENT (SC163)</b> | | |

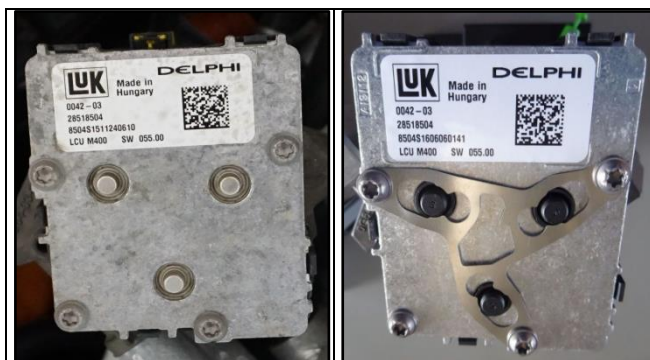
2. Inspect the bottom of the HCA phase plate assembly.

- If the original metal phase caps are installed (B), proceed to the next step.
- If the improved plastic phase caps and metal bracket are installed (C), reinstall engine undercover. No further action is required.

Original Metal  
Phase CapsImproved Plastic Phase  
Caps and Metal Bracket

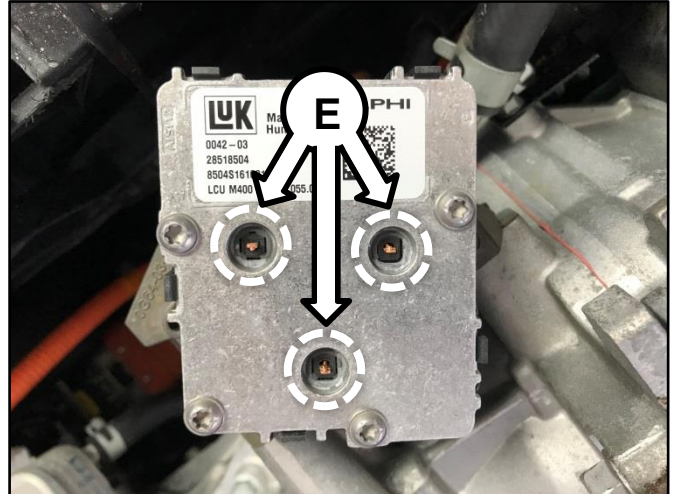
4. Inspect the three (3) electrodes (E).
  - If the electrodes are clean and not contaminated, proceed to the repair procedure below.
  - If an electrode is contaminated (with brake fluid), fulfill the requirement\* below and open a Techline case for review and replacement approval, and then proceed to the replacement procedure on page 7.

| Clean Electrode | Contaminated Electrode |

**\*Requirement:** Take one (1) KVID photo showing the contaminated electrodes for Techline review, Parts ordering, and Warranty claim.
