## Safety Recall: Driver's and Front Passenger Replacement (Service Part) Seat-back Pad

**Supersedes 18-061 dated April 27, 2018; See REVISION SUMMARY**

Year	Model	Trim	VIN Range
2017	Civic	5 Door	Check the iN VIN status for eligibility.

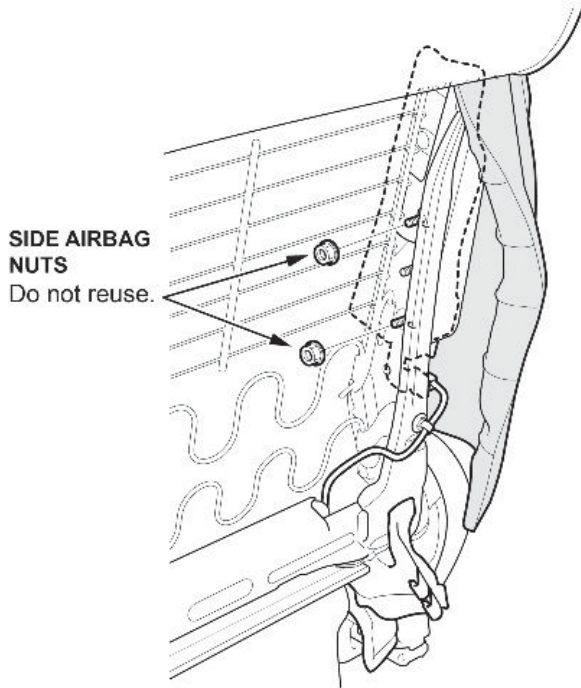
3. Remove the seat-back cover and pad from the seat frame. Refer to the service information.

Remove the nuts from the side airbag, but do not remove it. The seat cover is easier to install with the airbag loose.

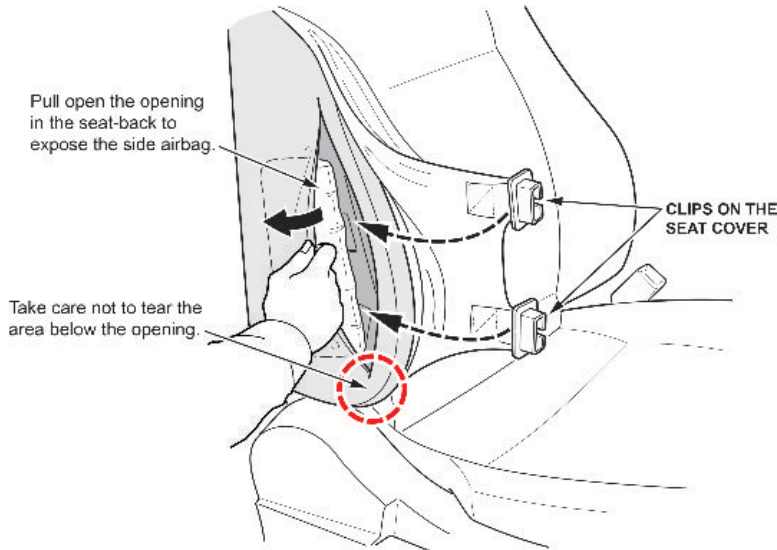
5.1. Carefully open the opening in the seat back and insert the two clips on the seat cover behind the side airbag.

Make sure you don't tear the seat back pad.

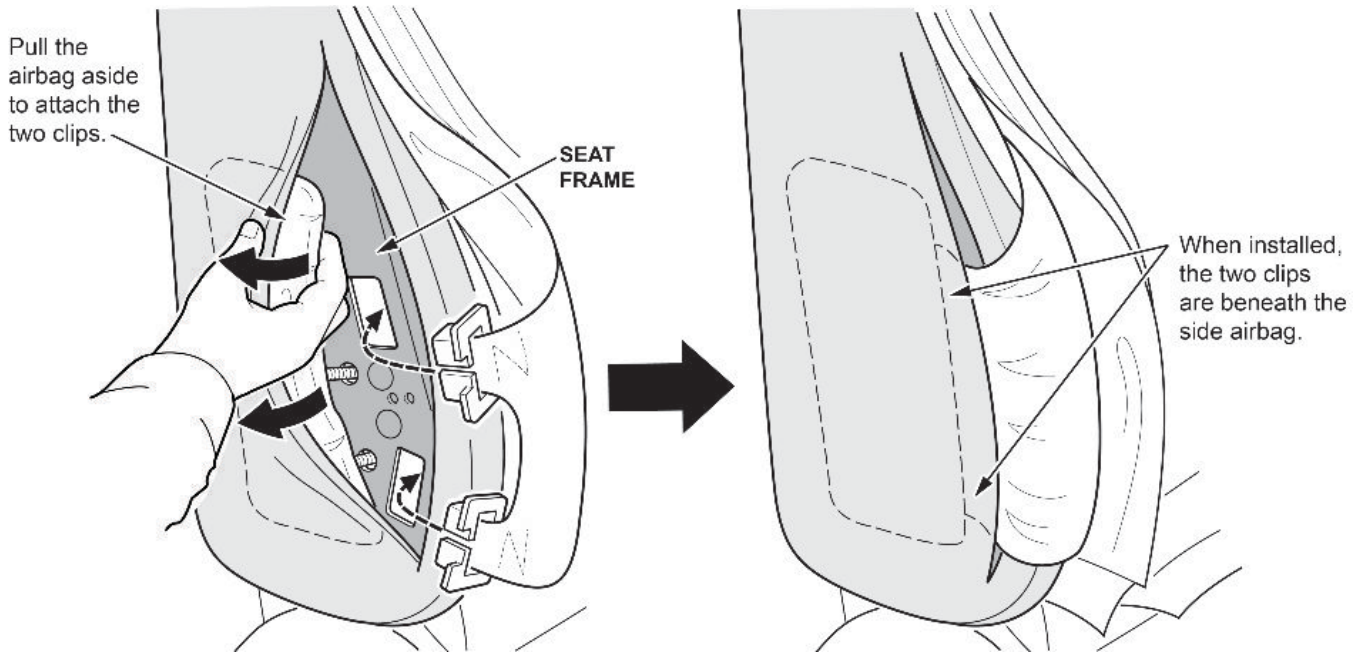
5.2. Pull the side airbag far enough to access the two clips on the seat frame, then attach the clips on the seat cover.

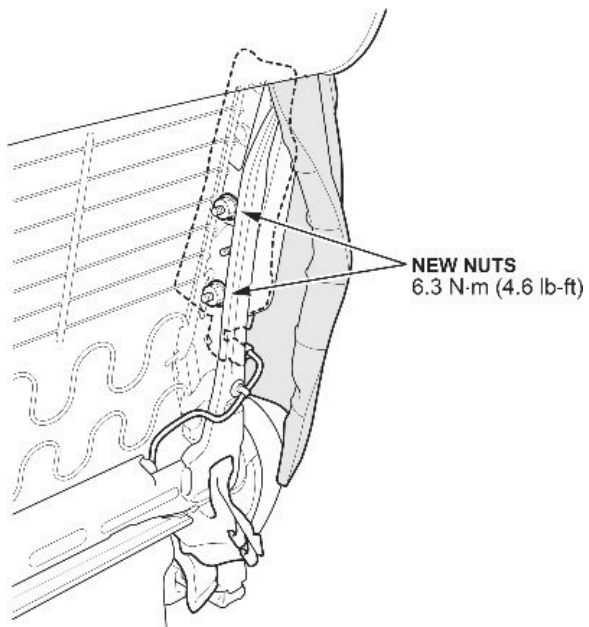
5.3. Torque the new side airbag nuts to **6.3 N·m (4.6 lb-ft)**.
