April 27, 2018

Safety Recall: Front Passenger's Replacement (Service Part) Seat-back Pad

Year	Model	Trim	VIN Range
2017	Civic	5 Door, Type-R	Check the iN VIN status for eligibility.

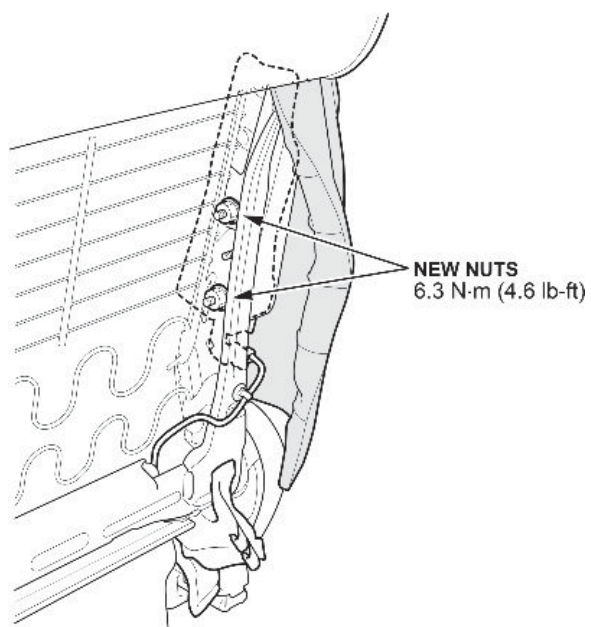
5.3. Torque the new side airbag nuts to **6.3 N·m (4.6 lb-ft)**.
