April 27, 2018

Safety Recall: Driver's Replacement (Service Part) Seat-back Pad

Year	Model	Trim	VIN Range
2017	Civic	5 Door	Check the iN VIN status for eligibility.

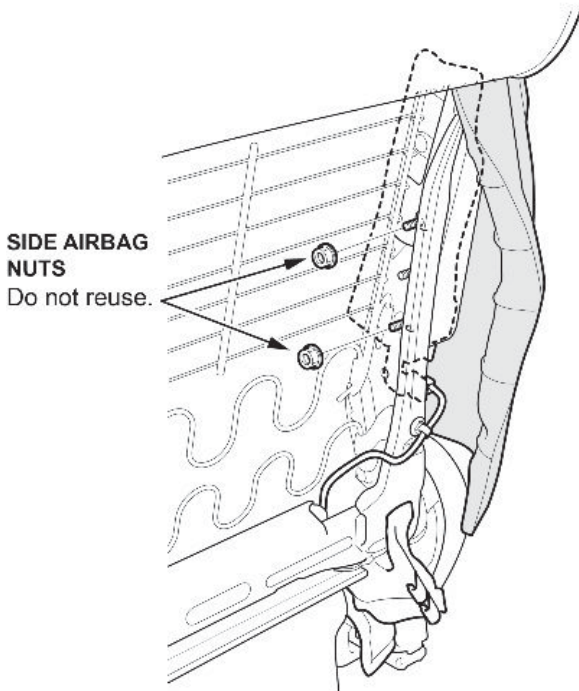
3. Remove the seat-back cover and pad from the seat frame. Refer to the service information.

Remove the nuts from the side airbag, but do not remove it. The seat cover is easier to install with the airbag loose.

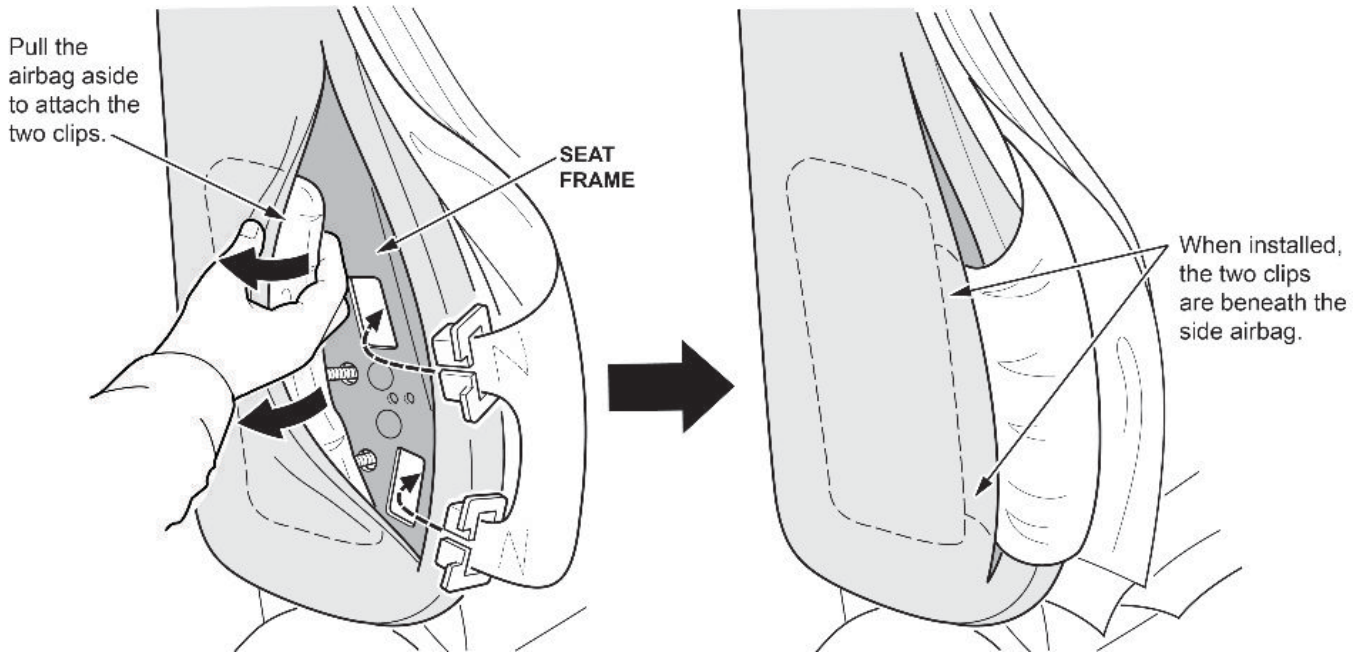
5.2. Pull the side airbag far enough to access the two clips on the seat frame, then attach the clips on the seat cover.

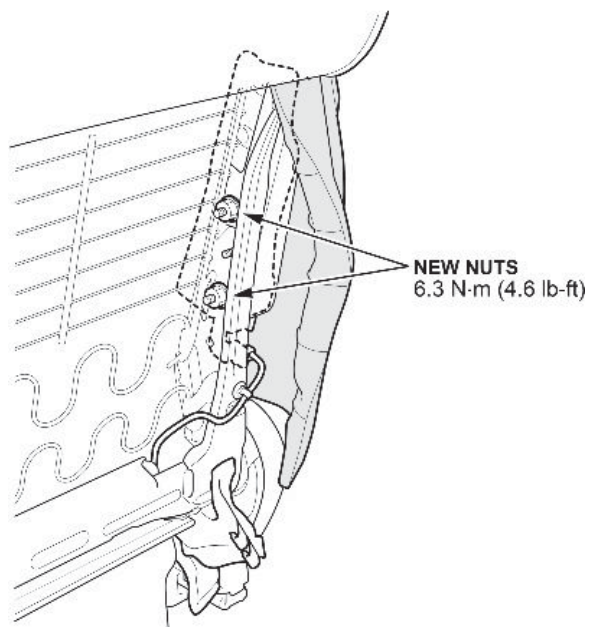
5.3. Torque the new side airbag nuts to **6.3 N·m (4.6 lb-ft)**.
