**September 28, 2018**

## **Safety Recall: Incorrect Installation of the Takata Front Passenger's Airbag Inflator**

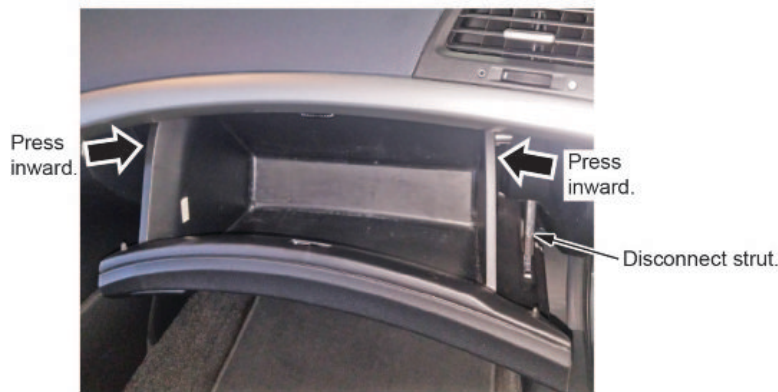
*Accord shown - others similar.*

1. Open the glove box.
2. **Accord/Crosstour** - Disconnect the strut.

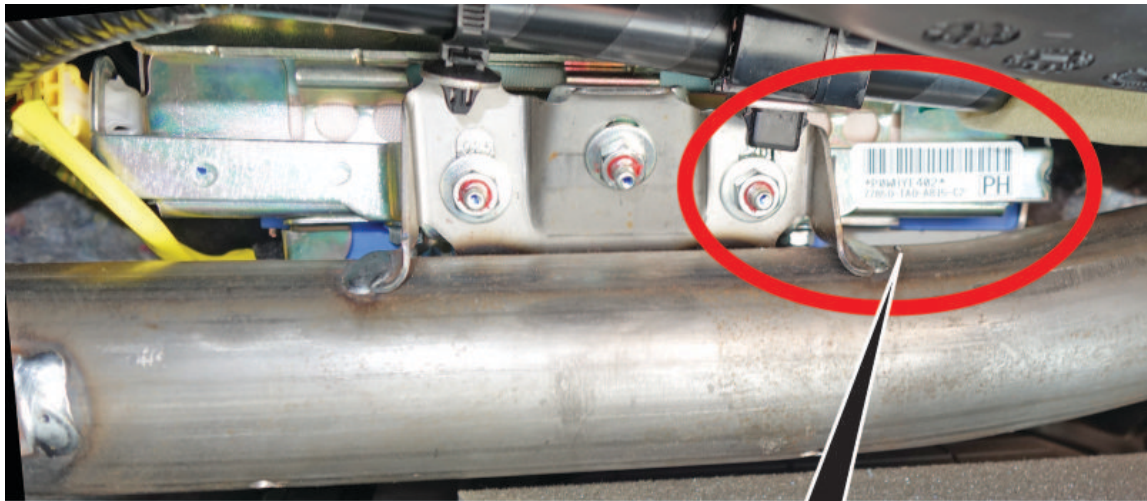
3. Push the glove box tabs in as shown, and lower the glove box.
4. Inspect the plastic collars on the passenger's airbag inflator. **Refer to the following pages for model specific images.**
  - If the long collar is closer to the front passenger's door, the inflator installation is **GOOD**. Reassemble the glove box in the reverse order of removal.
  - If the long collar is closer to the driver's side, the inflator installation is **NO GOOD**. Go to AIRBAG MODULE REPLACEMENT PROCEDURE.

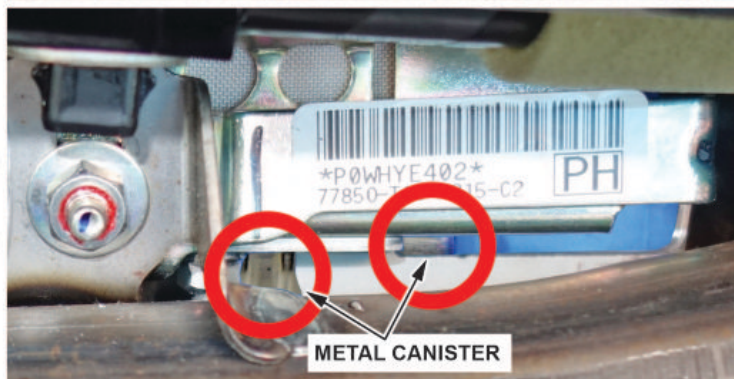
**NO GOOD**

If the inflator has been installed incorrectly, the metal canister will be visible.

Inspect the front passenger airbag inflator, and if the inflator is not installed correctly, replace the airbag module assembly.

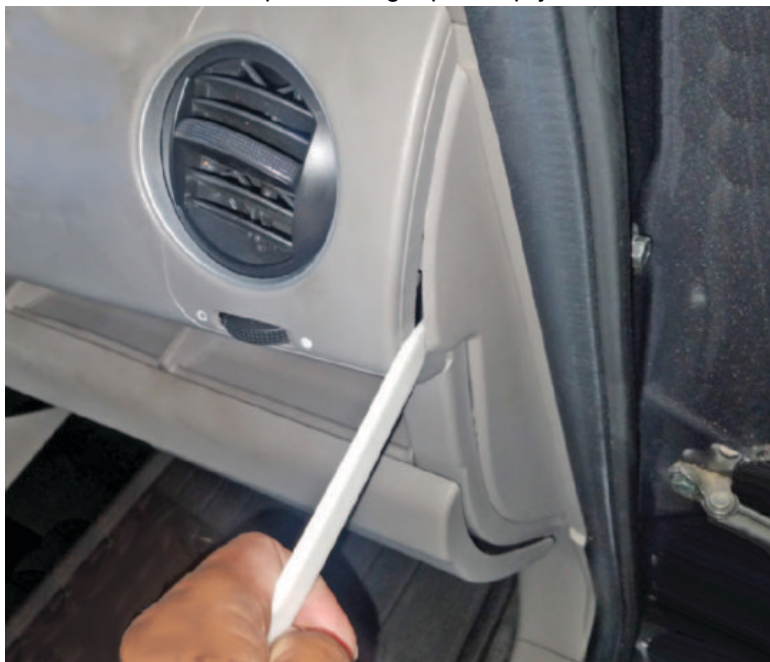
1. Remove the side trim panel using a plastic pry tool.

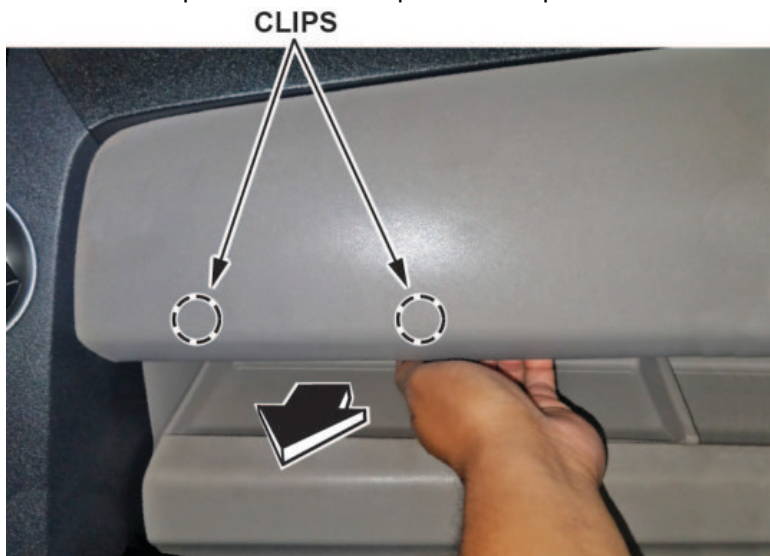
2. Pull on the left portion of the trim piece at the places shown to disengage the retaining clips.

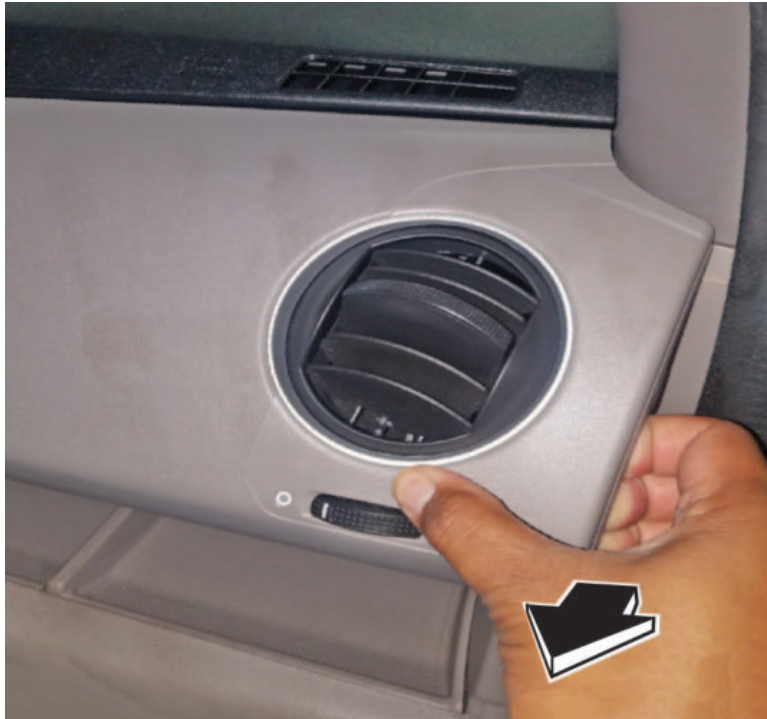
3. Pull on the right portion of the trim to disengage the remaining clips and remove the trim piece.

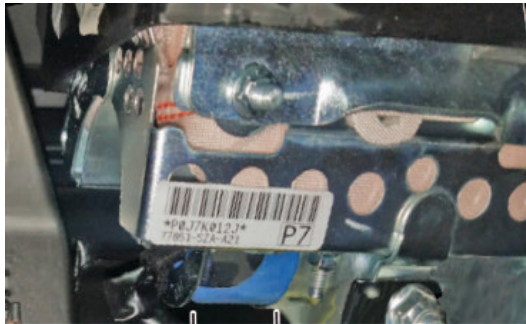
4. Inspect the plastic collars on the passenger's airbag inflator.

SHORT COLLAR ON  
THE LEFT SIDE

- If the long collar is closer to the front passenger's door, the inflator installation is **GOOD**. Reassemble the dashboard panel trim in the reverse order of removal.
- If the long collar is closer to the driver's side, the inflator installation is **NO GOOD**. Go to AIRBAG MODULE REPLACEMENT PROCEDURE.

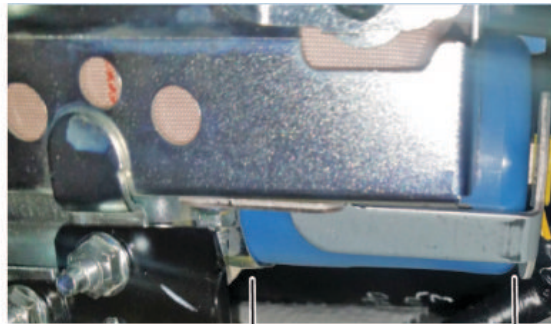
LONG COLLAR ON  
THE RIGHT SIDE

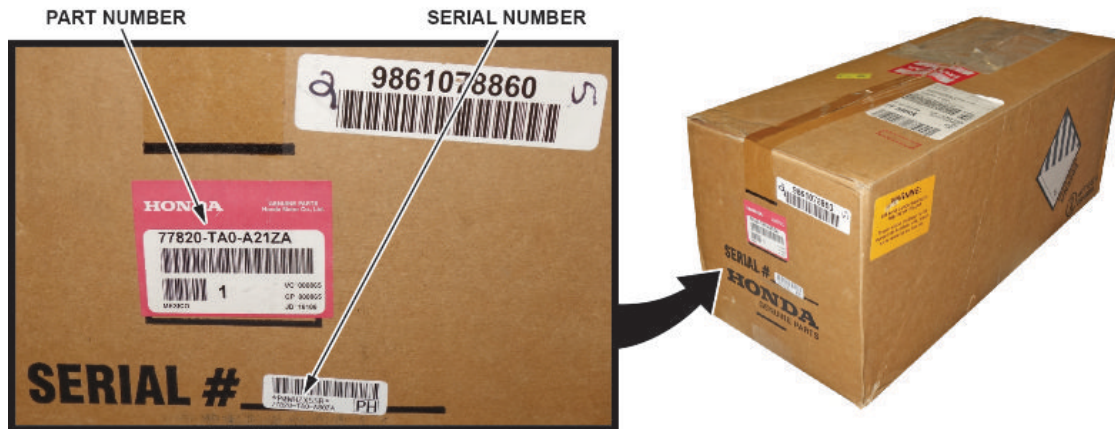
- If the indicator does not come on, or if it stays on, contact your DPSM for assistance.
2. Disconnect the battery negative cable, and wait at least 3 minutes before continuing.
  3. Remove the front passenger's airbag module (assembly). Refer to the applicable model's service information.
  4. Write the serial number and part number from the side of the new front replacement passenger's airbag module box on the RO. For the warranty claim to be paid, the **new front replacement passenger's airbag module part number and serial number** must be included in the warranty claim.

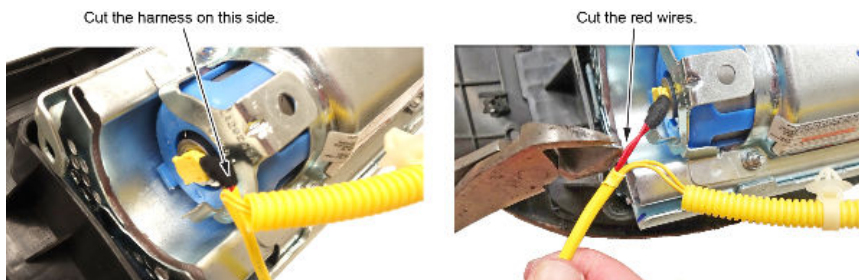
- 3.1. Cut the red wires about 2 inches from the inflator.

There may be some protective tube covering the wires that needs to be cut away to access the wires.

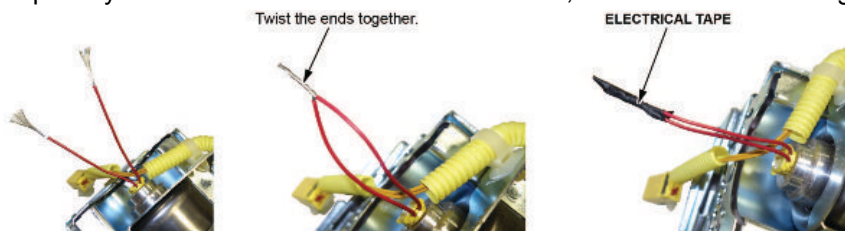
- 3.2. Strip away about 1 inch of the red wire insulation, then twist the wires together.

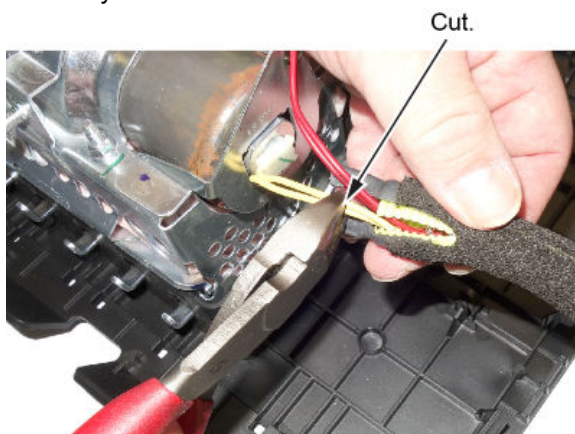
- 3.3. Tape the twisted ends with electrical tape.
- 3.4. Cut the yellow wires about 2 inches from the inflator.

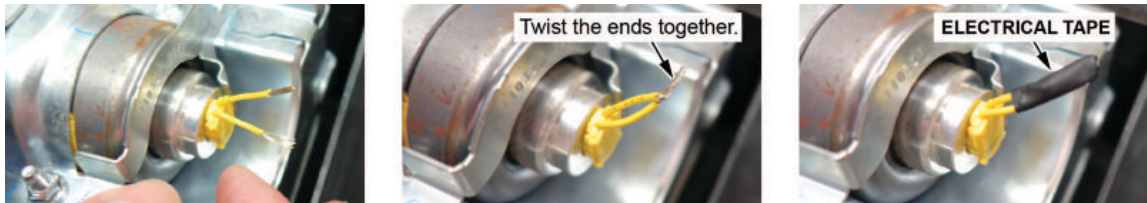
3.5. Strip away about 1 inch of the yellow wire insulation, then twist the wires together.

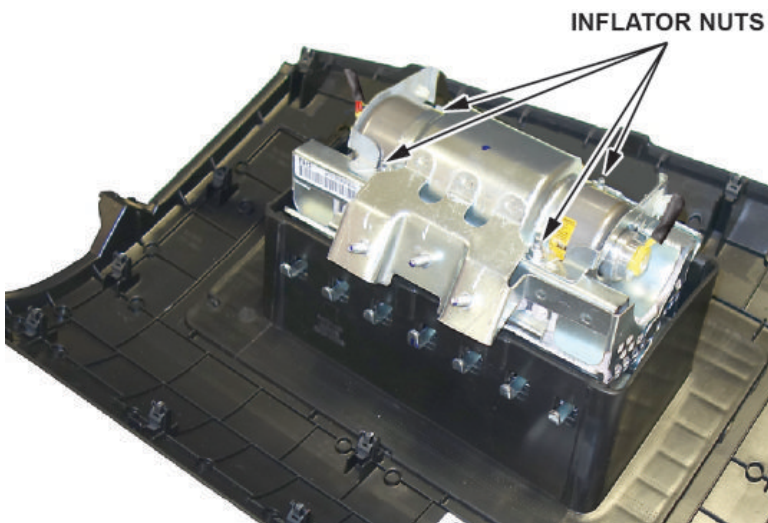
3.7. Remove the four inflator nuts.

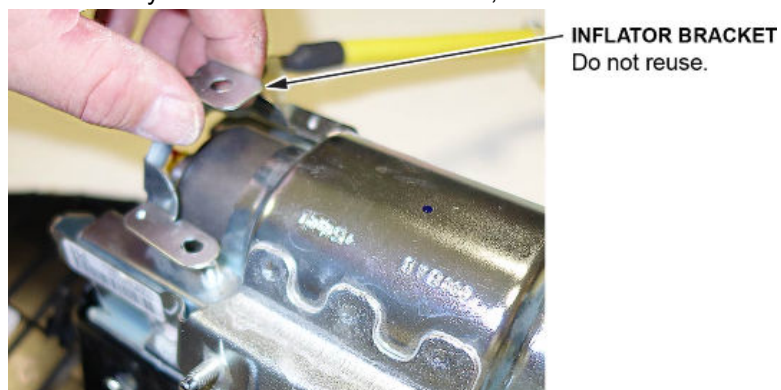
4. Remove the inflator bracket.

You can only remove one of the brackets, as the other is welded to the airbag housing.

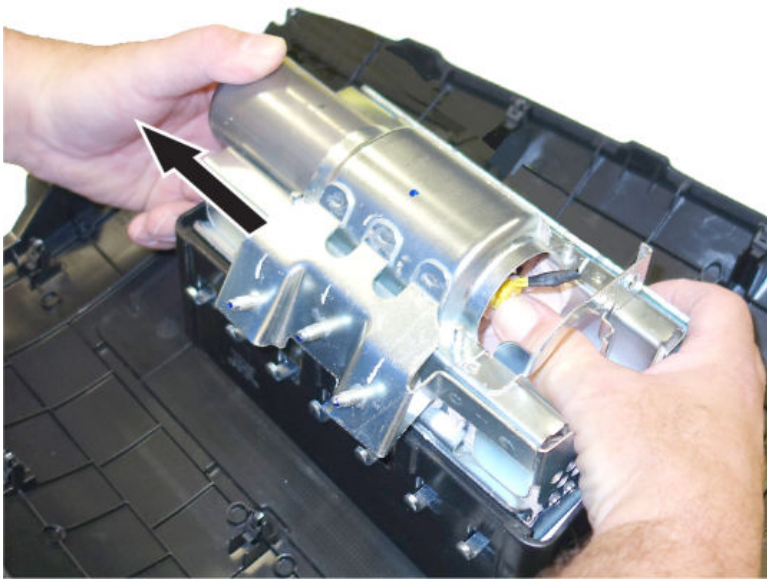
5. Remove the inflator by pulling it out.
