Dealer Service Instructions for:

# Safety Recall U42 / NHTSA 18V-279

## Front Lower Control Arms

**2018 (MP) Jeep® Compass**

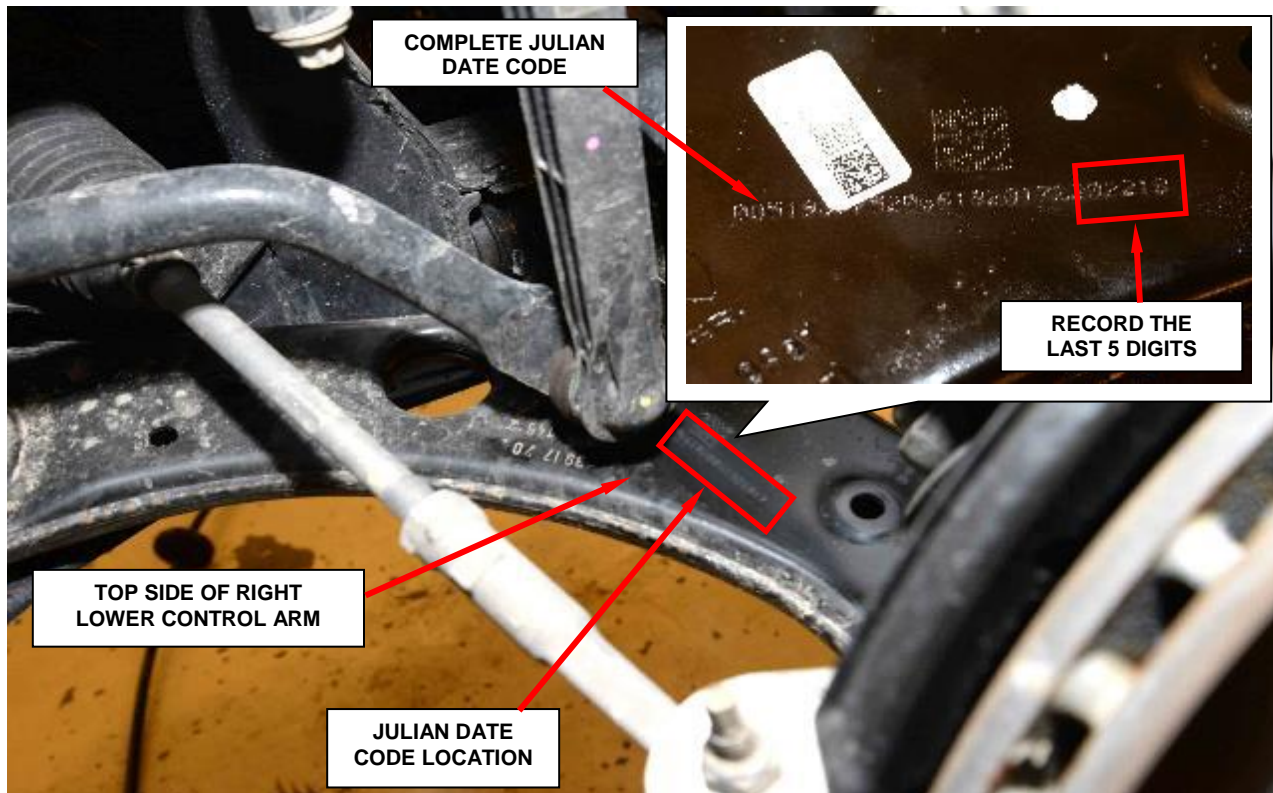
**NOTE: The Julian date code etching for the right front control arm is located on the top side of the control arm.**

**NOTE: The Julian date code etching for the left front control arm is located on the bottom side of the control arm.**

**Figure 1 – Right Side Julian Date Code Shown (record last 5 digits of etching number)  
Left Side Similar (Located on the Bottom of the Control Arm)**

1. Raise and support the vehicle.
2. Remove the right front tire and wheel assembly.
3. Locate the right front control arm Julian date code etching and record last 5 digits for use in Step 5 (Figure 1).

4. Locate the left front control arm Julian date code etching and record last 5 digits for use in Step 5 (Figure 1).

5. Are the last 5 digits of the Julian date code **00818**?
  - No, the lower control arm is good. Replacement not needed. If both control arms are good, continue with Step 6.
  - Yes, replace lower control arm(s) that have a Julian date code of **00818**, continue with section **B. Replace Front Lower Control Arm(s)**.
  - If the Julian date code is not visible continue with section **B. Replace Front Lower Control Arm(s)**.

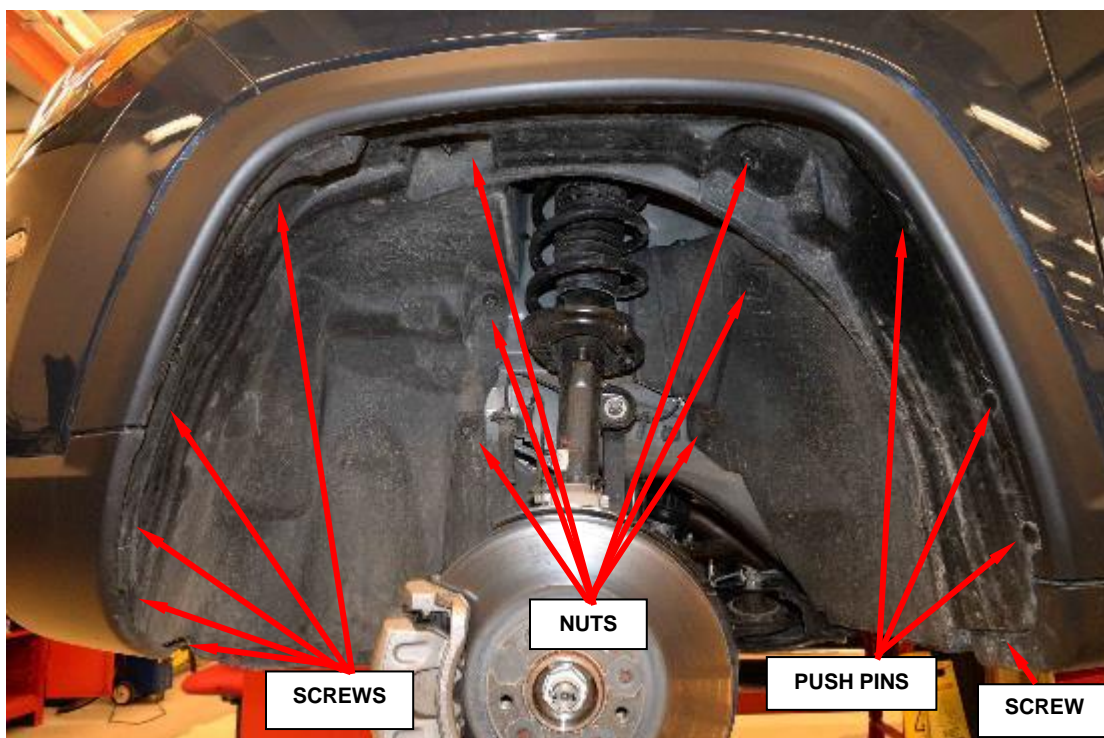
**Figure 2 – Wheel House Splash Shield**

1. Disconnect the negative battery cable.
2. Raise and support the vehicle to the appropriate height.
3. Remove the left front tire and wheel assembly.
4. Remove the front fascia using the following steps.
  - a. Remove six, screws, six plastic nuts and three push pins then remove the front wheel house splash shield, **both sides** (Figure 2).

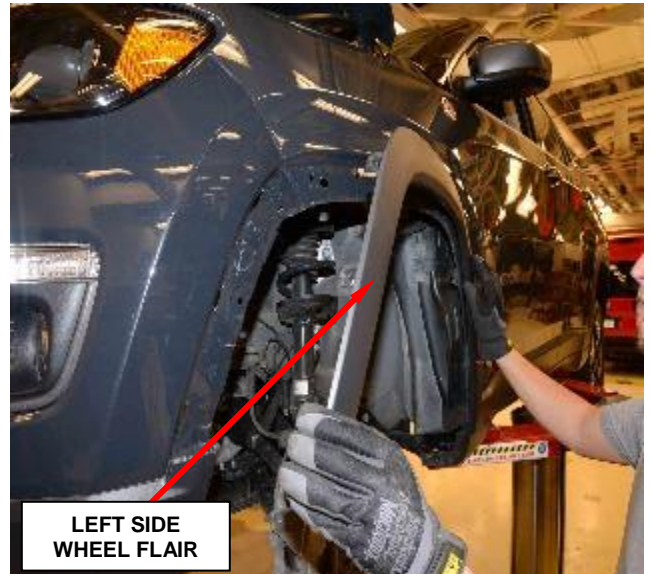
Figure 3 – Wheel Flair

- b. Working from the inside of the wheel opening, release the retaining clips by pinching the arrow head clips with an appropriate tool then remove **both** front wheel flairs (Figure 3).

**CAUTION:** Removing the wheel flare retaining clips using a trim tool may damage the retaining clips.

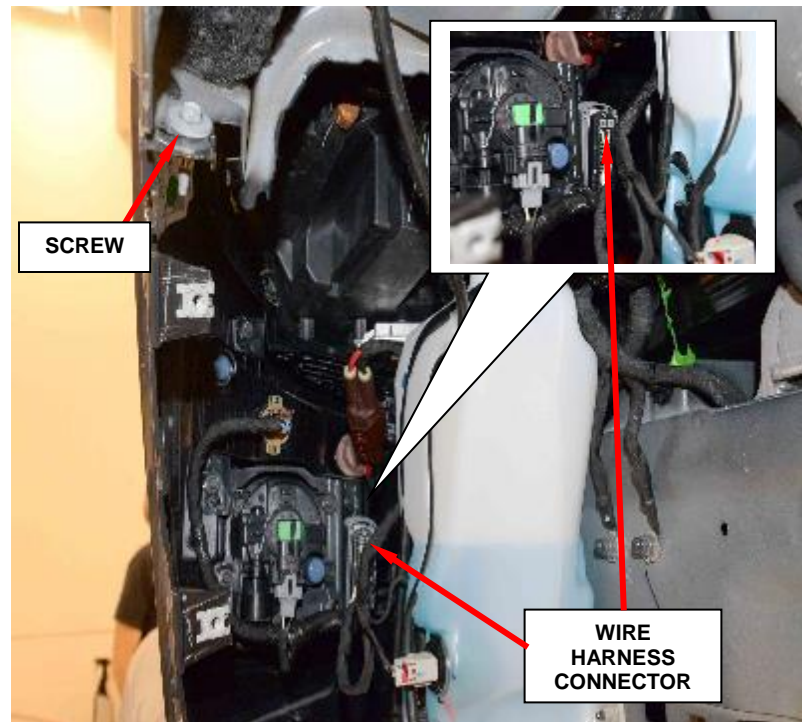
Figure 4 – Wire Harness Connector

- c. Disconnect the front end module wire harness connector (left side only) (Figure 4).

- d. Remove the screws attaching the fascia to the fenders (Figure 4).

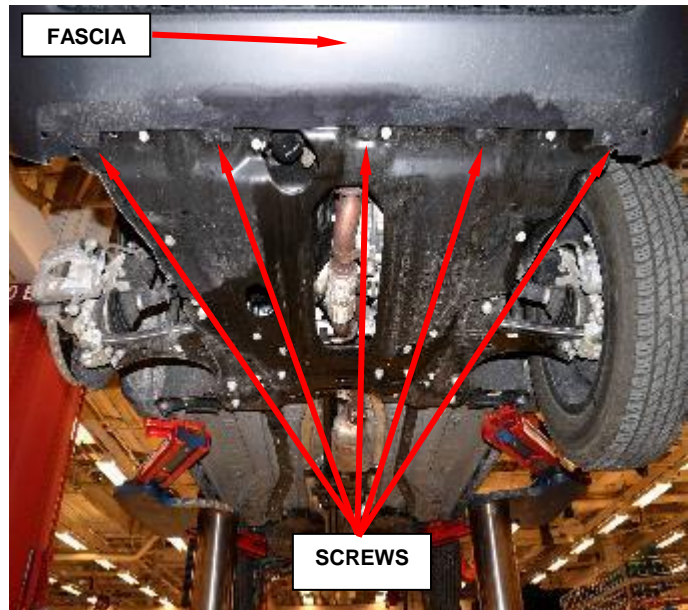
**Figure 5 – Lower Fascia Screws**

- e. Remove the five lower fascia screws (Figure 5).

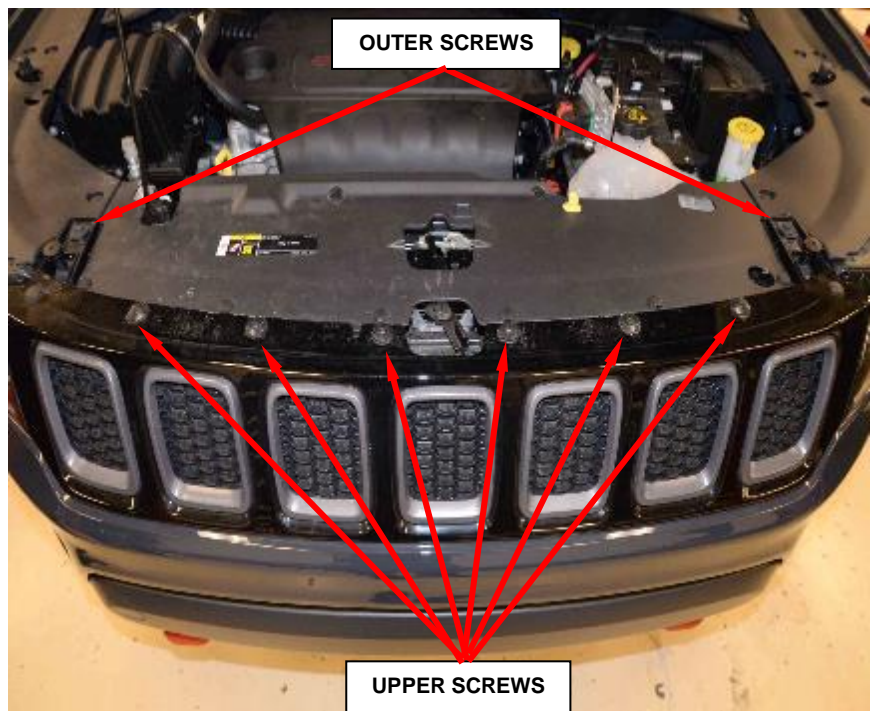
**Figure 6 – Upper Fascia Screws**

- f. Remove the two outer screws and remove the six upper grille screws (Figure 6).

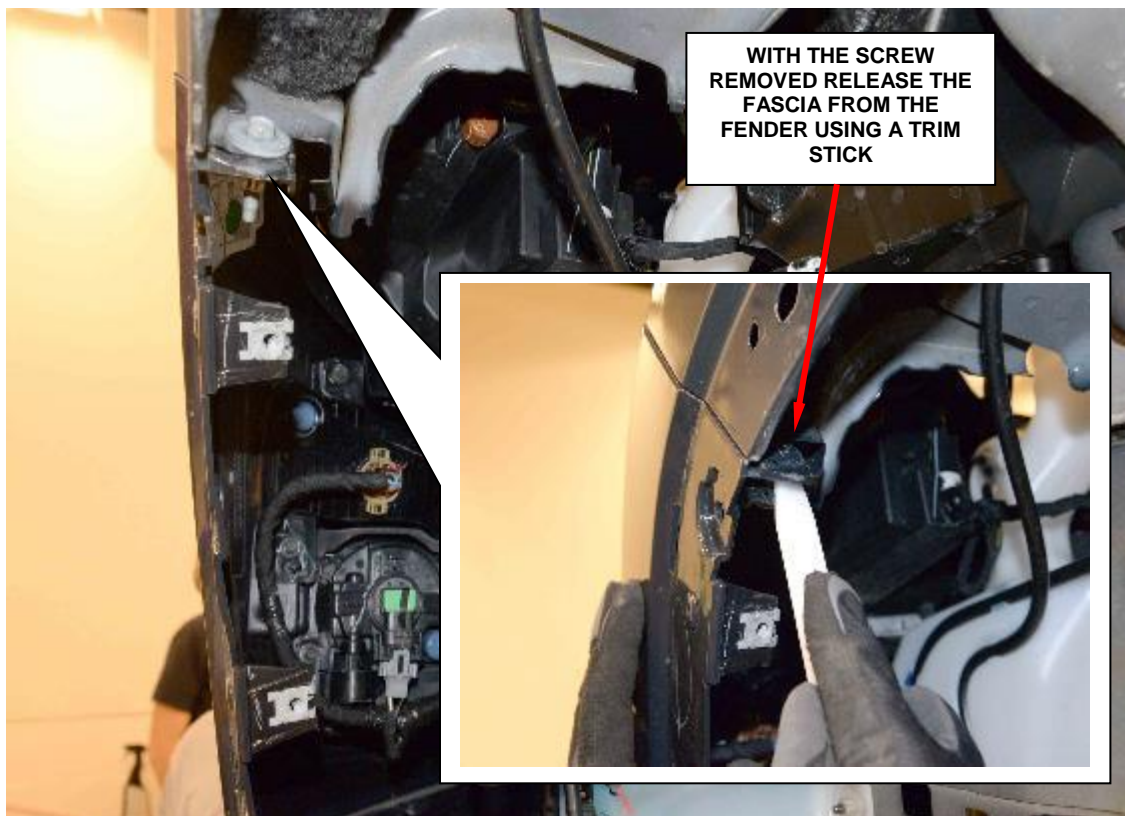
**Figure 7 – Fascia to Fender Attachment**

- g. Carefully pull out and release the fascia attachments from the fender attachment brackets using a trim stick (Figure 7).
- h. Carefully pull out and release the fascia attachments from the headlight brackets.
- i. Remove the fascia.

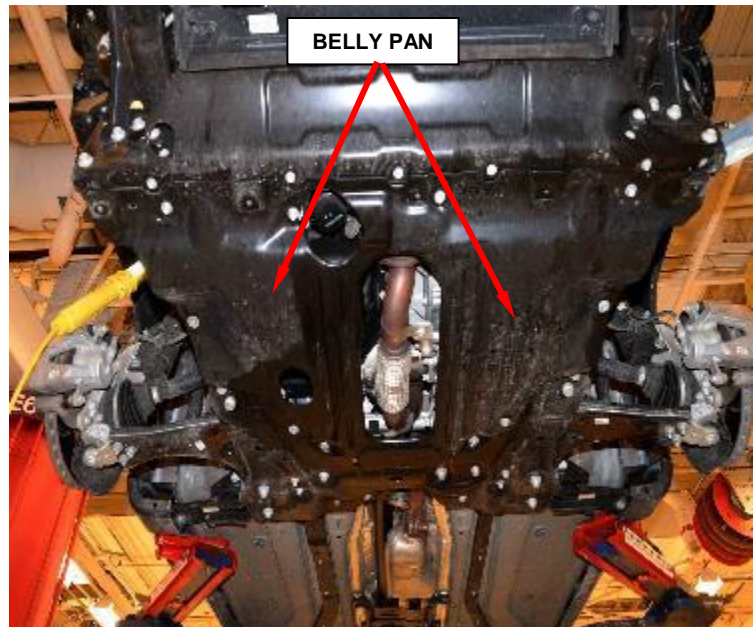
**Figure 8 – Belly Pan**

- a. Remove the belly pan, **if equipped** (Figure 8).

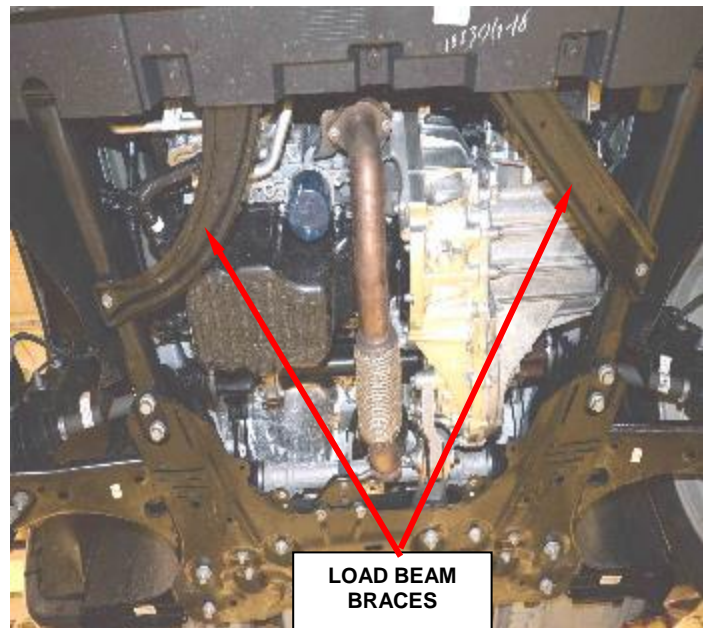
**Figure 9 – Load Beam Braces**

- b. Remove the two load beam braces, **if equipped** (Figure 9).

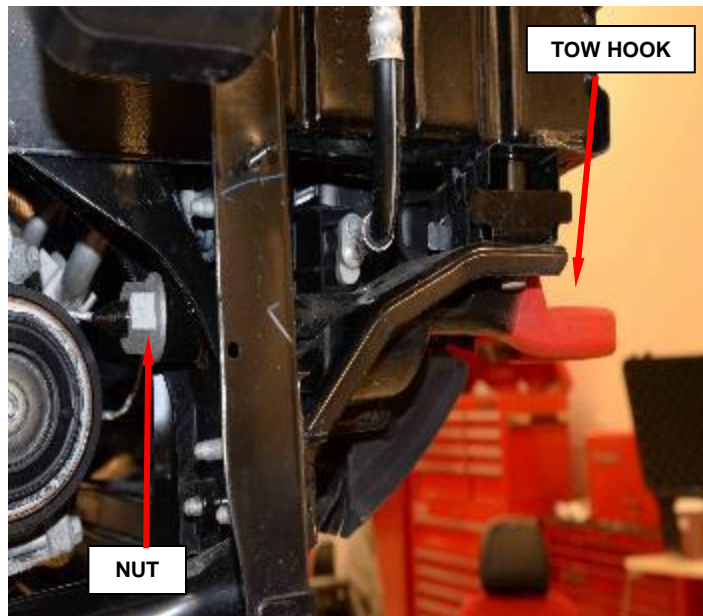
Figure 10 – Tow Hook Nut (right side shown)

- c. Remove and save the nut from the tow hook, **if equipped** (Figure 10).

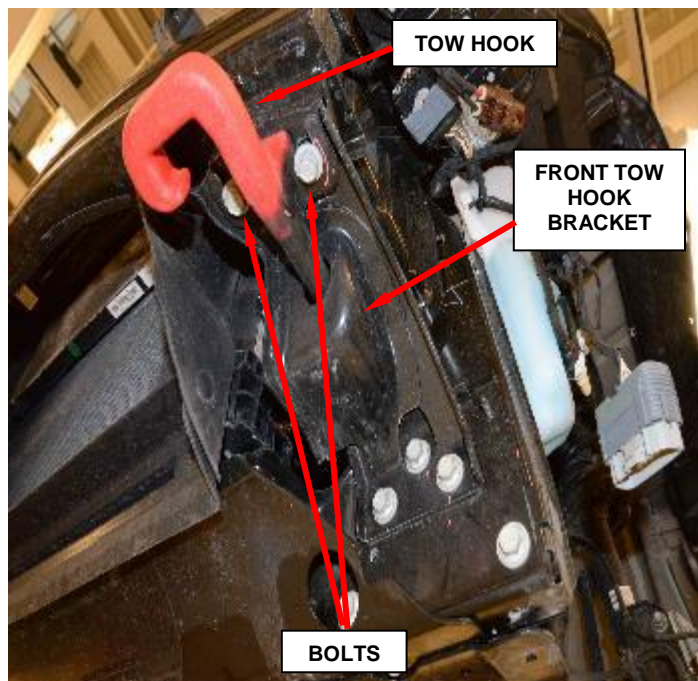
Figure 11 – Tow Hook Bolts (left side shown)

- d. Remove and save the two tow hook bolts, **if equipped** (Figure 11).
- e. Remove and save the tow hook.

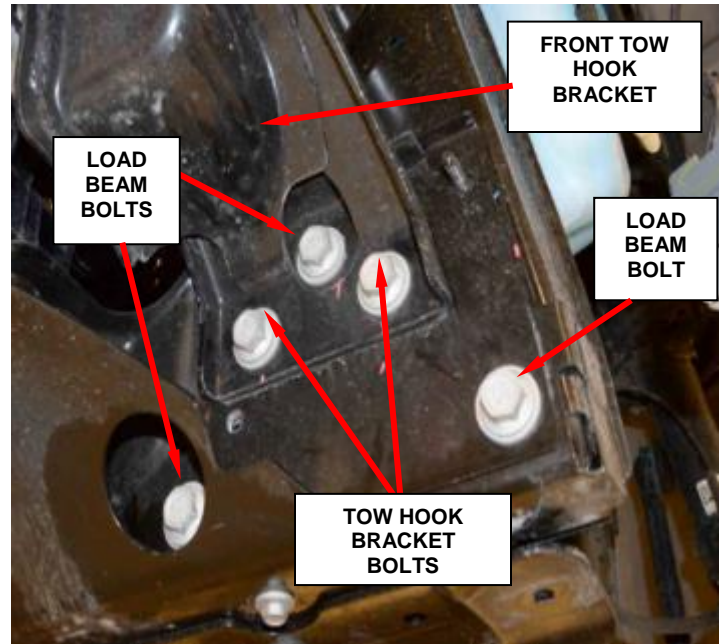
**Figure 12 – Front Tow Hook Bracket**

- f. Remove and save the two front tow hook bracket bolts, **if equipped** (Figures 11 and 12).
- g. Remove the front tow hook bracket, **if equipped** (Figures 11 and 12).
- h. Remove the three load beam and bracket bolts (Figure 12).

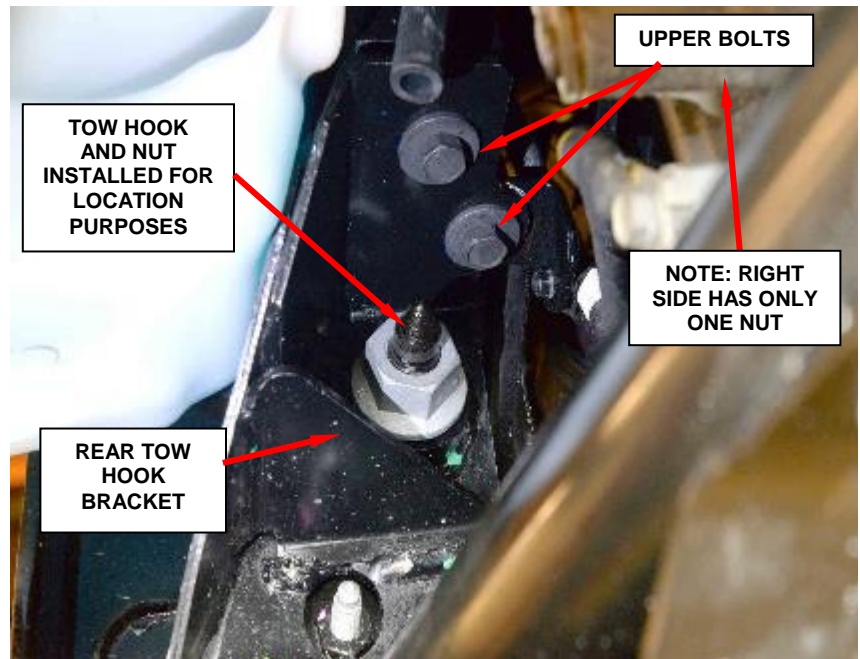
**Figure 13 – Rear Tow Hook Bracket**

- i. Remove the two rear tow hook bracket upper bolt(s), **if equipped** (Figure 13).
- j. Remove the rear tow hook bracket, **if equipped**.

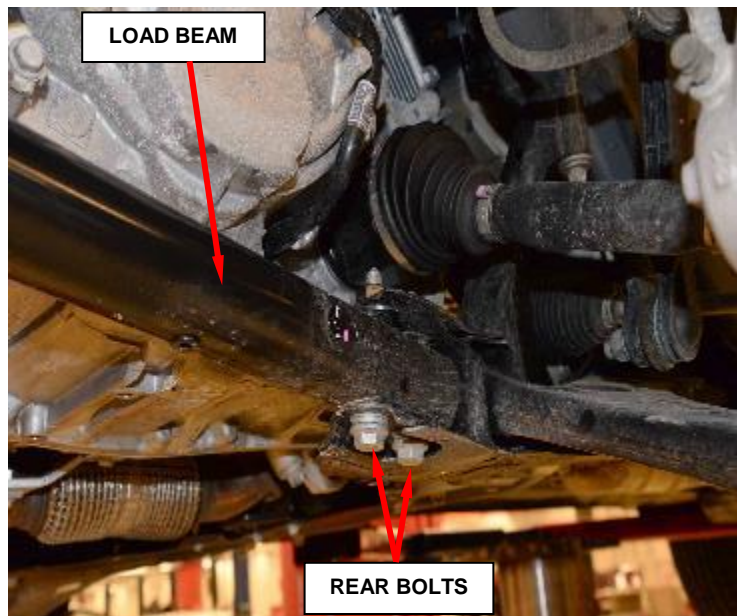
**Figure 14 – Rear Load Beam Bolts**

k. Remove and save the two rear load beam bolts (Figure 14).

l. Remove the load beam.

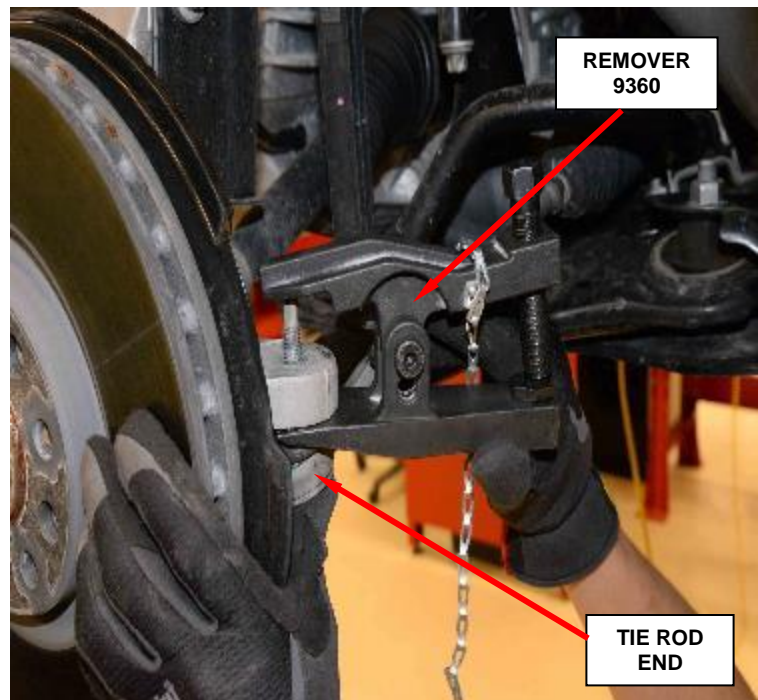
**Figure 15 – Tie Rod End**

6. Using **Remover 9360**, separate the outer tie rod end from the steering knuckle (Figure 15).

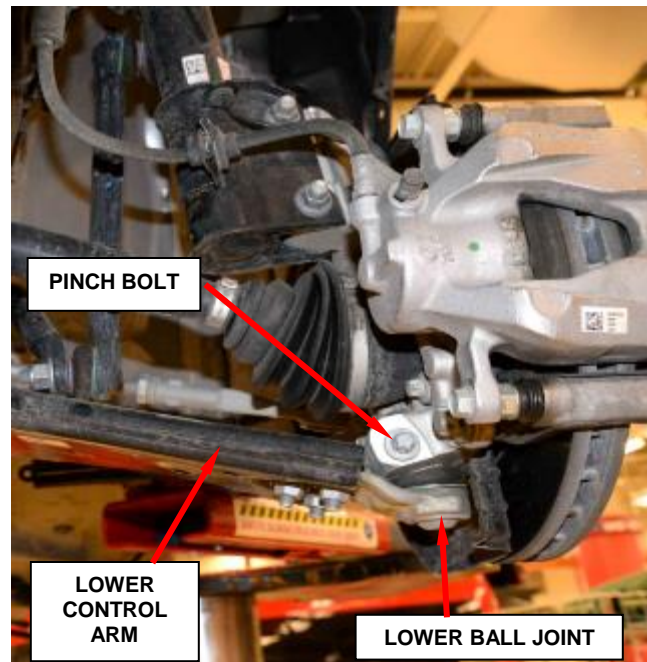
**Figure 16 – Pinch Bolt**

7. Remove and **DISCARD** the steering knuckle pinch bolt and nut (Figure 16).

8. Remove the lower ball joint stud from the steering knuckle (Figure 16).

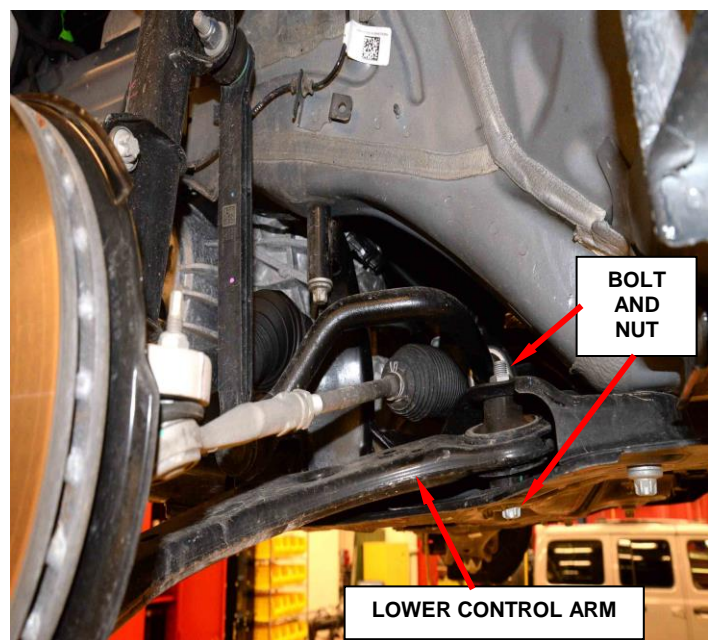
**Figure 17 – Lower Control Arm Rear Bolt**

9. Remove and **DISCARD** the lower control arm rear bolt and nut (Figure 17).

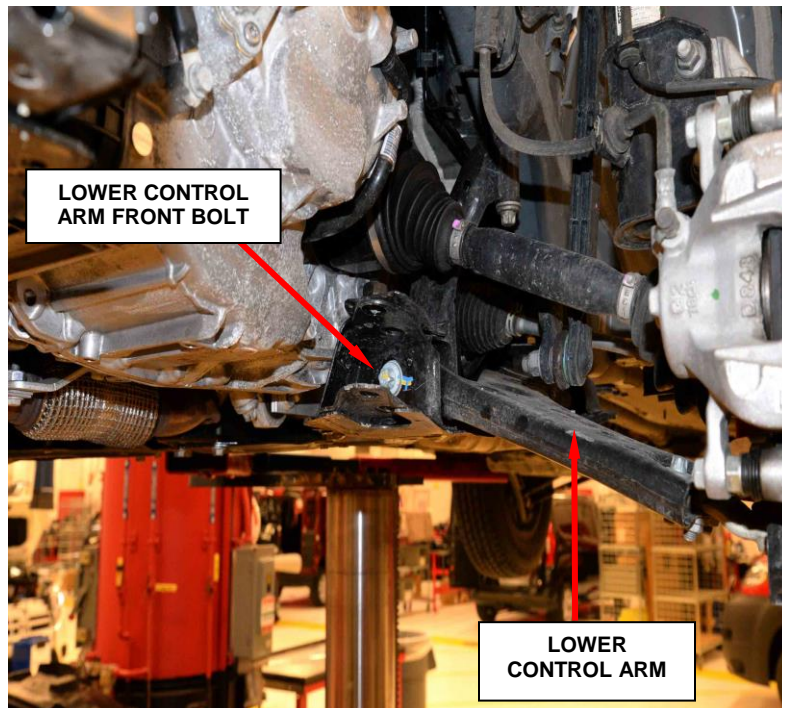
Figure 18 – Lower Control Arm Front Bolt

10. Remove and **DISCARD** the lower control arm **front** bolt (Figure 18).

11. Remove and **DISCARD** the lower control arm (Figures 17 and 18).
