Safety Recall U43 / NHTSA 18V-280

Transmission Park Lock Rod

2018 (LX) Chrysler 300

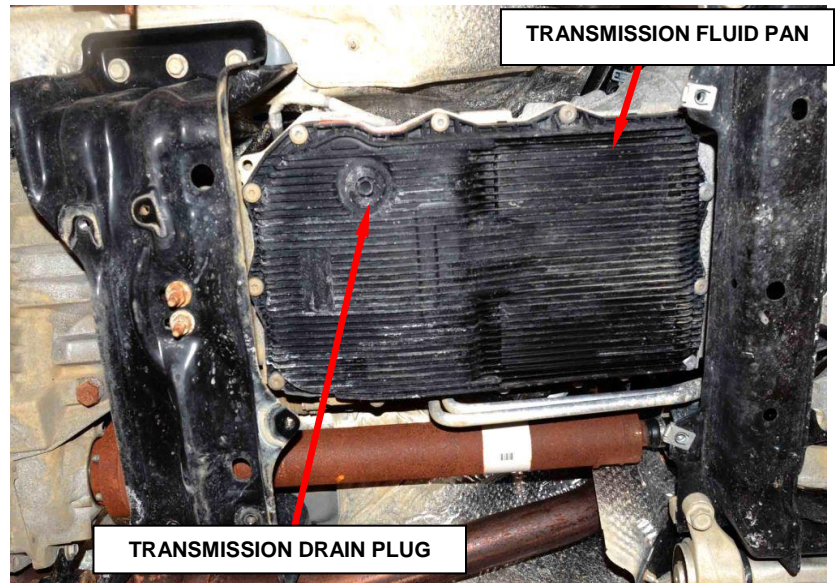
Figure 1 - Transmission Oil Pan

5. Remove the transmission fluid pan drain plug and allow the transmission fluid to drain into an appropriate container (Figure 1).
6. Reinstall transmission drain plug and tighten to 8 N·m (70 In. lbs.).

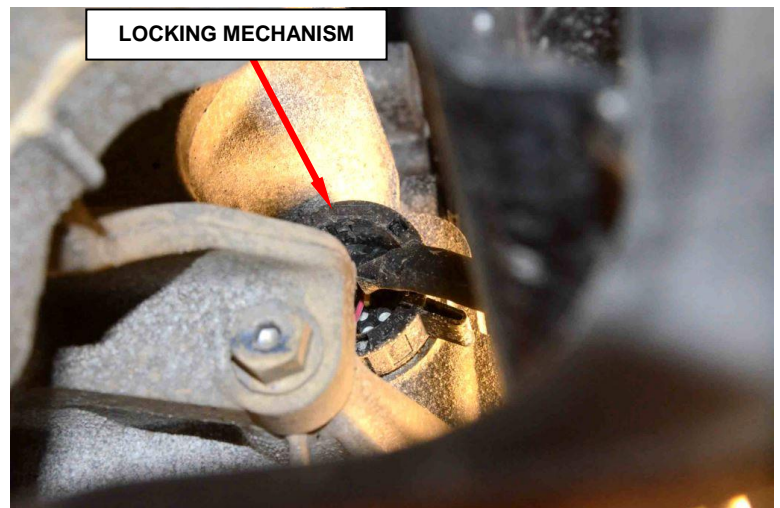
Figure 2 - Transmission Electrical Connector

7. Turn the transmission electrical connector locking mechanism counter-clockwise and disconnect the connector from the transmission (Figure 2).

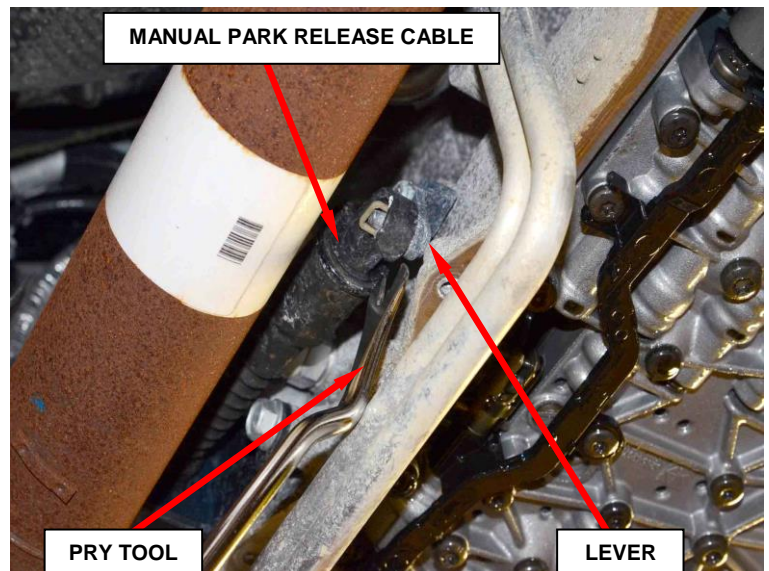
**Figure 3 – Manual Park Release Cable**

8. Remove the 13 transmission fluid pan retaining bolts.
9. Carefully remove the transmission fluid pan and the gasket which is attached to the pan.
10. Using a suitable tool, detach the Manual Park Release (MPR) cable from the lever (Figure 3).

32. Remove the tie strap and reattach the Manual Park Release (MPR) cable to the lever.
33. Install the transmission fluid pan with gasket.
34. Install the thirteen oil pan retaining bolts and tighten the fasteners to 10 N·m (89 in. lbs.) using the sequence given (Figure 20).

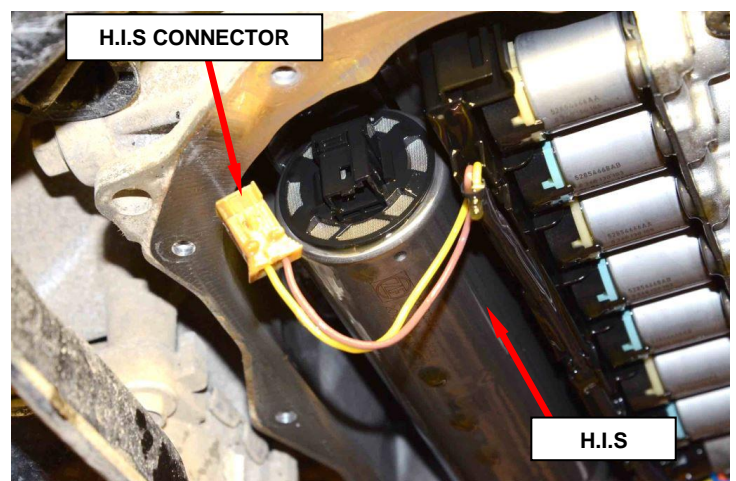
**Figure 4 – Hydraulic Impulse Storage**

11. Using a suitable tie strap, secure the MPR lever into position so the park release fork remains in the same position during the installation of the valve body assembly.
12. Disconnect the Hydraulic Impulse Oil Storage (H.I.S) connector from the oil accumulator (Figure 4).

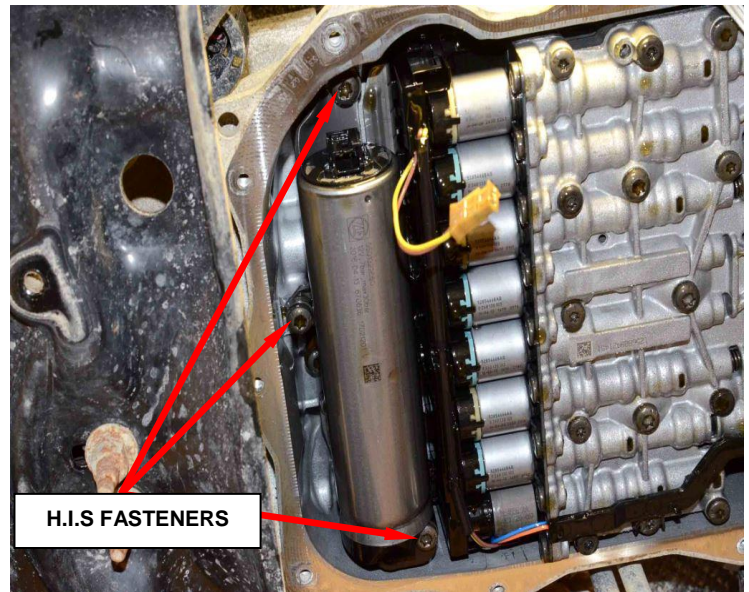
Figure 5 – H.I.S

13. Remove the three the H.I.S. fasteners (Figure 5).

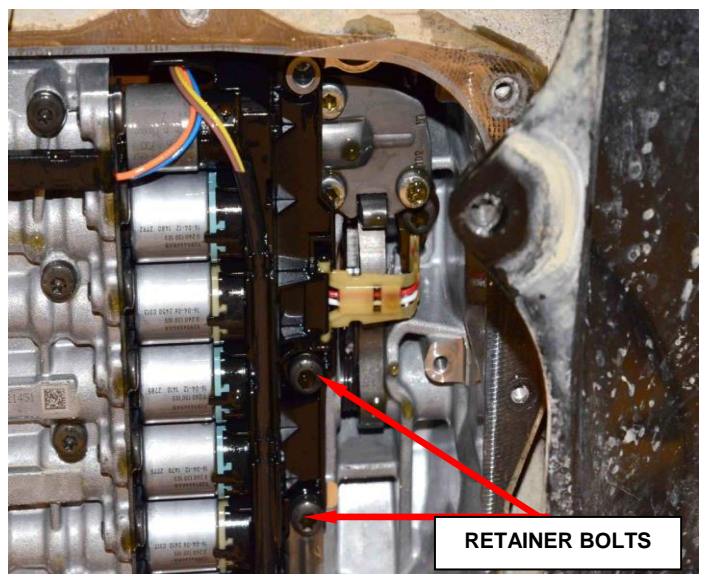
Figure 6 – End Retainer Bolts

14. Remove the two valve body assembly end retainer bolts (Figure 6).

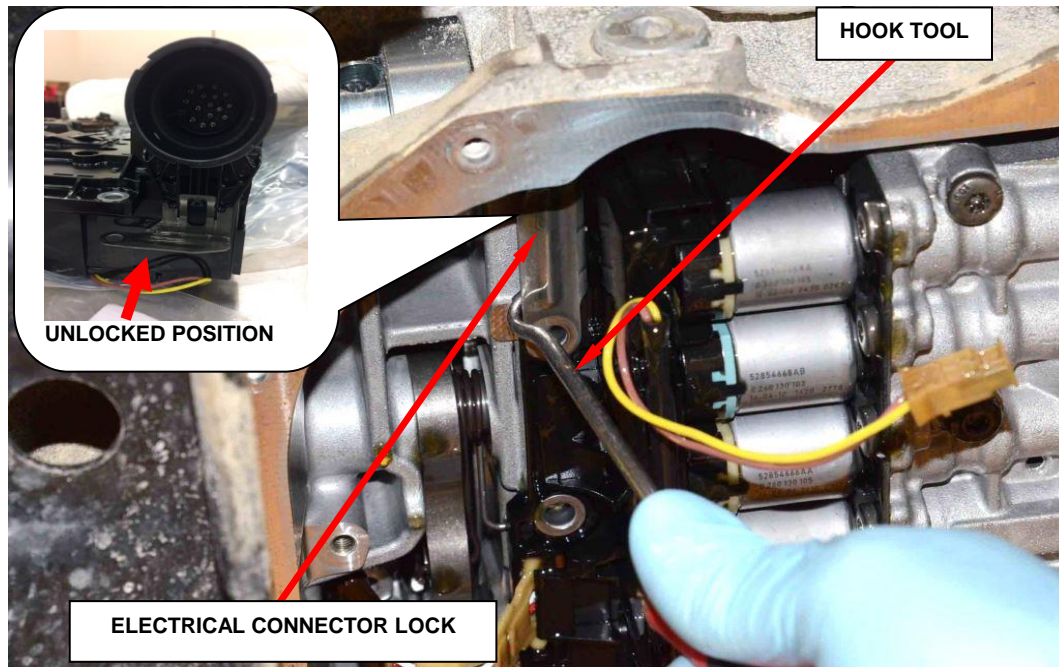
**Figure 7 – Electrical Connector Release**

15. Pull the electrical connector lock in a downward position to release the internal harness end from inside the transmission for valve body assembly removal (Figure 7).

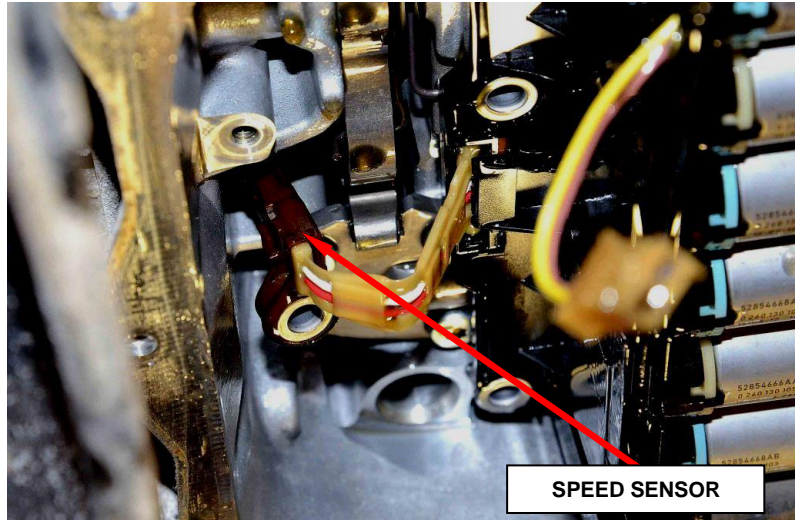
**Figure 8 – Speed Sensor Removal**

16. Remove the speed sensor retaining bolt and pull the sensor loose from the case (Figure 8).

28. Install the speed sensor into the case then install the retaining bolt and tighten the bolt to 8 N·m (71 in. lbs.).

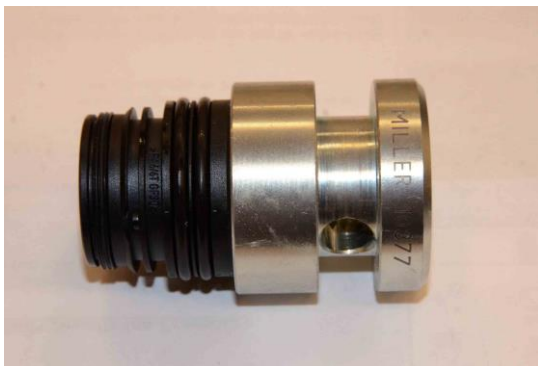
**Figure 9 – Guide Sleeve Tool**

17. Using Remover/installer, Guide Sleeve 10377 carefully pull the electrical harness insulator straight out from the transmission case (Figure 9, and 10).

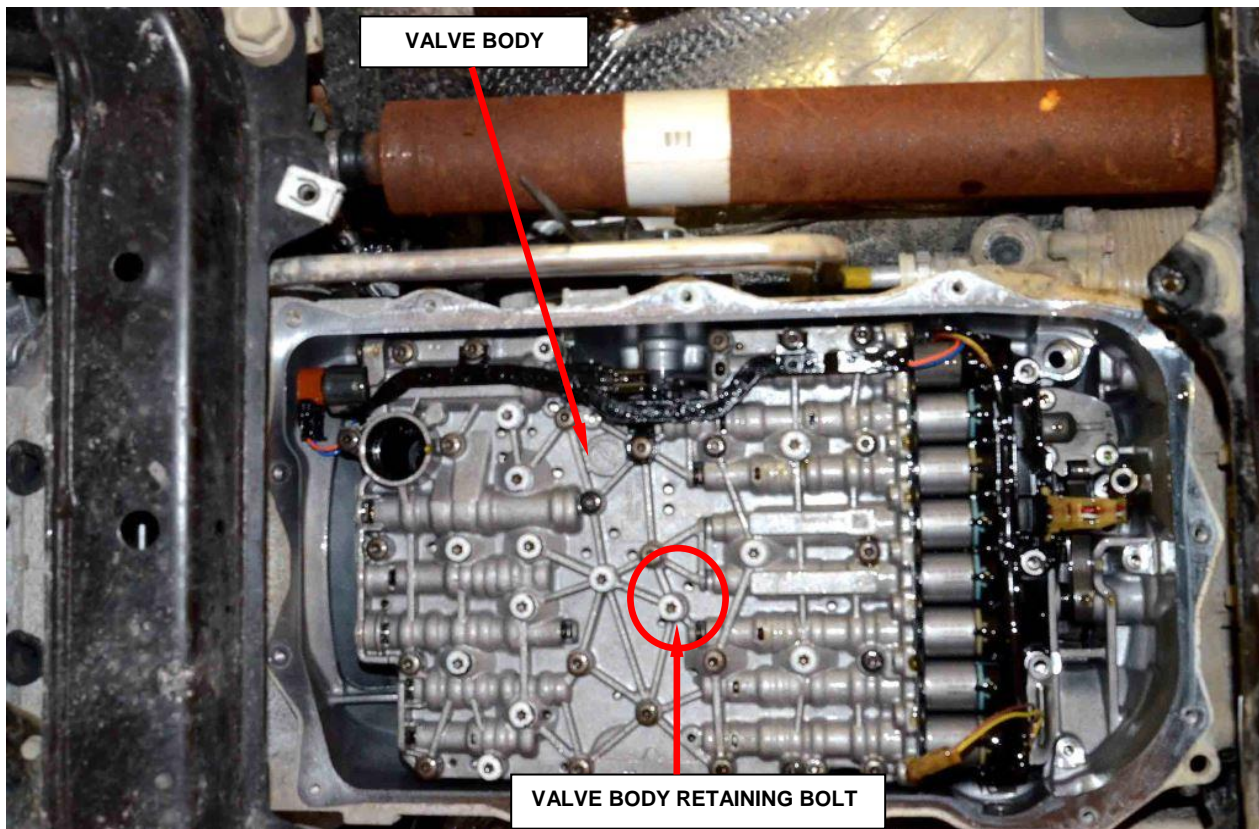
Figure 11 – Valve Body

18. Remove one of the middle valve body retaining bolts and install the alignment pin in its place (Figure 11).

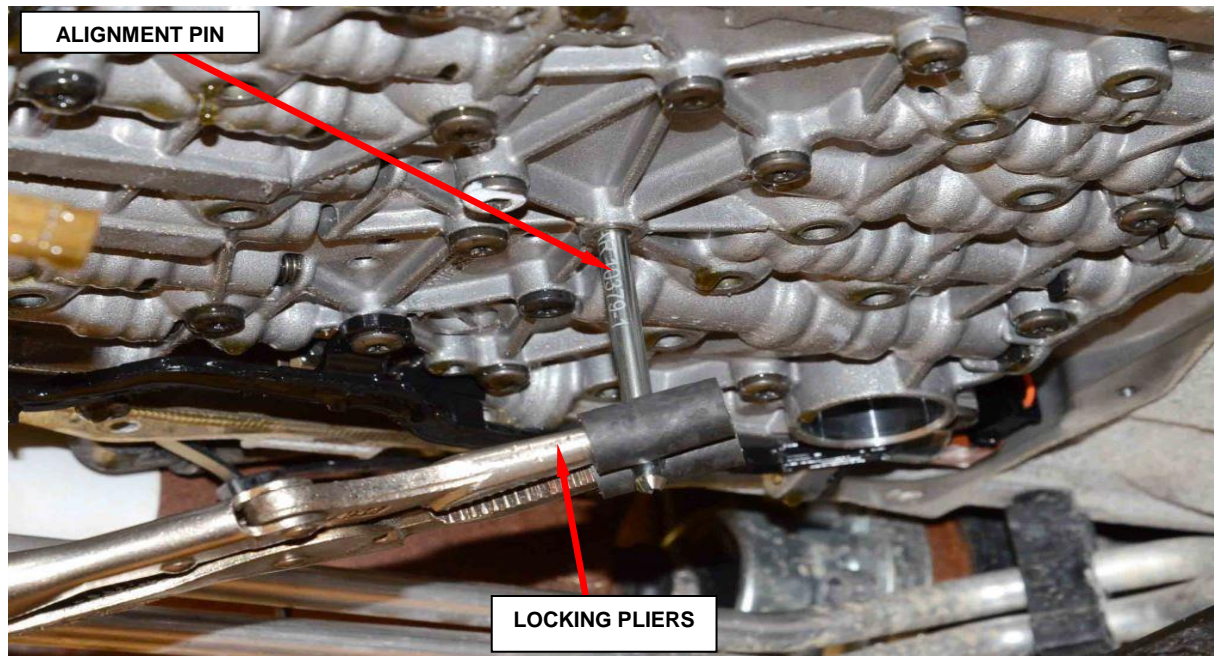
Figure 12- Valve Body Alignment Pin

19. Attach an appropriate tool on the alignment pin #10379 to assist with holding the valve body in position while removing the remaining fasteners (Figure 12).

20. Remove the last valve body bolt and carefully lower the valve body assembly from the transmission.
21. Remove the three park rod plate fasteners and detach the park rod from the keyed lever (Figure 13 and Figure 14).

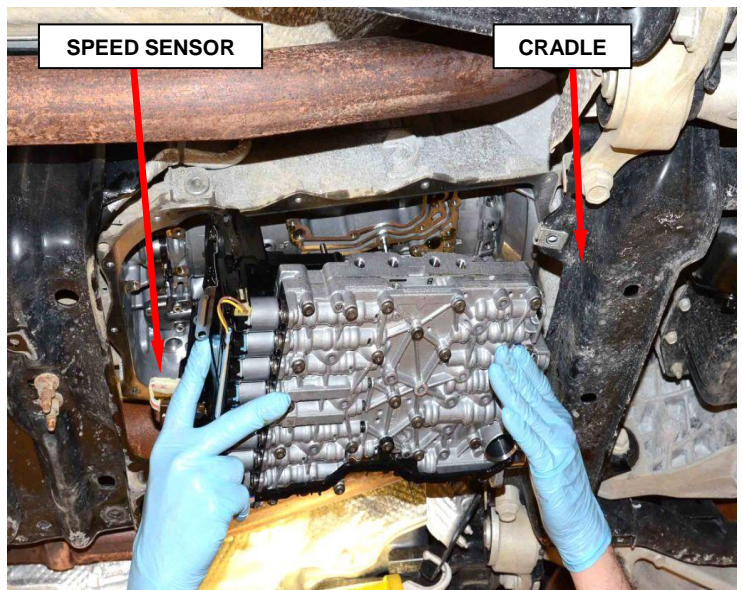
Figure 15 – Valve Body Installation

23. Carefully guide the front of the valve body over the cradle while aligning the rear of the valve body with the alignment pin (Figure 15).

NOTE: Make sure the speed sensor at the rear of the valve body does not get caught between the valve body and the transmission case when positioning the valve body to the case (Figure 15).

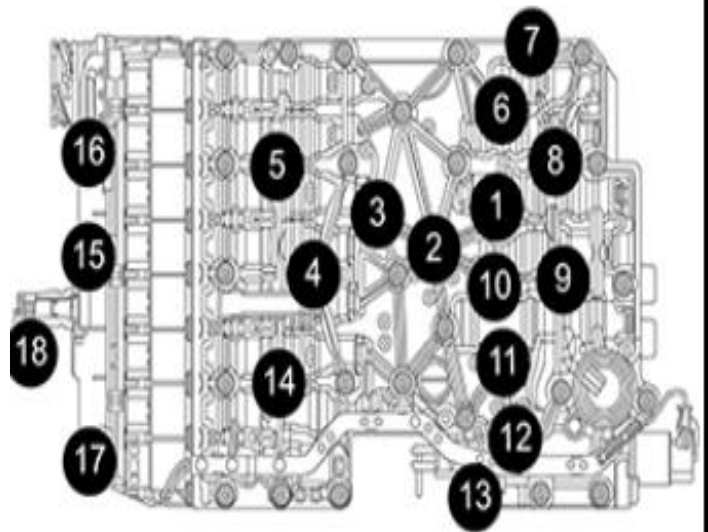
**Figure 16 – Valve Body Bolt Installation**

24. Install the valve body assembly retaining bolts not including 16-18 and hand tighten (Figure 16).
25. Remove the guide pin and install the remaining bolts.

29. Tighten the valve body fasteners to 8 N·m (71 in. lbs.).
30. Install the Hydraulic Impulse Oil Storage accumulator and tighten the bolts to 8 N·m (71 in. lbs.).

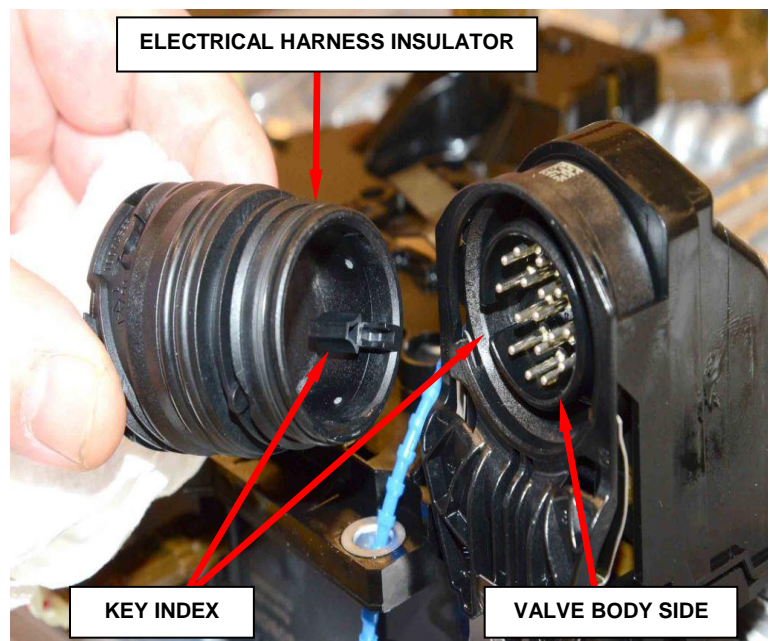
**Figure 17 – Electrical Harness Connector**

26. Using Remover/Installer, Guide Sleeve 10377 carefully install the electrical harness insulator to the transmission case.

NOTE: The connector has a key index that must be aligned to the mating side of the wiring connector (Figure 17).

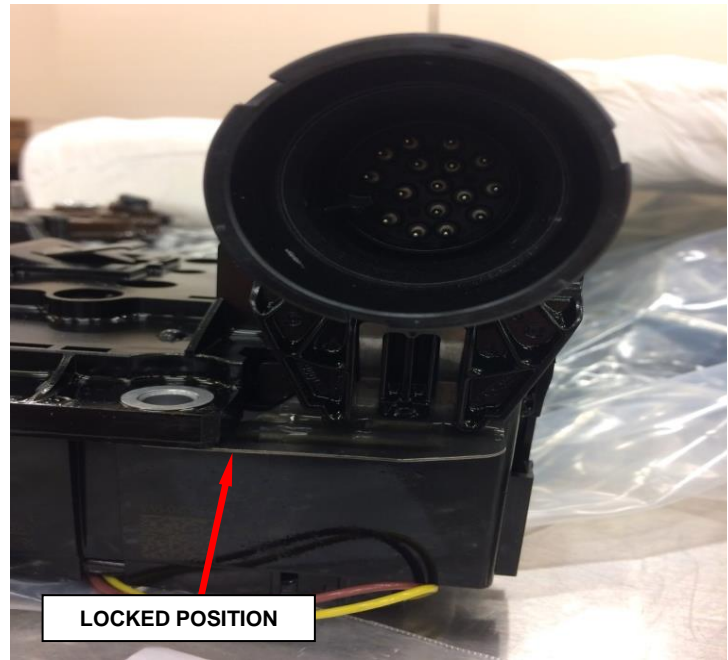
Figure 18 – Electrical Connector Lock

27. Lock the electrical connector lock to the valve body wire harness end (Figure 18).

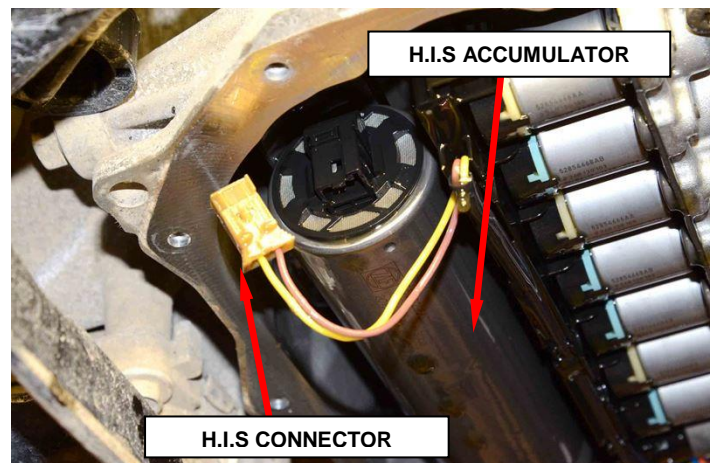
Figure 19 – Electrical H.I.S Connector

31. Connect the H.I.S. electrical connector (Figure 19).

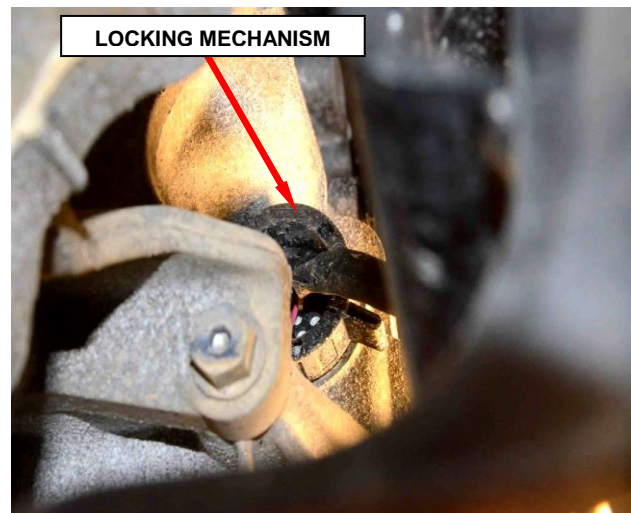
**Figure 21 – Harness Plug**

35. Connect the transmission electrical plug connector then turn the locking mechanism of the harness plug clockwise to lock in place (Figure 21).
