CHESAPEAKE/NEWPORT
FRAME REPAIR
INSTRUCTIONS

ALINER

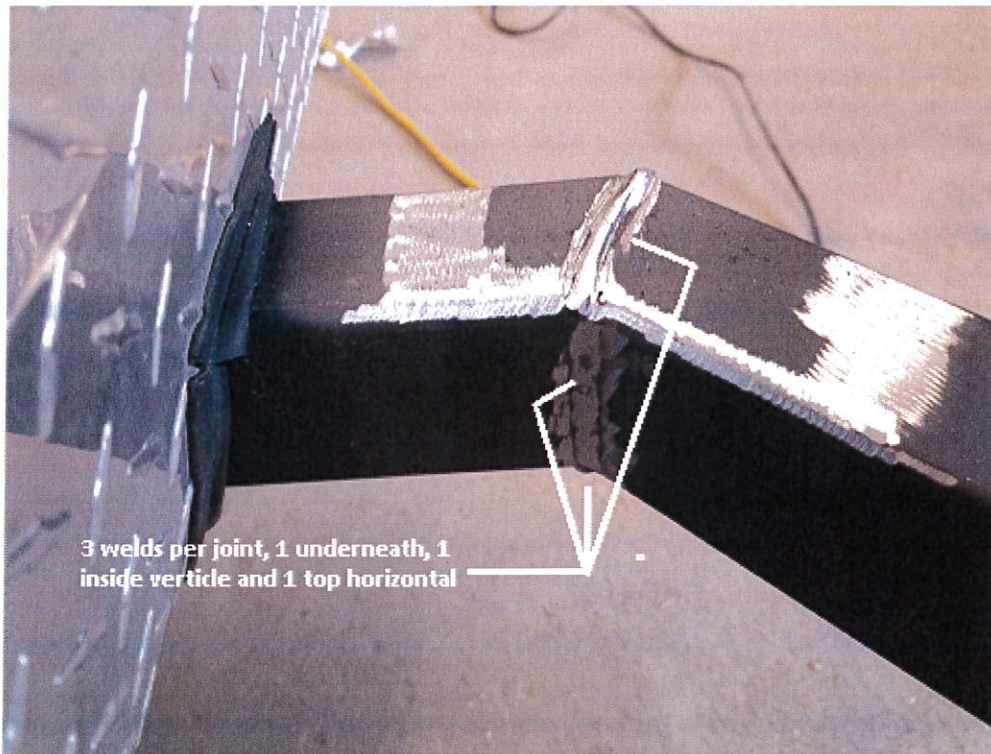
The first step is to inspect all the welds correlating to the front tongue at each point per joint as (pictured here)

at 4 points per camper tongue.

After inspection of these joints show any type of crack, these 3 areas will need to be cleaned and re-welded before proceeding to the next steps in this manual.

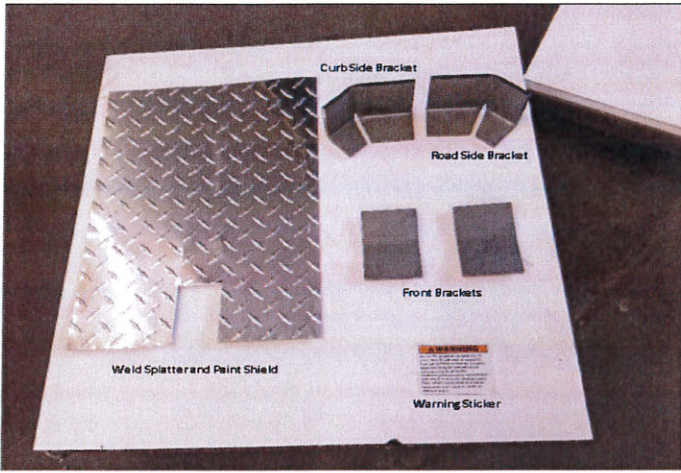
FIG 1

(Fig. 1) is the kit provided to repair the welded joints on the front of the campers tongue as shown in (Fig. 3), each side has a designation as to road side and curb side also shown in (Fig. 3), the corresponding brackets are shown in (Fig. 1) as to their designation.

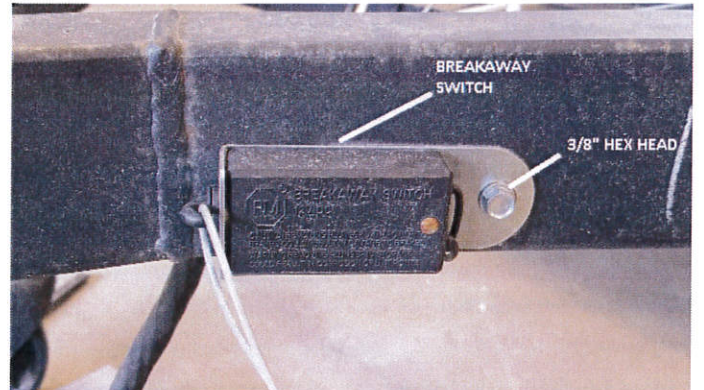
FIG 4

(Fig. 4) shows the breakaway switch, this switch will need to be removed temporarily to proceed with the prep work as described later in this manual.

After all repairs are made, the breakaway switch will need re-installed, it will need to be attached to the upper half of the tube 2-1/2" back from its original location to clear the newly installed gusset plate you have just installed, make sure it is attached to the upper portion of the tube from its original location at the bottom portion of the tube, this will prevent the mounting screw from damaging the cable running inside this frame tube when it is screwed in.

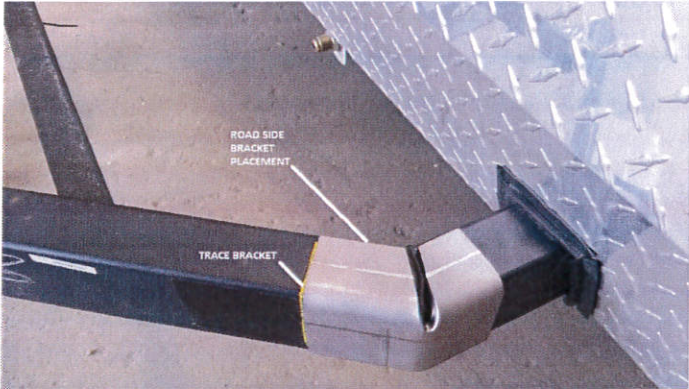
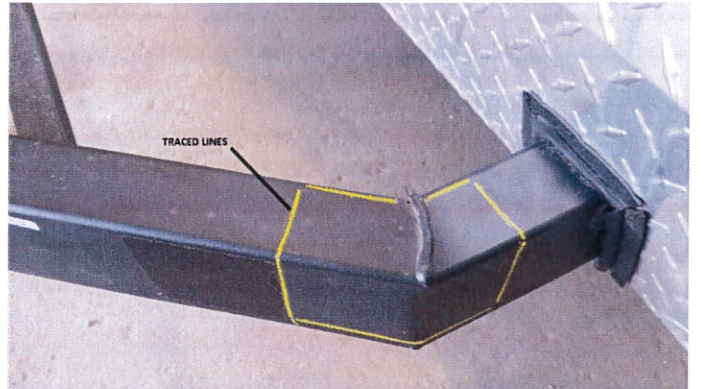
(Fig. 5) shows the road side bracket set into place with a traced outline of this bracket onto the frame, (Fig. 6) simply shows the traced outline once the bracket is removed. This outline gives you a reference as to where the paint will need to be removed to prep this area for welding. Once the area is completely paint free as shown in (Fig's 7 & 8), the brackets are now set into place with a weld splatter shield as shown in (Fig. 9), this shield will prevent weld splatter from damaging the front panel of the camper and is provided in the repair kit.

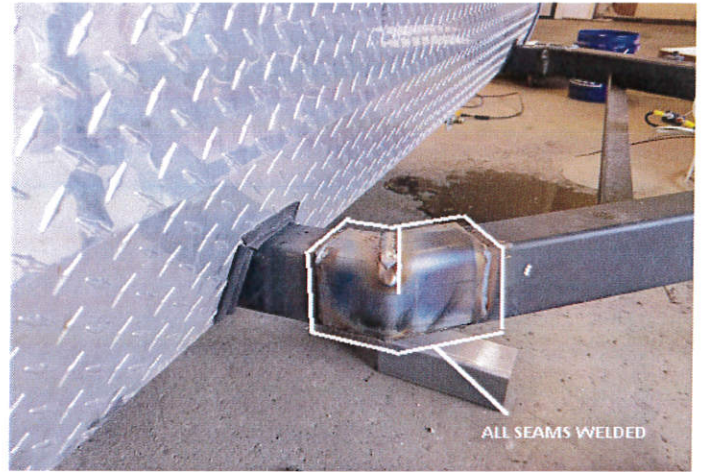
FIG 10

(Fig. 10) shows where the entire perimeter of the supplied bracket will be welded, (Fig. 11) shows this is a vertical down weld overlapping the existing weld for added strength. **Note: before any welds are to be done on the roadside bracket closest to the front of the camper wall, have a bucket of cold water handy with a rag. This bracket must be cooled immediately after each individual weld around the perimeter of this bracket, inside this frame tube on the road side only is a bargeman cable that runs from the front of tongue of the camper to the rear of the camper, this cooling process will keep from damaging this cable with the heat generated during the welding process, failure to do so as instructed will damage the cable and will need replaced. The curbside is free of any cables and will not need to be cooled as in the same manner the road side does.**

Note to welder: The frame tubing thickness is 1/8"

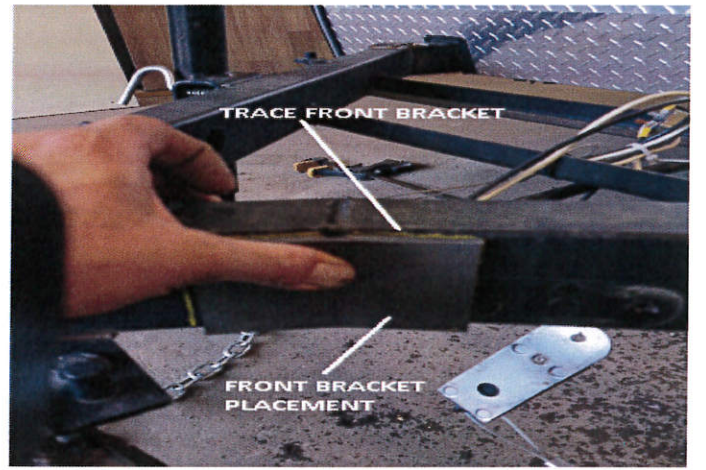
FIG 12

(Fig. 12) depicts the placement of the front gusset plates as provided in your kit, this is to be set into place and traced out as shown in (Fig. 13). The next step is to clean these surfaces free of paint as shown in (Fig. 14).

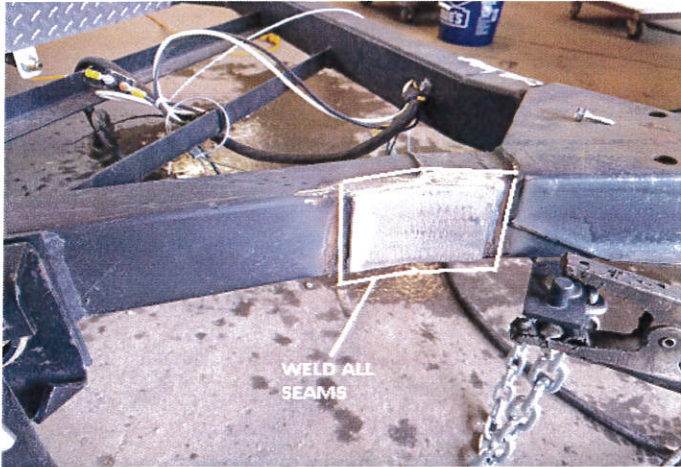
FIG 15

(Fig. 15) shows the front bracket welded into place and it is welded completely around the perimeter of the plate. After all welding has taken place, all surfaces

WELD ALL SEAMS

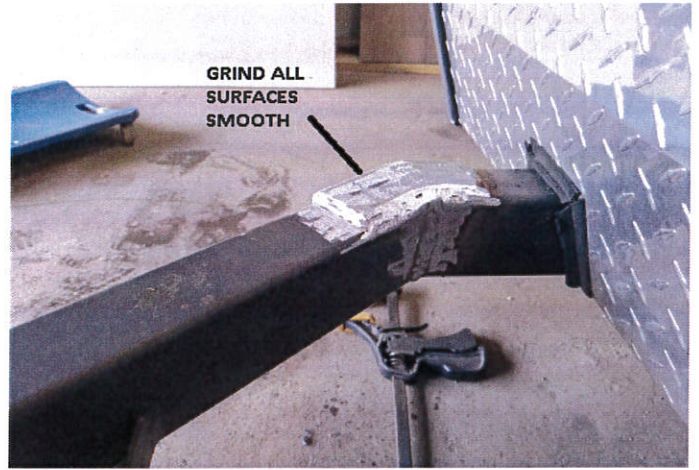
FIG 16

are to be ground smooth as shown in (Fig. 16), after welds have cooled to the touch, all bare metal is to be prime coated with a red oxide steel primer as shown in (Fig. 17 & 18), noting the splatter shield being used for overspray at this point and is supplied in your repair kit as well. (Fig. 19) shows the finished job complete with a coat or 2 of a flat black rustoleum paint or equivalent.

GRIND ALL SURFACES SMOOTH

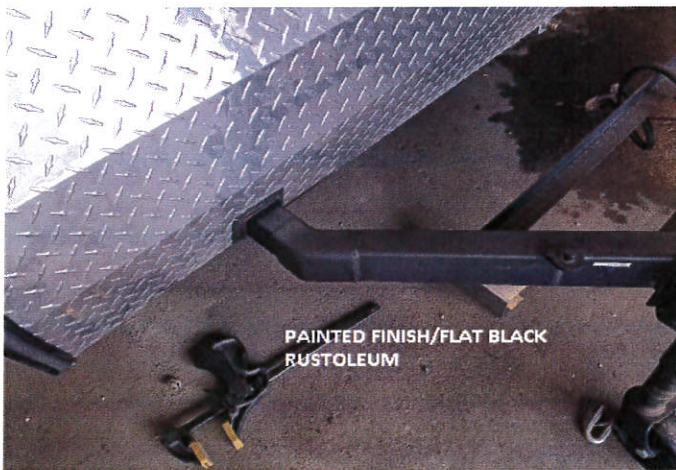
FIG 19

PAINTED FINISH/FLAT BLACK
RUSTOLEUM
