Maserati Technical Bulletin

Date: June 4, 2018
Safety Recall Campaign # 369
Inspection/Replacement of the Front Suspension
Sub-frame - US
Supersedes: N/A
Section: Compliance

Subject: Safety Recall Campaign # 369 – Inspection/Replacement of the Front Suspension Sub-frame

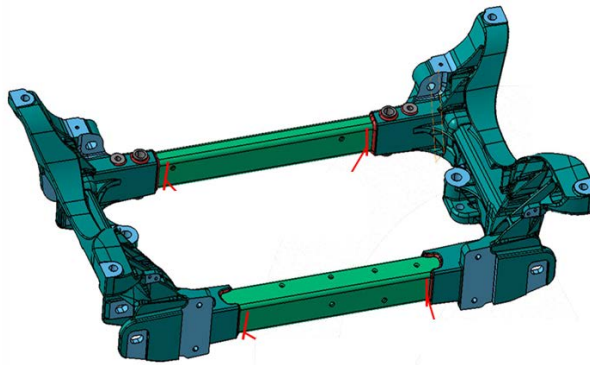
Fig.1

Maserati S.p.A. and MNA have determined that the above-described vehicles were manufactured with a front suspension sub-frame (Fig.1) that may have incomplete or missing welds. In certain circumstances, complete welds near the incomplete or missing welds may break and in some cases, the operators' control of vehicles could be diminished. This condition can cause a vehicle crash without prior warning.

Vehicles in the recall will require an underbody inspection to verify the sub-frame welds are all installed and complete. If a missing or incomplete weld is found, replacement of the sub-frame will be required.
