GROUP <b>Safety Recall Campaign</b>	MODEL <b>Multiple Models</b>
	NUMBER <b>SC165</b>	DATE <b>October 2018</b>
<b>SAFETY RECALL CAMPAIGN</b>		
<b>SUBJECT:</b> AIRBAG CONTROL UNIT (ACU) – EXTENSION WIRE HARNESS INSTALLATION (SC165)

## AIRBAG CONTROL UNIT (ACU) – EXTENSION WIRE HARNESS INSTALLATION (SC165)

### **Extension Wire Harness Kit Installation Procedure (All MYs & models):**

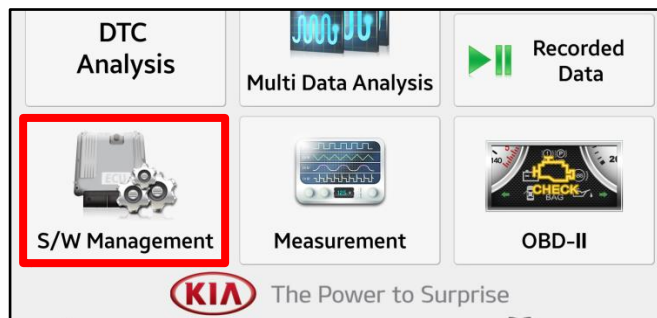
- Using the KDS, confirm VCI-II communication and configure vehicle (AUTO VIN) and then select **S/W Management**.

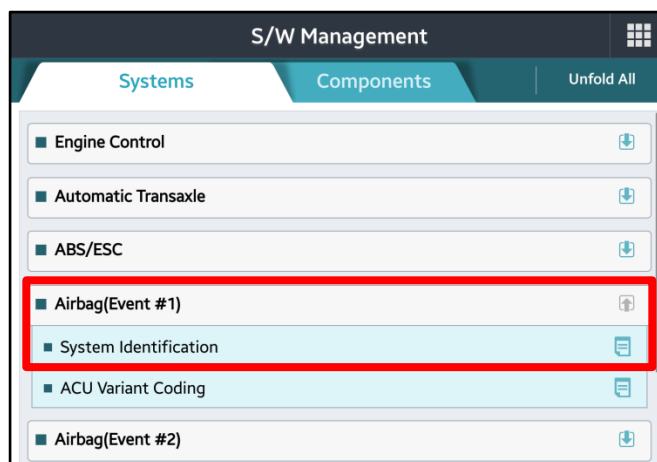
- Select **Airbag (Event #1) → System Identification**.

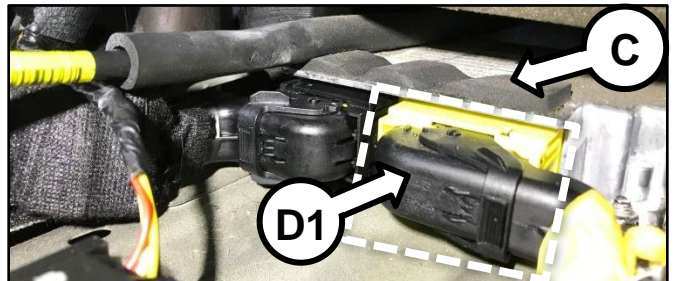
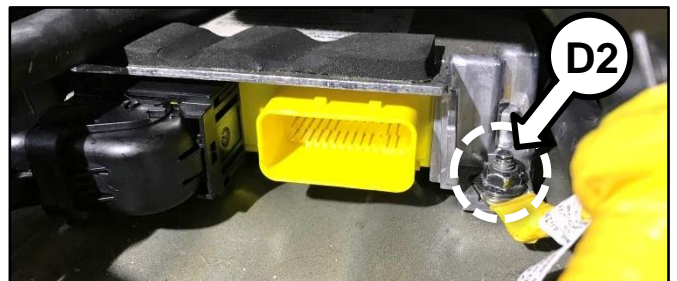
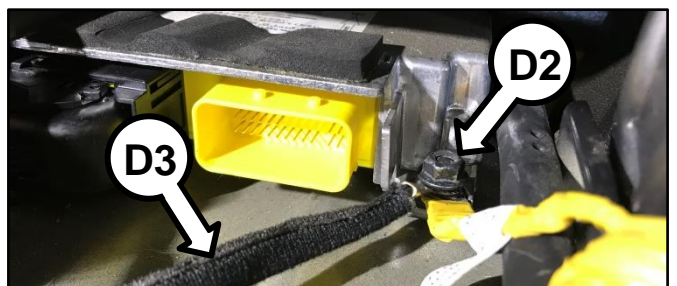
## 4a. TF HEV Only (Ground Wire):

1. Remove the right connector (D1) from the ACU (C).
2. Remove the ground wire retaining nut (D2) located at the right of the ACU.
3. Install the ground wire (D3) of the TF HEV extension harness (D4) to the ground (D2) and secure by reinstalling the retaining nut (D2).
4. Install the right connector (D1).

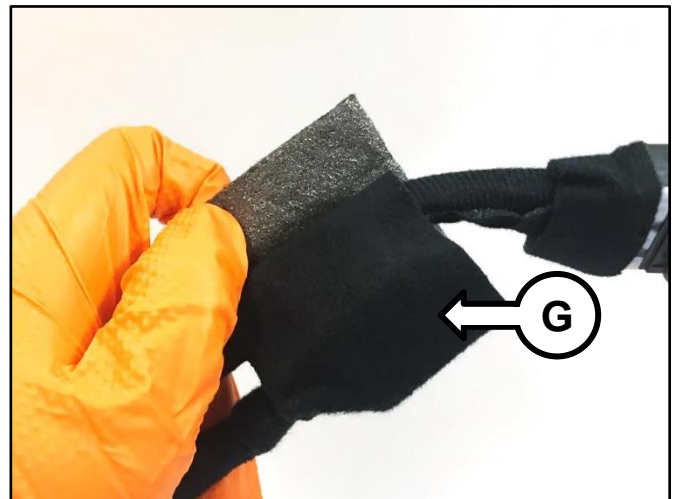
7. Using the second large felt pad provided, secure the diode module (G) to the extension (E).
