GROUP  
Safety Recall Campaign

NUMBER  
SC165 (Rev 2, 10/21/2025)

SUBJECT: AIRBAG CONTROL UNIT (ACU) –  
EXTENSION WIRE HARNESS INSTALLATION (SC165)

The airbag control unit (“ACU”) detects crash severity and commands deployment of the advanced airbags and seatbelt pretensioners when necessary. The ACU in these vehicles contain a certain Application-Specific Integrated Circuit (“ASIC”) that may be susceptible to electrical overstress (“EOS”) during certain frontal crash events. If the ASIC becomes damaged, the frontal airbags and seatbelt pretensioners may not deploy in certain frontal crashes where deployment may be necessary, thereby increasing the risk of injury.

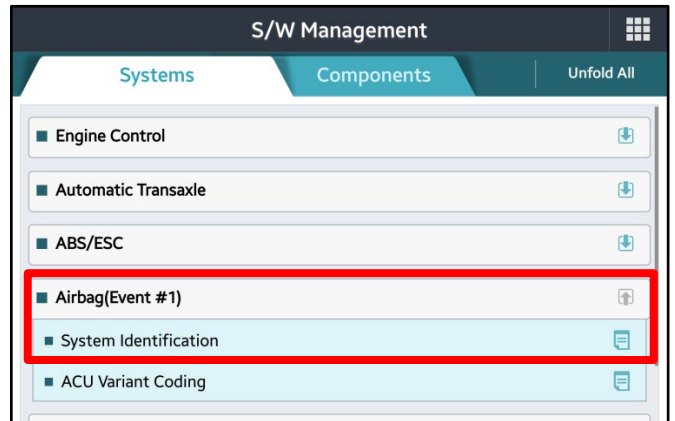
- Select **Airbag (Event #1) → System Identification**.

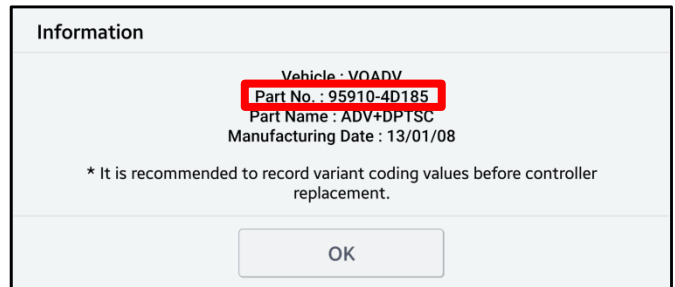
- Check the ACU part number and perform the required action per table below.

2011MY SEDONA (VQ) ONLY	
Part No.	Action
95910 4D080 95910 4D180	Install Extension Wire Harness Kit (page 3)
95910 4D060 95910 4D160 95910 4D185	*No Extension Wire Harness Kit required. Submit one (1) photo of ACU part number screen.

**\*Requirement:** Take and attach one (1) photo displaying the ACU part number to ensure the inspection procedure has been performed.

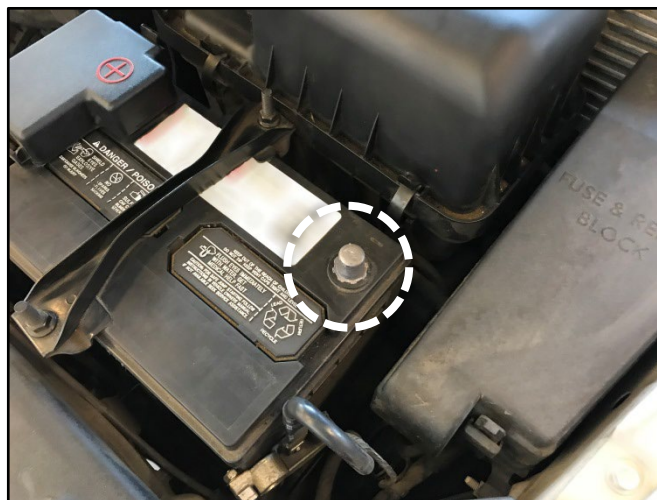
1. Record the customer's radio presets and then disconnect the negative "-" battery terminal.

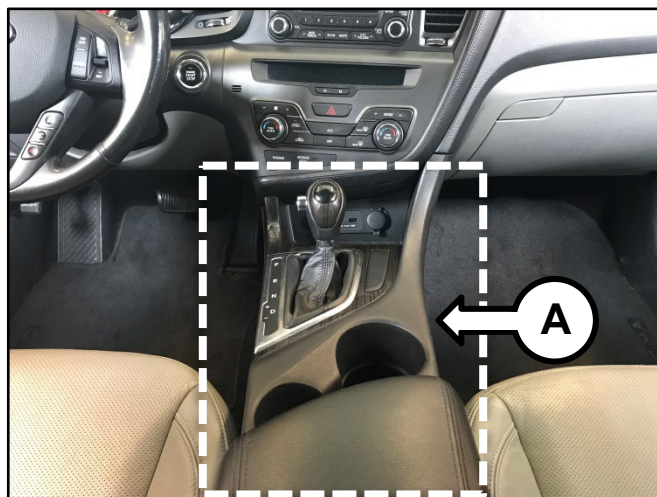
2. Remove the center console (A) by referring to the "Body (Interior and Exterior) → Interior → Console → Repair procedures" chapter in the applicable Shop Manual on KGIS.

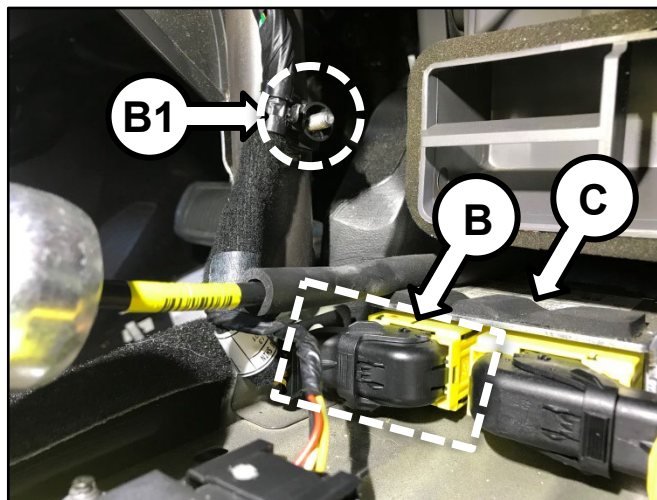
3. Disconnect the left connector (B) from the ACU (C) and if applicable, detach the harness retaining clip (B1).

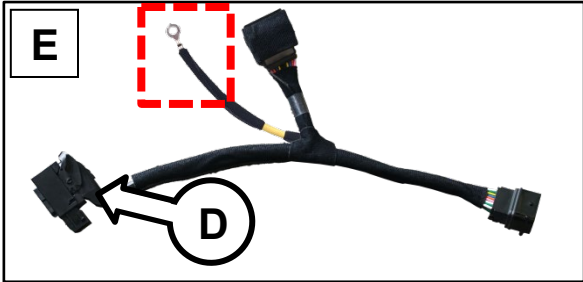
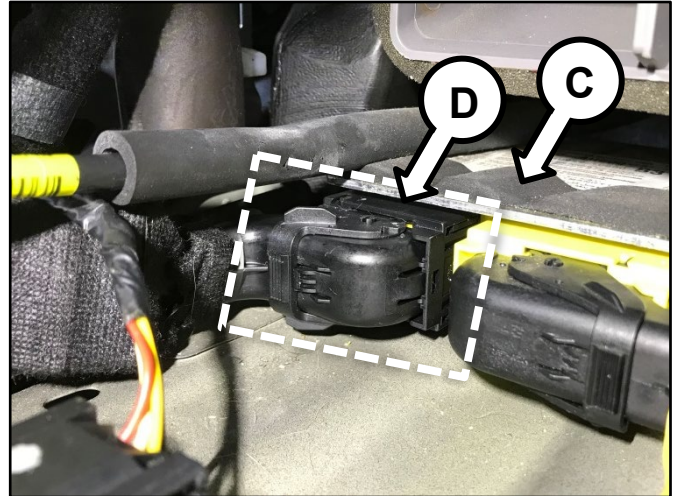
- 4a. Install the connector (D) of the extension harness (E) to the ACU (C).

- 4b. **For non-HEV models**, wrap the the (-) ground connector with electrical tape. This ground connection is not required.

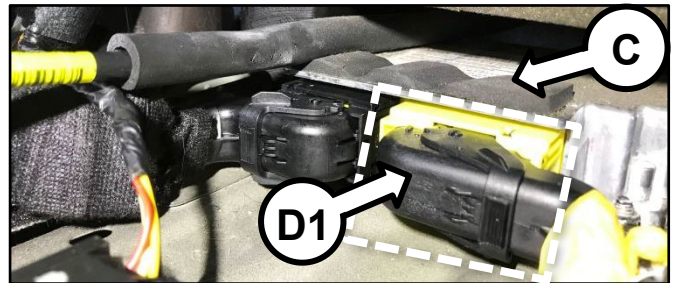
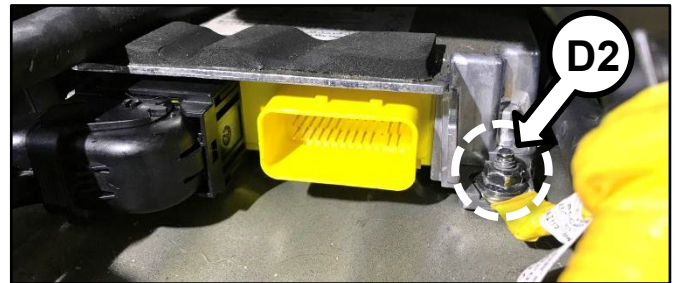
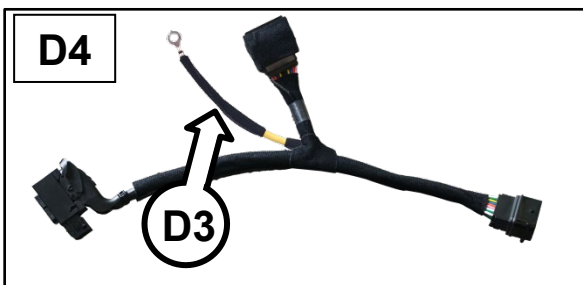
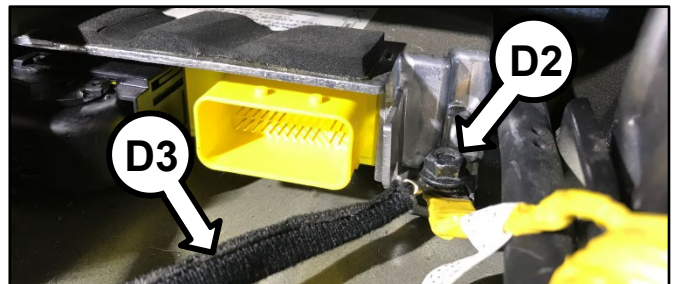
- 4c. **Optima Hybrid (TF HEV) Only (Ground Wire):**

1. Remove the right connector (D1) from the ACU (C).
2. Remove the ground wire retaining nut (D2) located at the right of the ACU.
3. Install the ground wire (D3) of the TF HEV extension harness (D4) to the ground (D2) and secure by reinstalling the retaining nut (D2).
4. Install the right connector (D1).

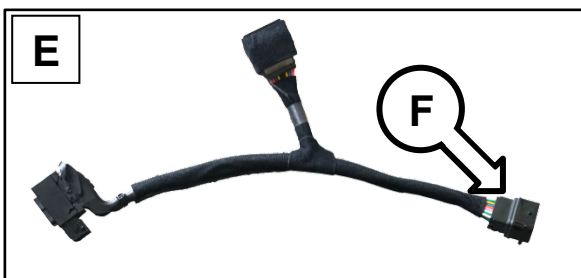
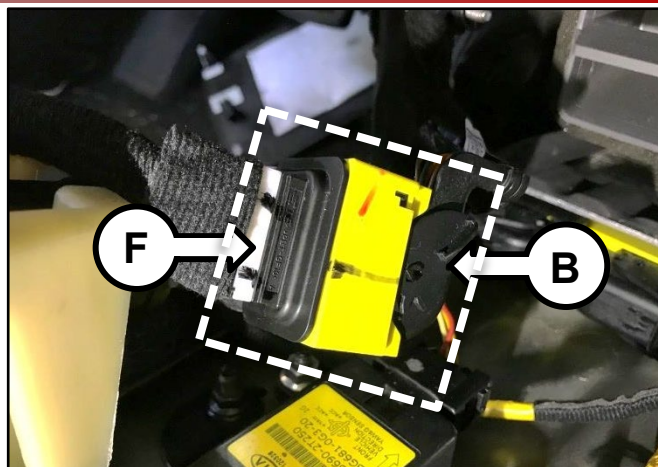
5. Install connector (B) (from step 3) to connector (F) of the extension harness (E).

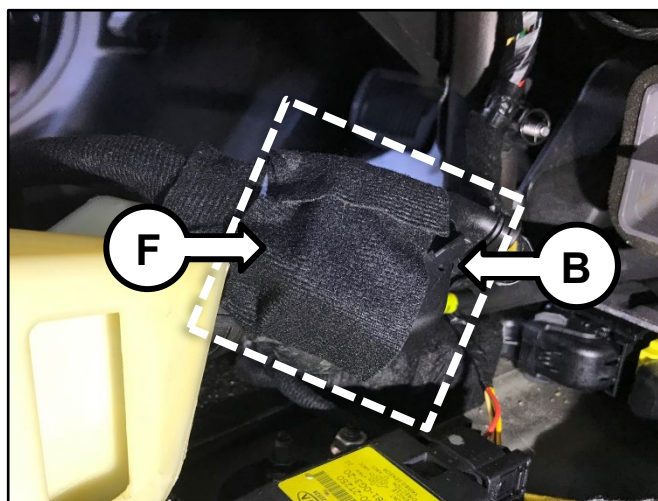
6. Using a large felt pad supplied with the extension kit, wrap connectors (B) and (F).

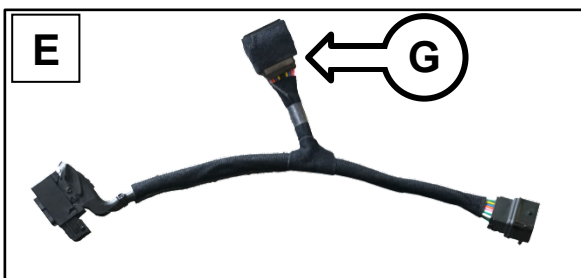
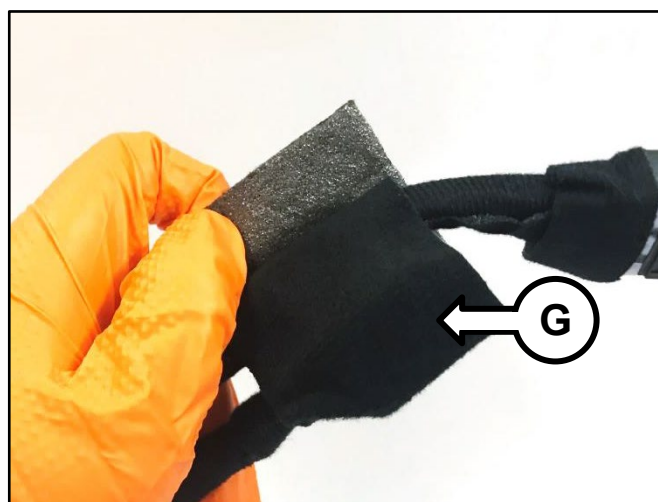
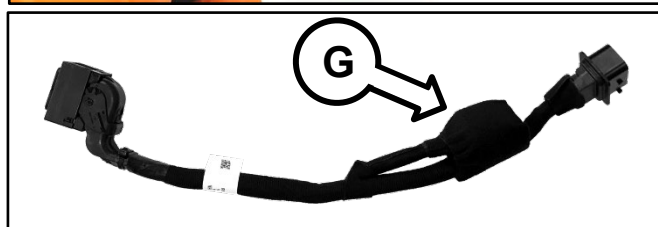
7. Using the second large felt pad provided, secure the diode module (G) to the extension (E).

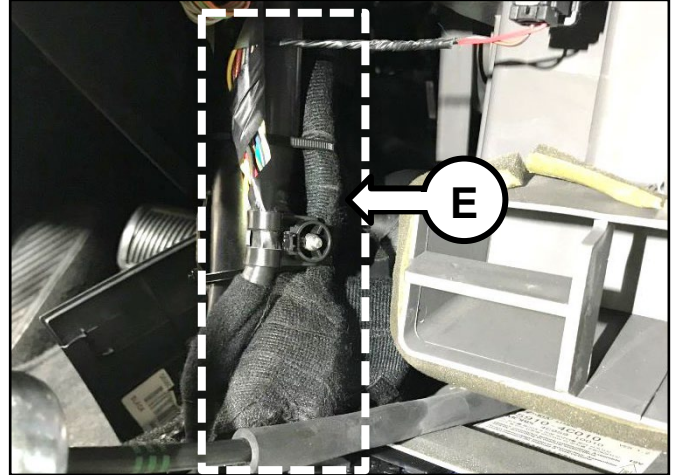
- Secure the extension harness (E) with the provided cable ties.

Harness secured for QF, TF, & TF HEV

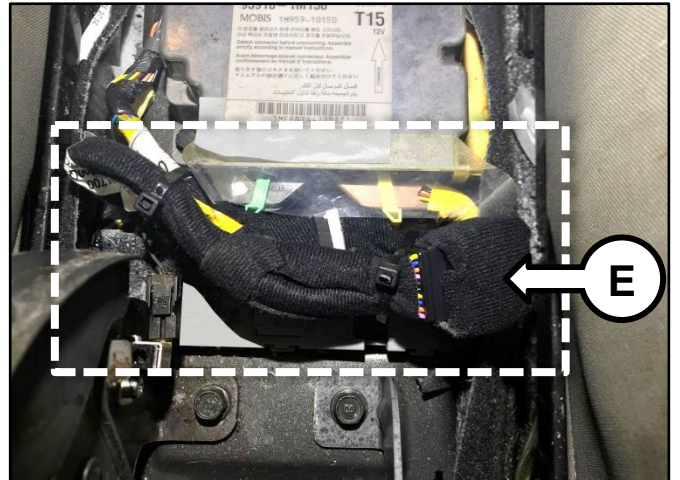
Harness secured for TD

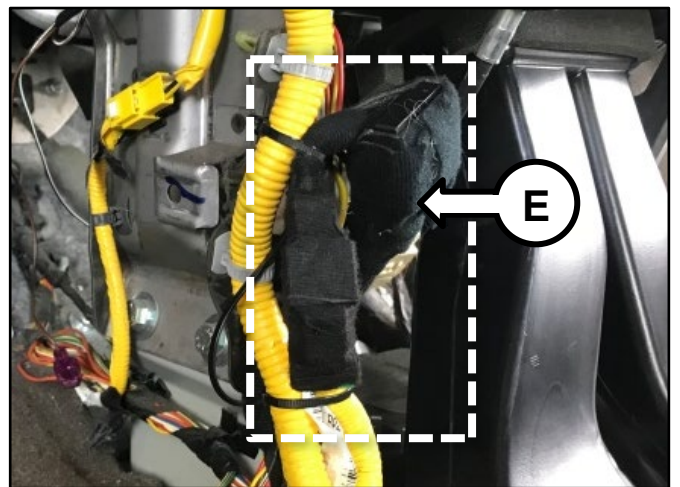
Harness secured for VQ

- Reinstall all removed components in the reverse order of removal.
- Confirm proper ACU system operation by turning the ignition ON and ensuring the SRS malfunction indicator turns off after approximately six (6) seconds.
- Restore the customer's radio presets.
