GROUP <b>Safety Recall Campaign</b>	MODEL <b>Multiple Models</b>
	NUMBER <b>SC165 (Rev 1, 10/02/2018)</b>	DATE <b>October 2018</b>
<b>SAFETY RECALL CAMPAIGN</b>		
SUBJECT: <b>AIRBAG CONTROL UNIT (ACU) – EXTENSION WIRE HARNESS INSTALLATION (SC165)</b>

# AIRBAG CONTROL UNIT (ACU) – EXTENSION WIRE HARNESS INSTALLATION (SC165)

### **Extension Wire Harness Kit Installation Procedure (All MYs & Models):**

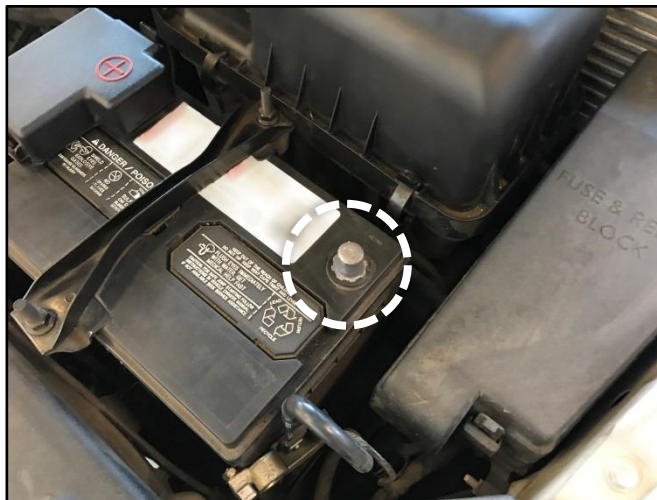
1. Record the customer's radio presets and then disconnect the negative “-” battery terminal.

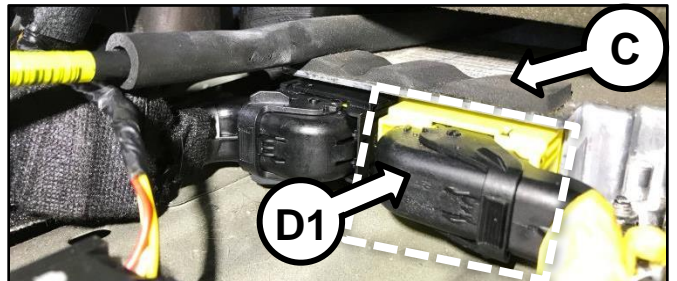
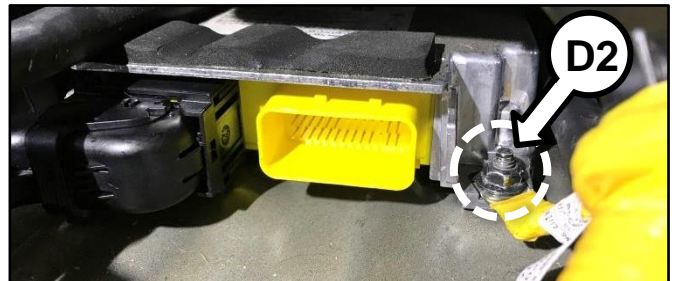
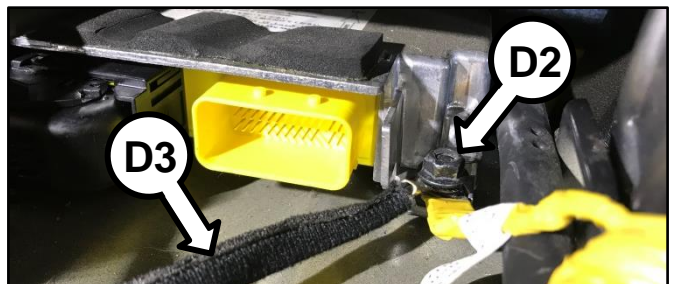
### 4a. Optima Hybrid (TF HEV) Only (Ground Wire):

1. Remove the right connector (D1) from the ACU (C).
2. Remove the ground wire retaining nut (D2) located at the right of the ACU.
3. Install the ground wire (D3) of the TF HEV extension harness (D4) to the ground (D2) and secure by reinstalling the retaining nut (D2).
4. Install the right connector (D1).
