Safety Recall

Code: 69X1

Subject	Second Row Bench Seat Safety Belt Buckles
Release Date	July 17, 2018
Revision Summary	Removed Techline block on seat belt buckles.
Affected Vehicles	U.S.A. & CANADA: Certain 2018 MY Volkswagen Atlas with second row bench seat <i>Check Campaigns/Actions screen in Elsa on the day of repair to verify that a VIN qualifies for repair under this action. Elsa is the <u>only</u> valid campaign inquiry & verification source.</i> <ul style="list-style-type: none">✓ Campaign status must show "open."✓ If Elsa shows other open action(s), inform your customer so that the work can also be completed at the same time the vehicle is in the workshop for this campaign.
Problem Description	If a child restraint with a larger than recommended base is installed in the center position of the second row bench seat, it may damage both the center and adjacent outboard safety belt buckles. A damaged safety belt buckle can release unexpectedly, increasing the risk of injury to vehicle occupants in a crash.

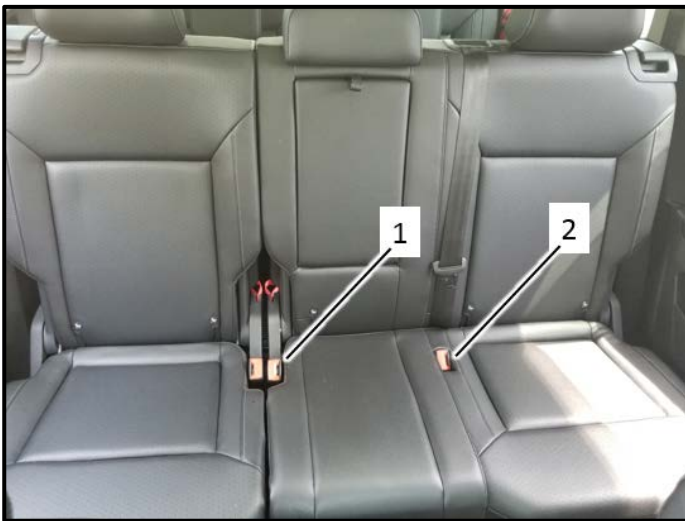
- Inspect center passenger <1> and left passenger <2> seat belt buckles on the bench seat.
- **A flashlight should be used to aid in the inspection.**
- If the buckle is damaged, it must be replaced.

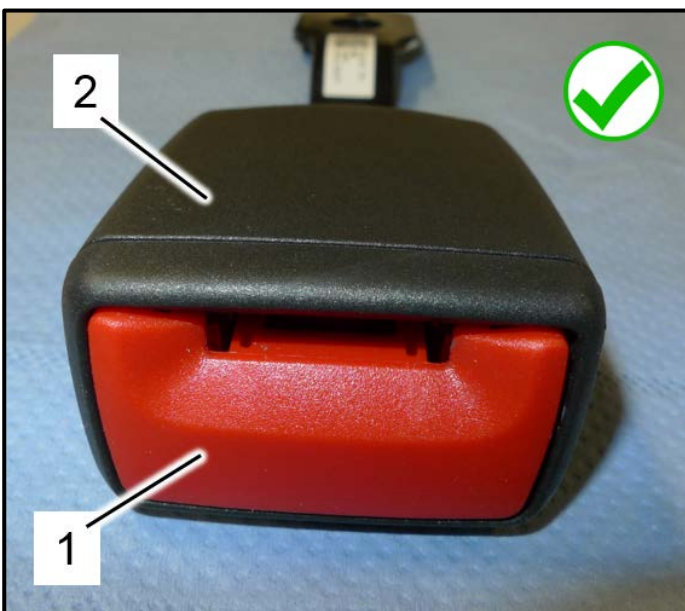
- The release button <1> is flush with the buckle housing <2>.
- The housing <2> is not deformed or separated.

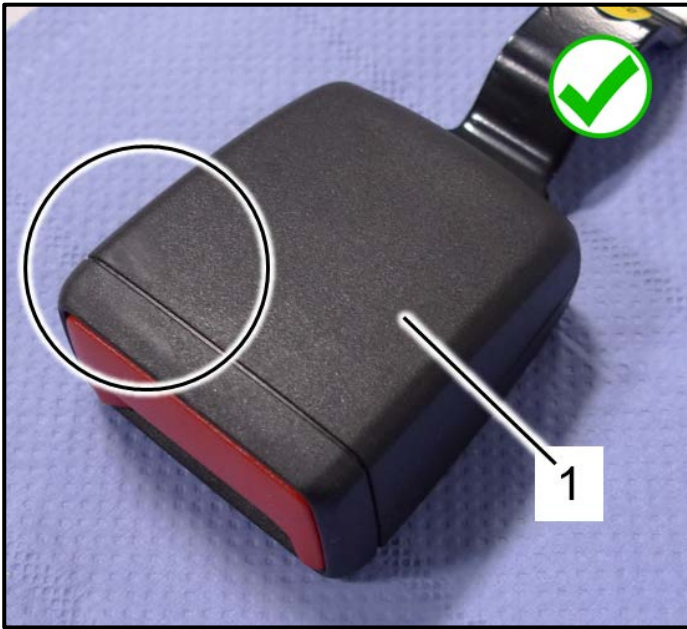
- The housing <1> may show scuff marks or other indications of normal usage (surface scratches, for example).
- These marks are not an indication of damage and the buckle will not require replacement.
- If no damage to the buckle is found, **place owner's manual supplement in glove compartment and Proceed to Section E.**

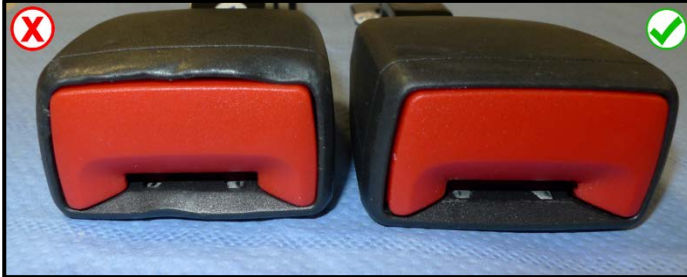
- The housing is deformed on the top in the area of the release button.

- **If any of the following scenarios are found:**
 - **The affected seat belt buckle must be replaced.**
 - **The vehicle should be grounded until parts arrive.**
- **See Section C and/or Section D for seat belt buckle replacement instructions.**

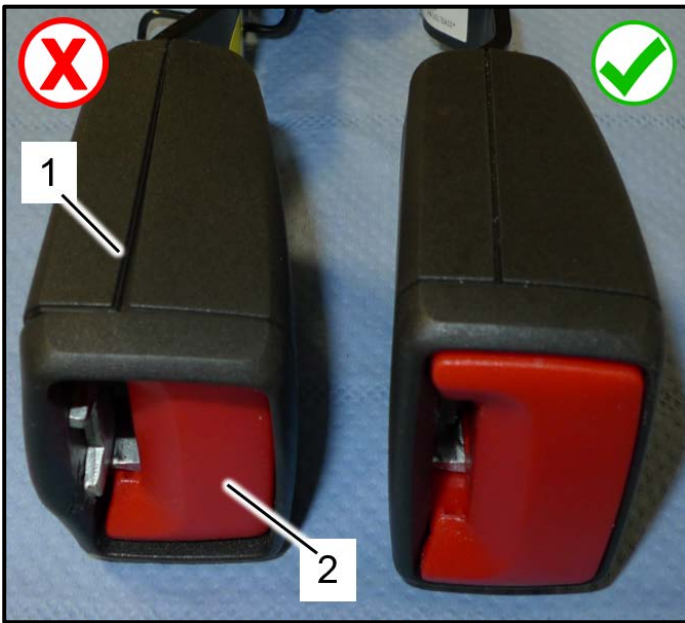
- The housing is broken or split <1>.
- AND/OR
- The button no longer returns to the released position <2>.

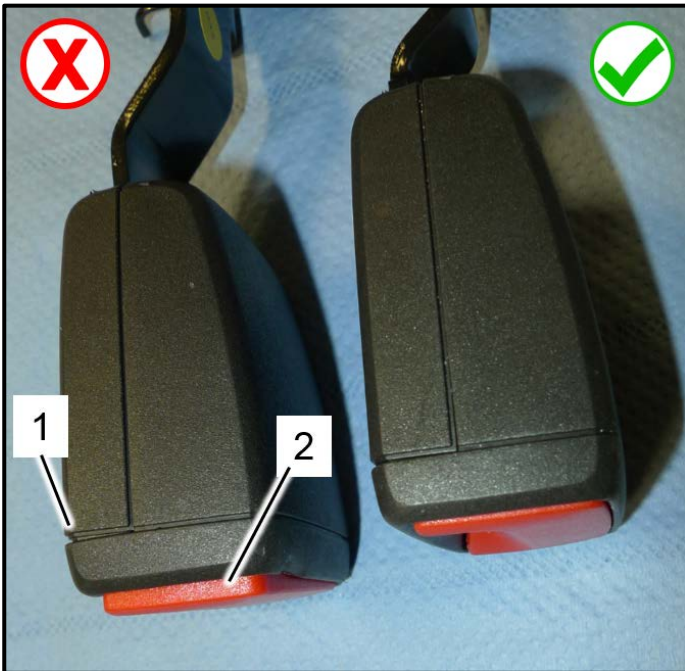
- The housing is broken or split <1>.
- AND/OR
- The button protrudes outside of the housing <2>.

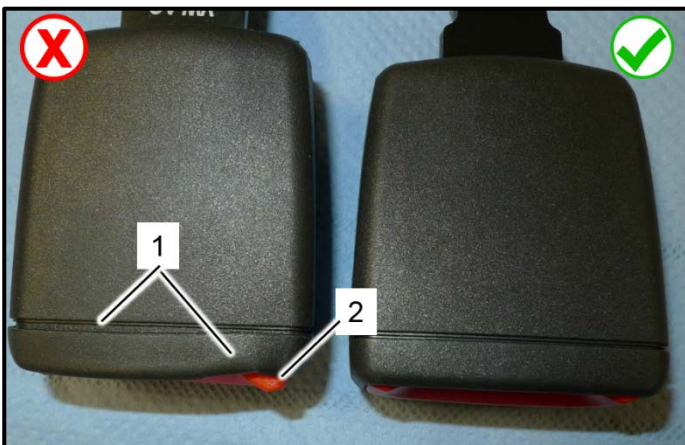
- The housing is deformed <1>.
- AND/OR
- The button protrudes outside of the housing <2>.

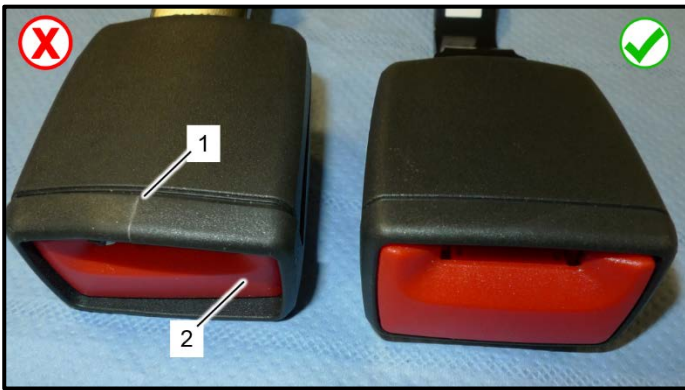
- The housing is deformed and/or cracked <1>.
- AND/OR
- The button no longer returns to the released position <2>.

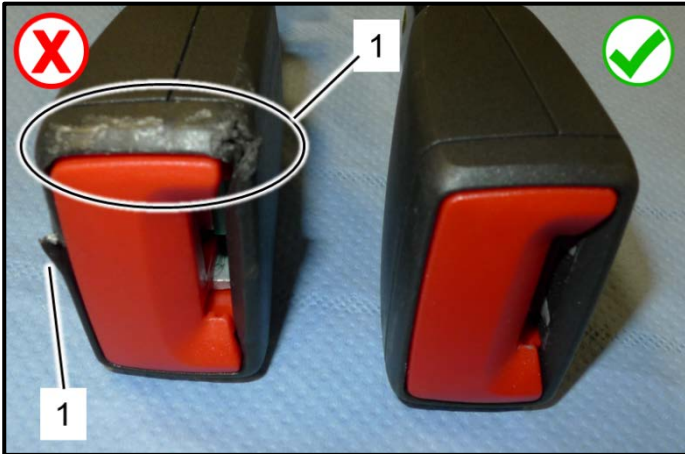
- The housing is deformed or broken <1>.

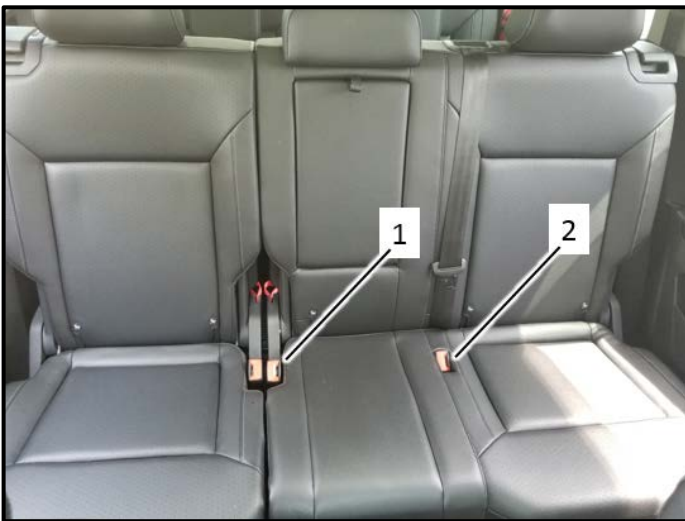
- If center passenger seat belt buckle <1> requires replacement, **Proceed to Section C.**
- If left passenger seat belt buckle <2> requires replacement, **Proceed to Section D.**
