# Keystone RV Company

## SAFETY ADVISORY # 18-322

### Capital Grille Installation

Keystone is conducting a voluntary RECALL notification campaign in accordance with the National Highway Transportation and Safety Act. It has been decided that the vehicles in the recall population have an outdoor propane grill installed with clearances that are no longer within the grill manufacturer's specified tolerances to combustible material. Under certain conditions when using the outside propane grill it is possible for the wooden assembly the grill is installed in to be exposed to elevated temperatures leading to an increased risk of fire.

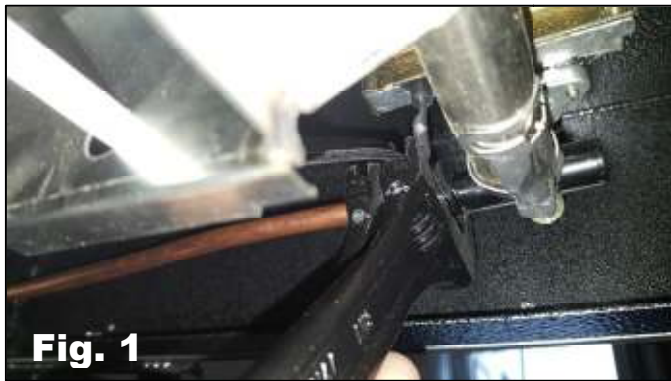
**Fig. 1**

Remove the vinyl coated "P" clamps from the propane line in the back, noting how the hose was routed. Next, using a back-up wrench, remove the propane supply line from the grill, Figure 1.

Install the grill and attach the copper supply tube (KRV # 439090) using a back-up wrench to prevent damage to the gas valve for the grill, Figure 1. After the supply tube is installed, install the rubber propane line. Attach the line so that there is only enough rubber propane line to reach the quick disconnect under the unit.

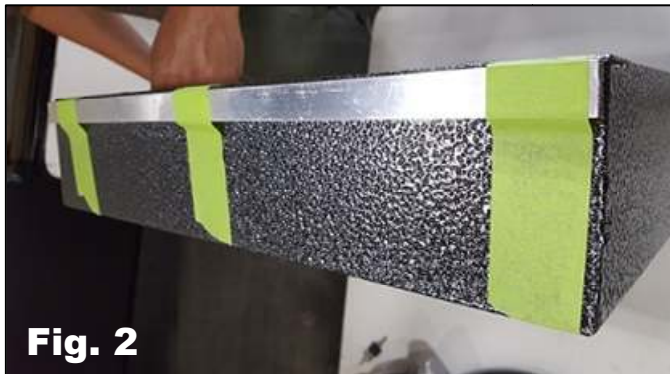
**Fig. 2**

- Attach drawer guides on each side of the box, this will require 2 shims (KRV # 327496), Figure 2.
- Use masking tape to hold shims in place when installing drawer guides.

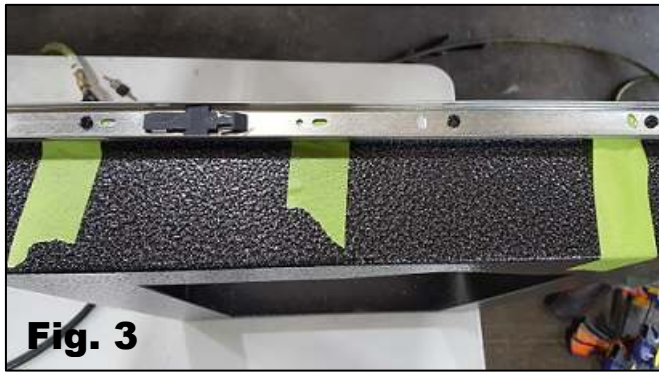
- Using 3 #8 pan head screws, pre-drill using 1/8" drill bit and attach the drawer guide. The drawer guide should be lined up flush with front and bottom of the box, Figure 3.

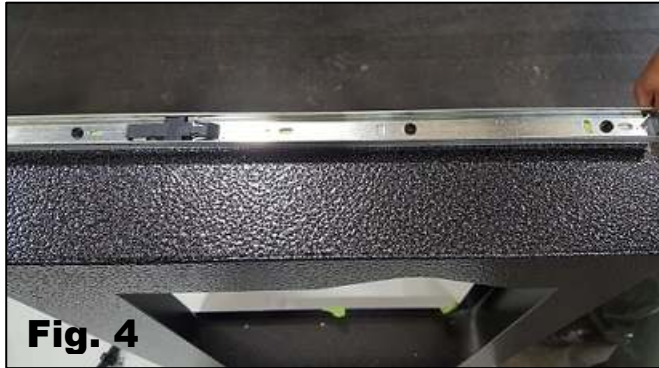
- Remove masking tape, Figure 4.

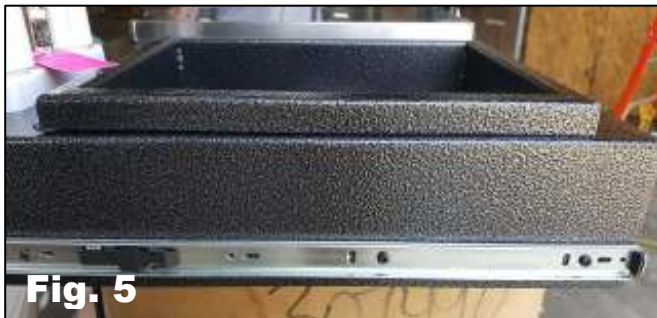
- After removing the faucet, drawer guides, and grill from the old assembly, install them in the new assembly as seen in Figure 5. The new assembly has a metal dry sink (KRV # 607707).

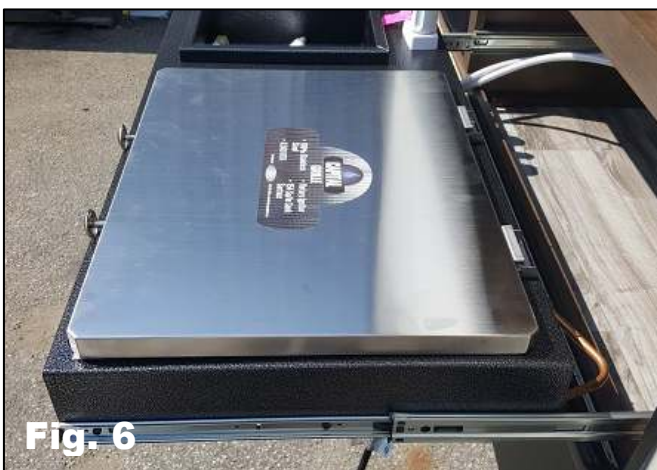
After all the attachments have been transferred to the new metal assembly, it can be installed in the pre-existing drawer guide in the compartment. See Figure 6.
