Keystone RV Company

SAFETY ADVISORY # 18-322

Capital Grille Installation

Keystone is conducting a voluntary RECALL notification campaign in accordance with the National Highway Transportation and Safety Act. It has been decided that the vehicles in the recall population have an outdoor propane grill installed with clearances that are no longer within the grill manufacturer's specified tolerances to combustible material. Under certain conditions when using the outside propane grill it is possible for the wooden assembly the grill is installed in to be exposed to elevated temperatures leading to an increased risk of fire.

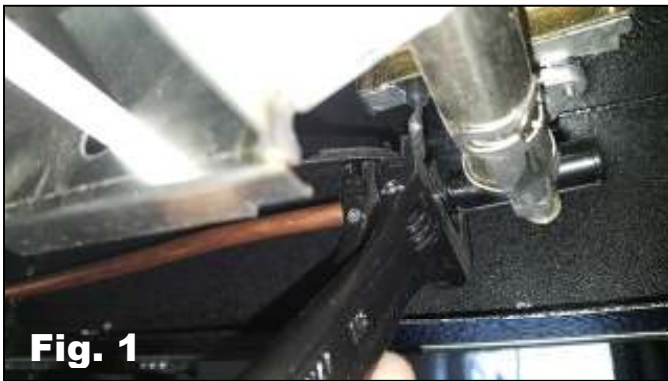
Fig. 1

Remove the vinyl coated “P” clamps from the propane line in the back, noting how the hose was routed. Next, using a back-up wrench, remove the propane supply line from the grill, Figure 1.

damage to the gas valve for the grill, Figure 1. After the supply tube is installed, install the rubber propane line. Attach the line so that there is only enough rubber propane line to reach the quick disconnect under the unit.

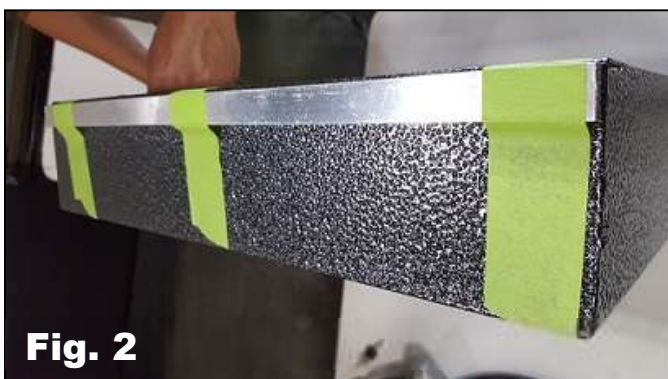
Fig. 2

- This step is for all models except the 34TSB. See step 6 for that model prep.
- Attach drawer guides on each side of the box, this will require 2 shims (KRV # 327496), Figure 2.
- Use masking tape to hold shims in place when installing drawer guides.

- Attach drawer guides on each side of the box, this will require 1 shim (KRV # 327496), Figure 2.

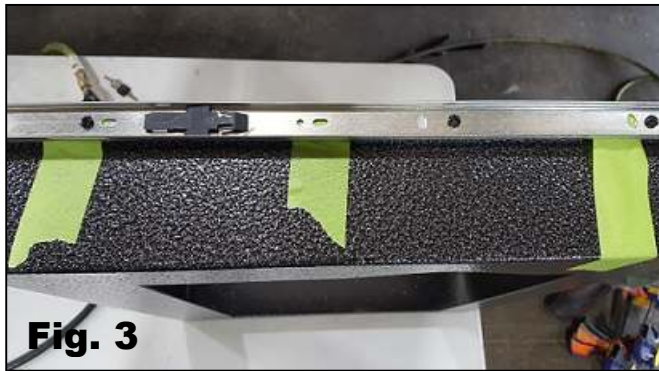
**Fig. 3**

- Using 3 #8 pan head screws, pre-drill using 1/8" drill bit and attach the drawer guide. The drawer guide should be lined up flush with front and bottom of the box, Figure 3.

- Using 3 #8 pan head screws, pre-drill using 1/8" drill bit and attach the drawer guide. The drawer guide should be lined up flush with front and bottom of the box, Figure 3.

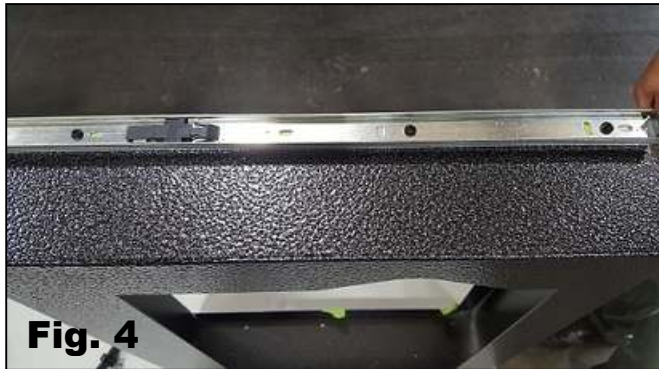
**Fig. 4**

- Remove masking tape, Figure 4.

- Remove masking tape, Figure 4.

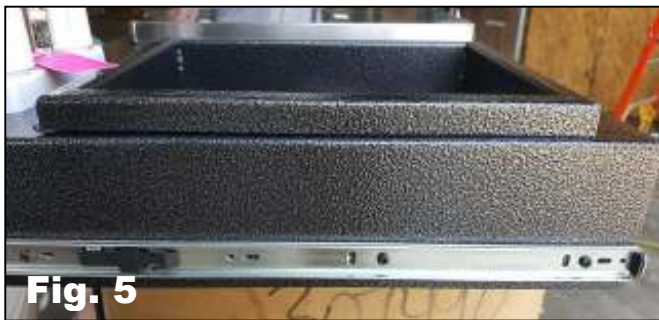
**Fig. 5**

- After removing the faucet, drawer guides, and grill from the old assembly, install them in the new assembly as seen in Figure 5. The new assembly has a metal dry sink (KRV # 607707).

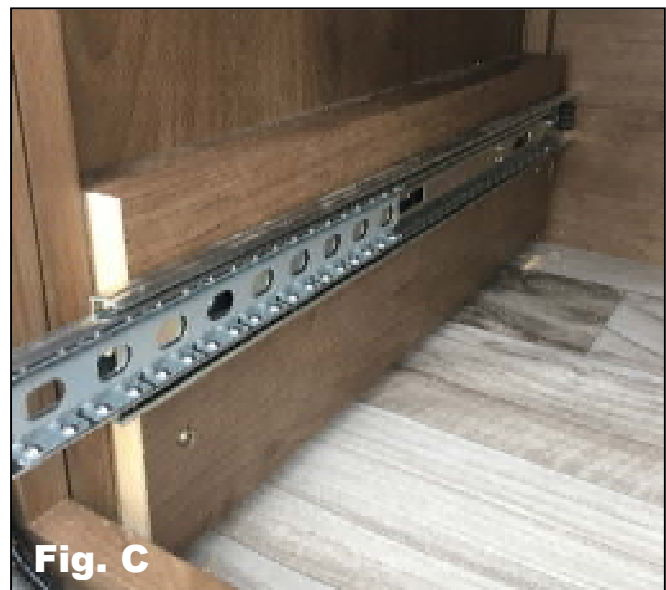
2. Using the stiles in the existing wooden grill assembly, measure and cut the long sides of the box to install under the existing cabinet drawer guides in the cabinet opening. See Figure (C) for use as spacer.

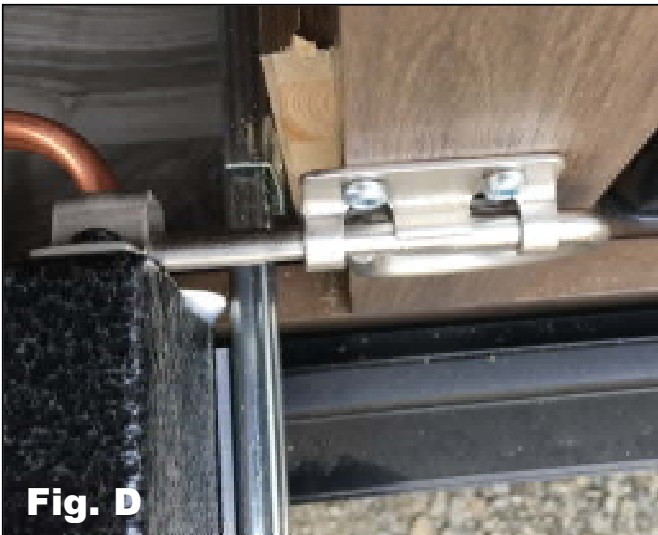
**Fig. D**

3. Remove the existing latch and move to the side of the new metal assembly as seen in Figure (D), the catch is not required to install.
4. Cut and install plastic trim KRV#362647 to fit over existing stile to cover holes from previous latch location. Use KRV#242001 Vinyl Tape Mirror Tape to adhere the plastic trim to the existing stile See Figure (E) and Figure (F).

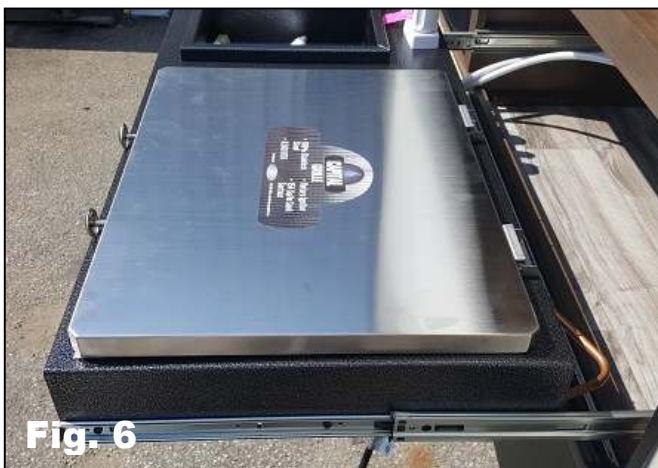
**Fig. 6****Step 11**

After all the attachments have been transferred to the new metal assembly, it can be installed in the pre-existing drawer guide in the compartment. See Figure 6.
