Safety Recall

Code: 69X3

Subject Driver Frontal Airbag Inflator

Affected Vehicles **U.S.A. & CANADA: Certain 2003 Model Year Volkswagen vehicles***

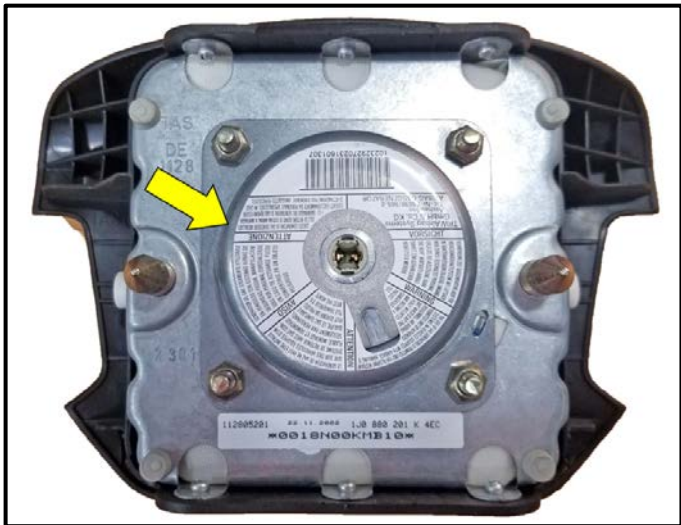
- Replace driver frontal airbag inflator.

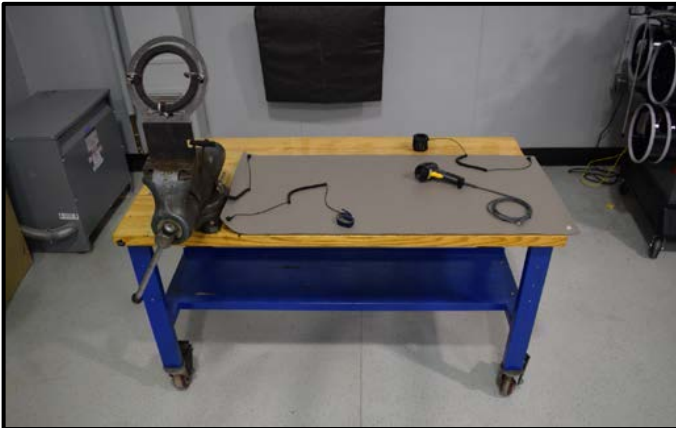
It is critical that a clean, uncongested work environment is utilized during the inflator replacement procedure. Extra tools, debris, etc... in the blast area of an airbag impose a danger in the event an airbag were to deploy. Ensure there are no loose components in the blast area of the airbag.

- Workbench that will support a vise.
- Work surface free of unnecessary tools, equipment and debris.

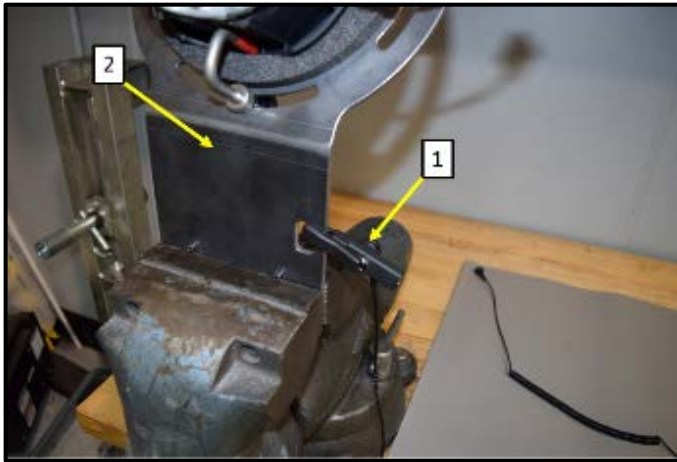
- Clamp Airbag Support T10568 <2> into the vice.
- Connect crocodile clip <1> to airbag support <2> and ESD workplace -VAS 6613-.

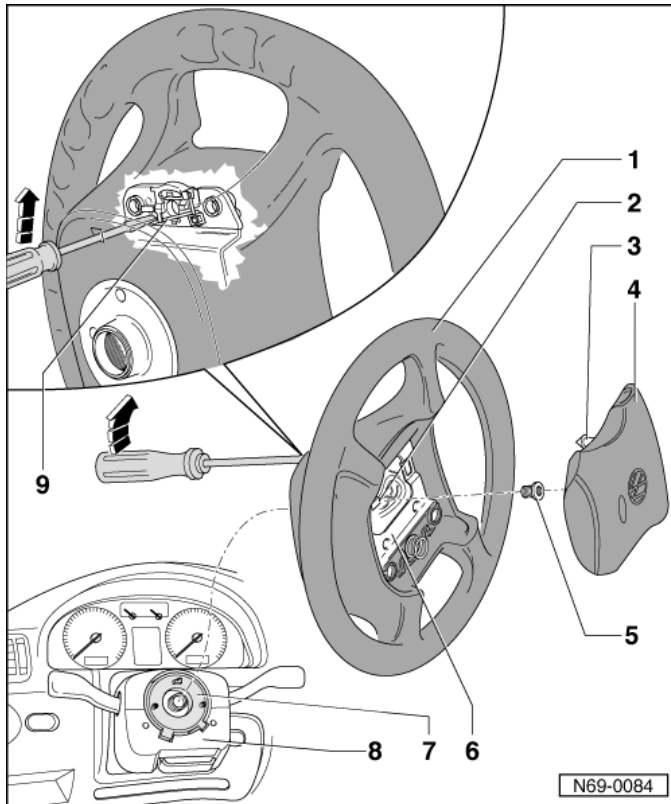
Remove driver frontal airbag:

- Release steering column adjuster.
- Pull out steering column entirely and push into lower position.
- Turn the steering wheel until the spokes are in a vertical position.
- Secure steering column adjustment.
- Insert a screwdriver all the way into the hole on the back of the steering wheel (approximately 45 mm).
- Pull up on screwdriver in direction of <arrow> to release the clamp <9>.
- Turn the steering wheel 180° and repeat the procedure on the opposite side.

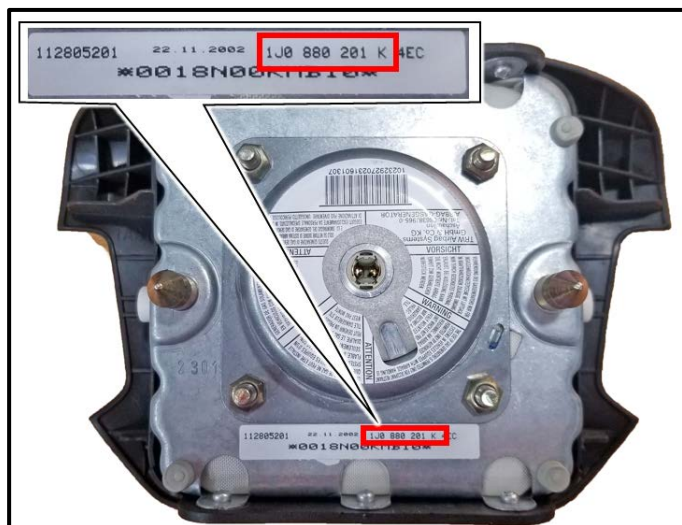
Criteria	Core Airbag Part Number
01 or 02	3B0.880.201.AS
03 or 04	1J0.880.201.E -or- 3B0.880.201.AQ

- Check driver frontal airbag part number.
- Compare the core part number <arrow> of the removed driver frontal airbag to the chart below.
- If the core part number of the fitted driver frontal airbag **does not match** the criterion and the part number in the table, or if the core part number **is not available**:
 - Take a clear photo of the airbag part number AND the bar code on the inflator.
 - Create a VTA WEB Ticket and wait for further direction.
- If the core part number of the fitted airbag unit matches the criterion and the core part number in the table:
 - **Proceed to Section E.**

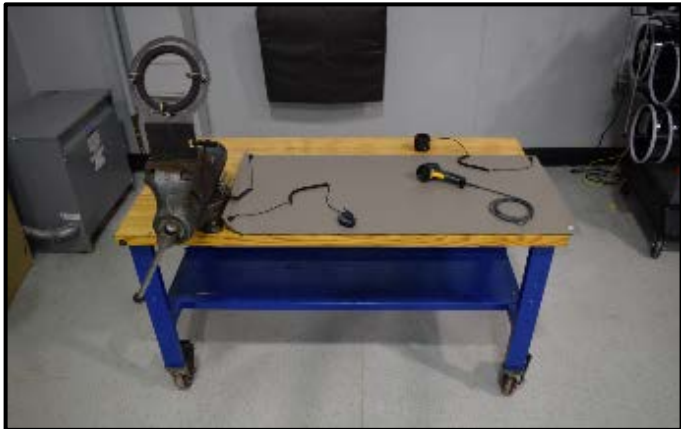
It is critical that a clean, uncongested work environment is utilized during the inflator replacement procedure. Extra tools, debris, etc... in the blast area of an airbag impose a danger in the event an airbag were to deploy. Ensure there are no loose components in the blast area of the airbag.

- Prior to beginning work, all parts and tools are to be placed on the ESD table mat.
- The workstation must be in the vicinity of the vehicle.

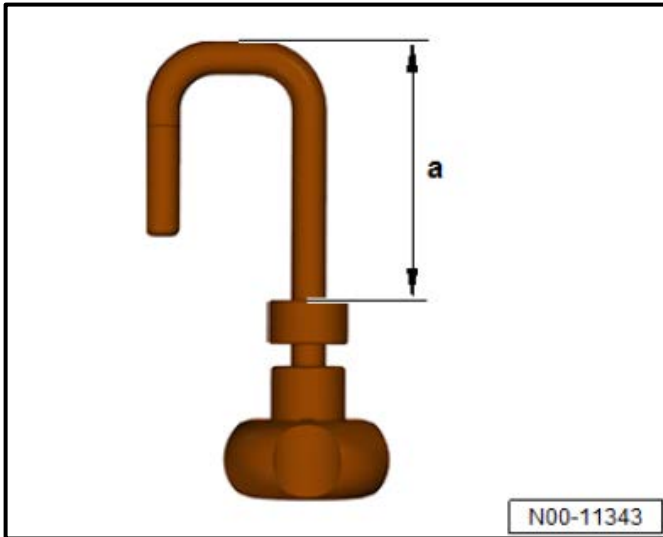
Adjust securing hooks:

- Adjust the knurled nuts of securing hooks to dimension <a> as follows:
 - Two hooks = 48 mm
 - One hook = 66 mm

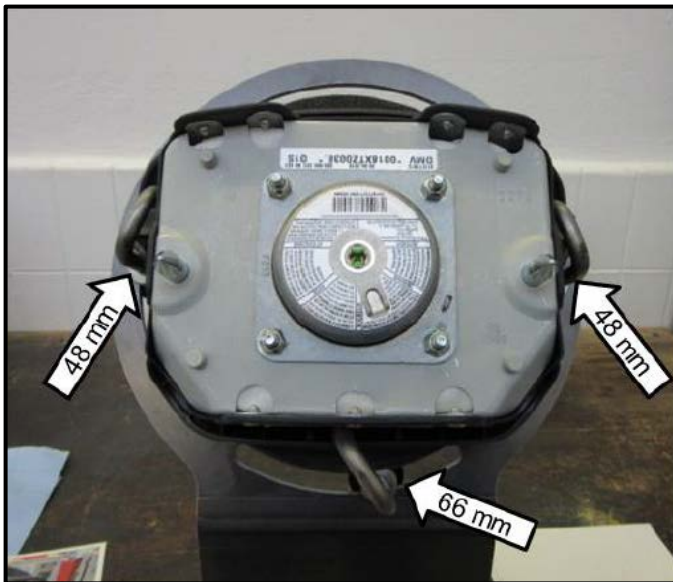
Clamp airbag into airbag support:

- Clamp airbag centrally in airbag support. There are securing points on the sides <arrows>, parallel, opposite each other, and at the bottom.

The clamps must be placed in the positions shown <arrows> to prevent damage to the airbag. Damage to the airbag is not covered under this action.

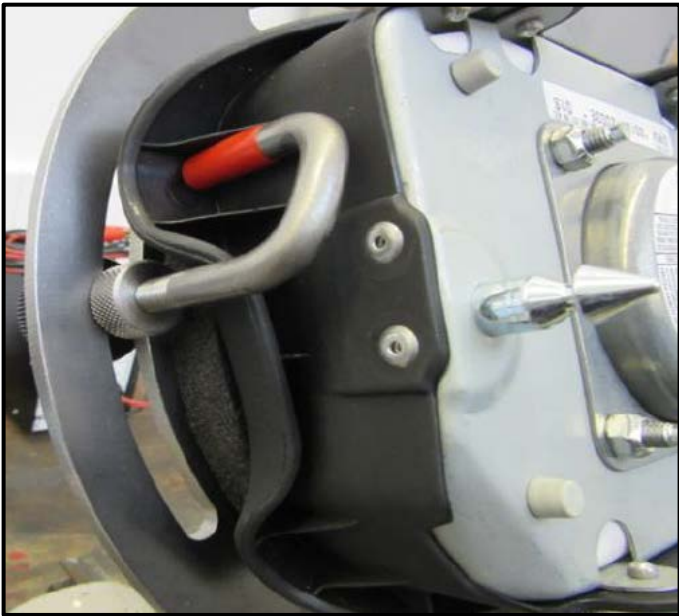
- Left mounting point = 48 mm.

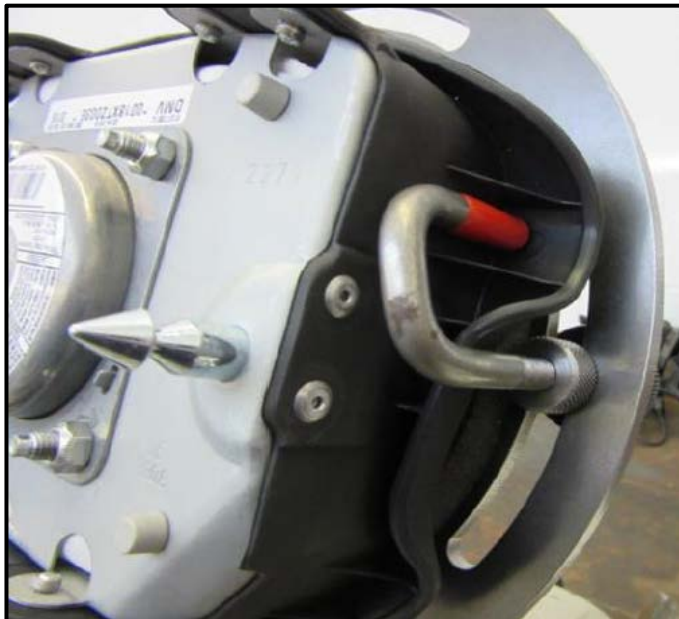
- Right mounting point = 48 mm.

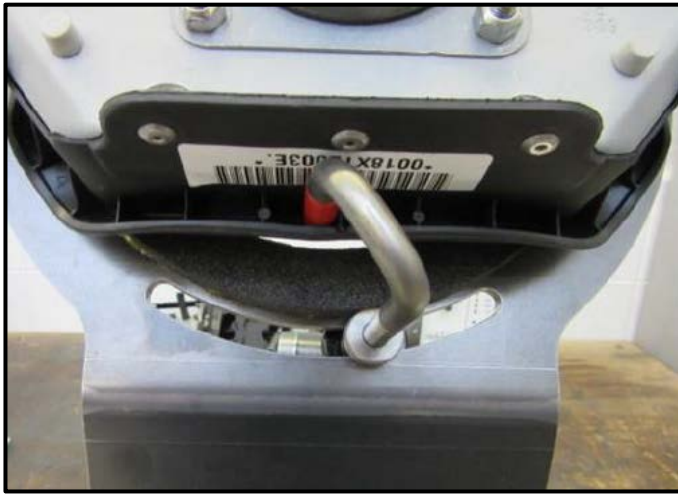
- Lower mounting point = 66 mm.

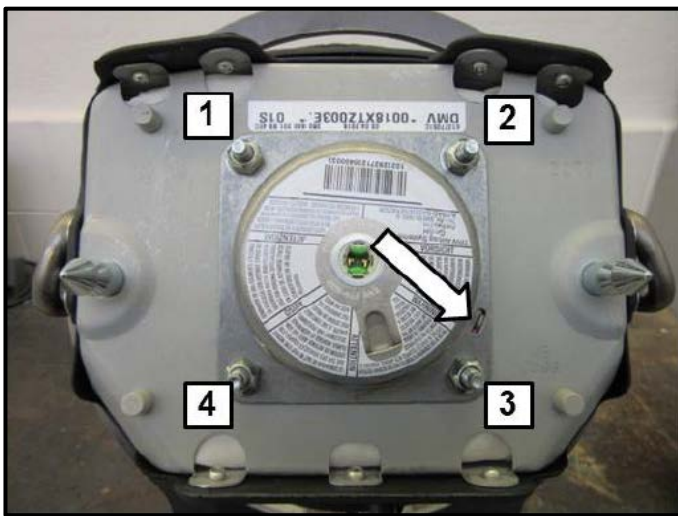
Replace inflator:

- Set the new inflator on the ESD mat.
- Remove the nuts <1 through 4>.
- Install the new inflator.
- The inflator only fits in one position. Observe the recess <arrow>.
- Install new nuts from the inflator kit and torque to 7 Nm in sequence 1 > 3 > 2 > 4.
- Place the removed inflator back into the original packaging and return to your parts department.

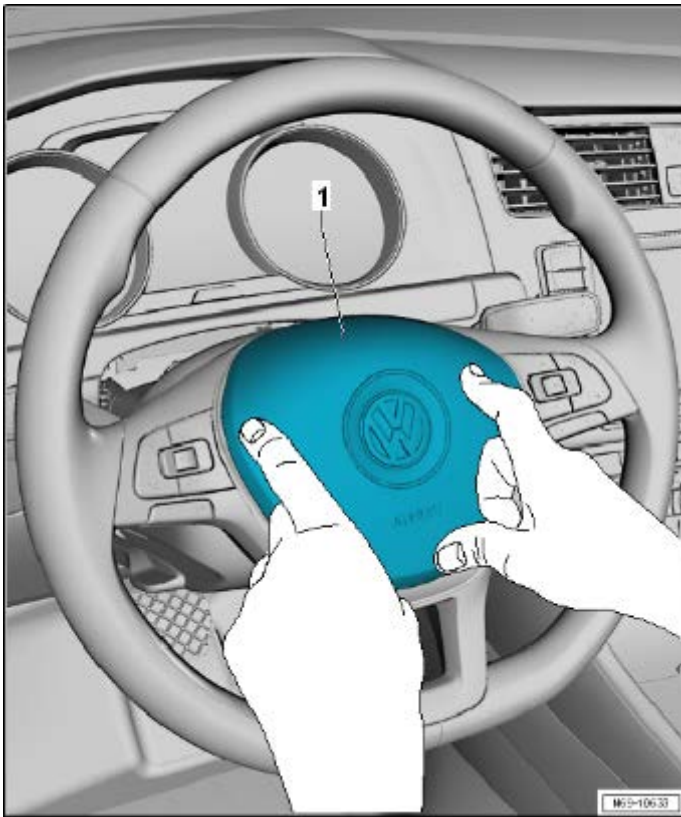
Install driver frontal airbag into vehicle:

- The battery must be disconnected before installing the airbag back into the vehicle.
 - Before handling pyrotechnic components (for example, disconnecting the connector), the person handling it must “discharge static electricity”. This can be done by touching the door striker, for example.
-
- Connect the connector to the airbag.
 - Press on the edge of the airbag unit <1> with both hands until it locks into place.
 - Gently pull on the airbag unit to make sure the airbag unit is secured correctly at all attachment points in the steering wheel.

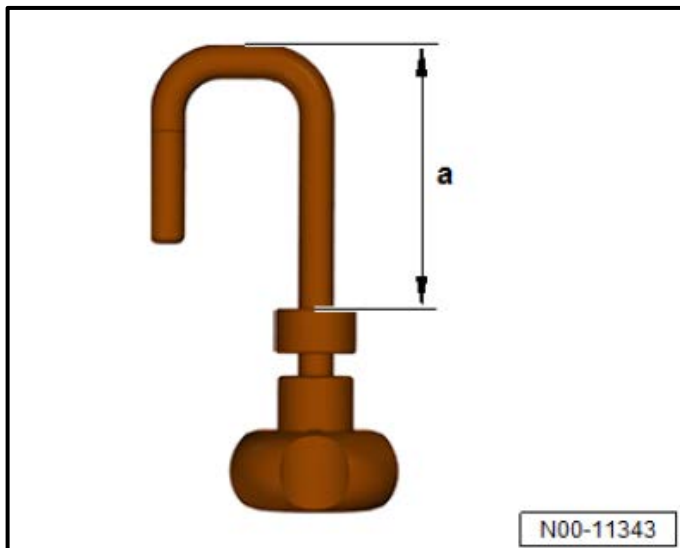
Adjust securing hooks:

- Adjust the knurled nuts of securing hooks to dimension <a> as follows:
 - Two hooks = 48 mm
 - One hook = 62 mm

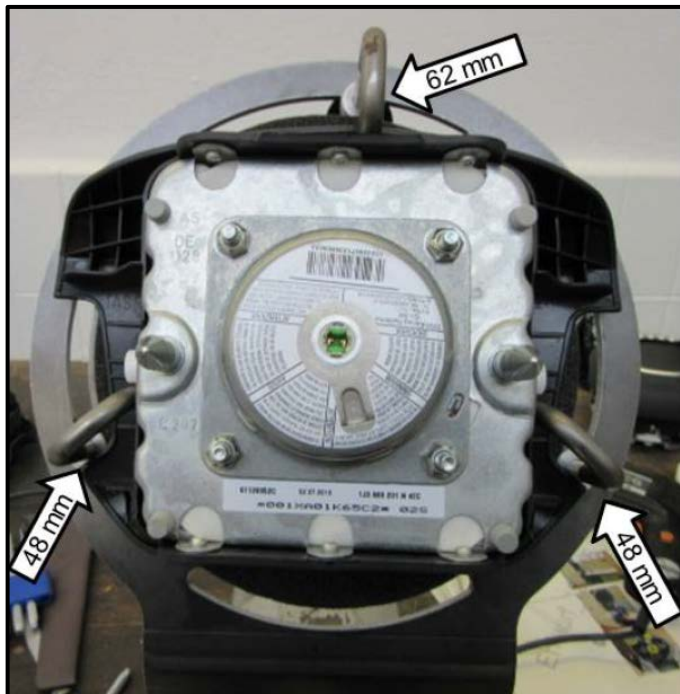
Clamp airbag into airbag support:

- Clamp airbag centrally in airbag support. There are securing points on the sides <arrows>, parallel, opposite each other, and at the top.

The clamps must be placed in the positions shown <arrows> to prevent damage to the airbag. Damage to the airbag is not covered under this action.

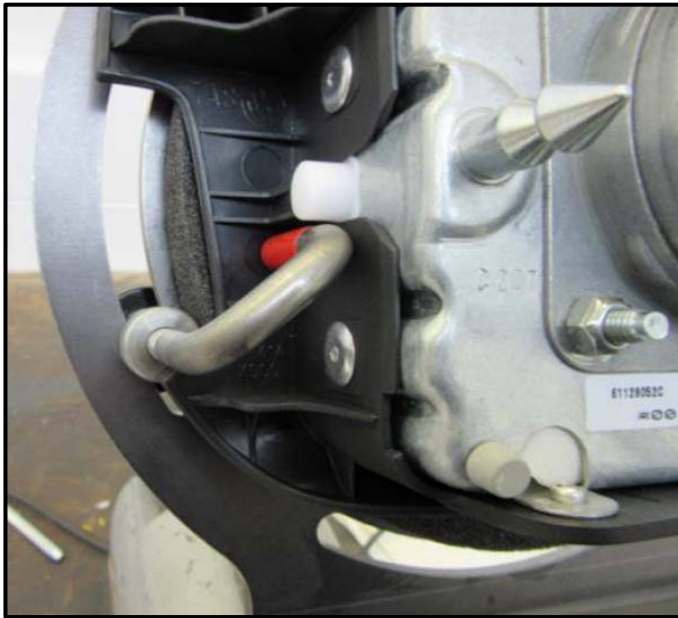
- Left mounting point = 48 mm.

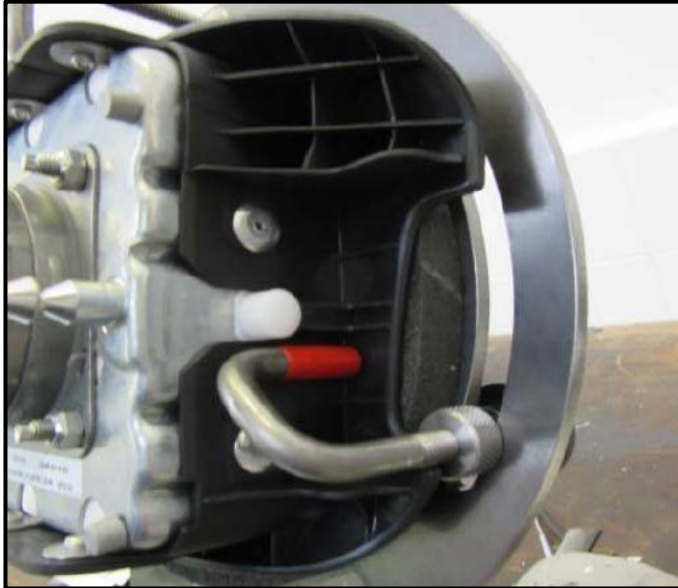
- Right mounting point = 48 mm.

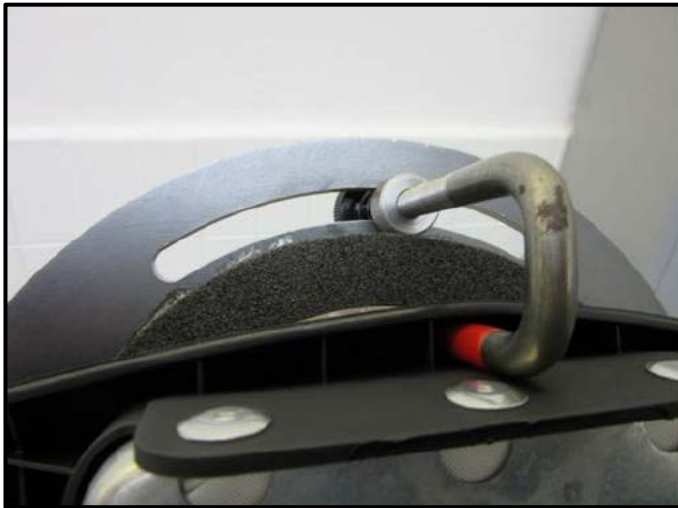
- Upper mounting point = 62 mm.

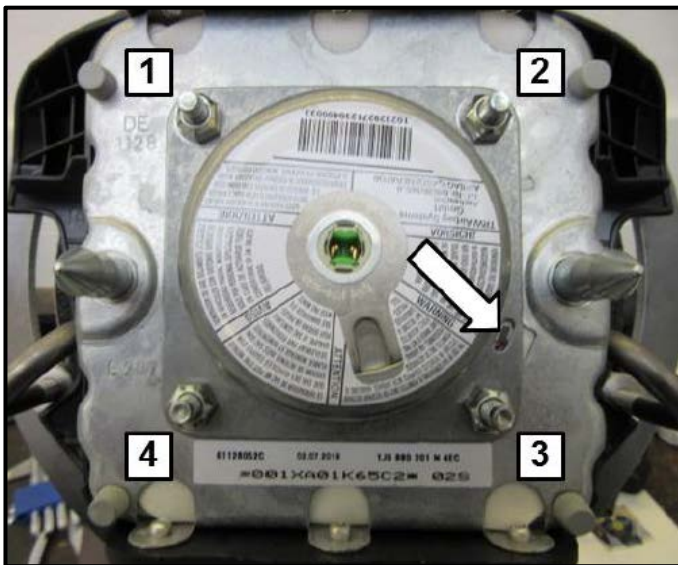
Replace inflator:

- Set the new inflator on the ESD mat.
- Remove the nuts <1 through 4>.
- Install the new inflator.
- The inflator only fits in one position. Observe the recess <arrow>.
- Install new nuts from the inflator kit and torque to 7 Nm in sequence 1 > 3 > 2 > 4.
- Place the removed inflator back into the original packaging and return to your parts department.

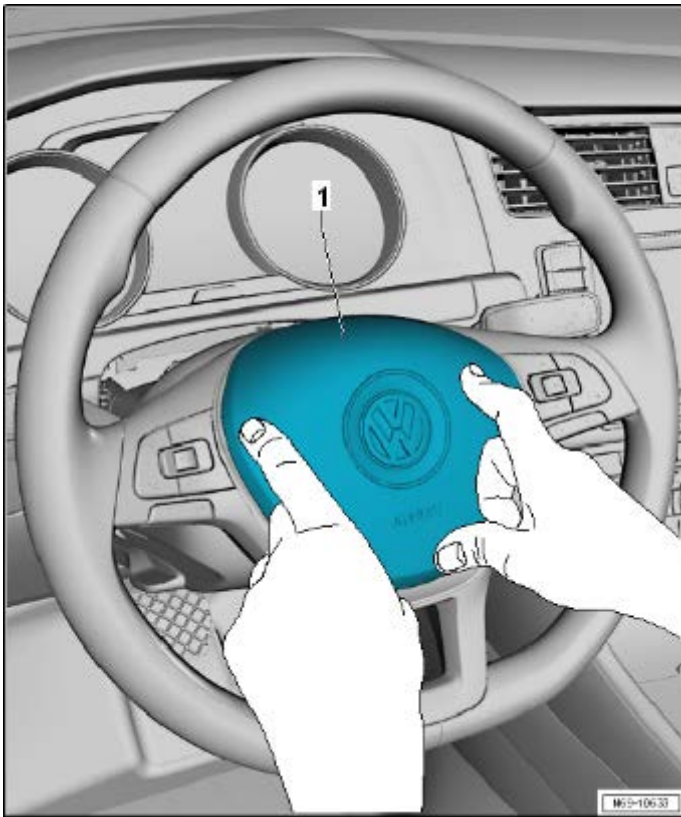
Install driver frontal airbag into vehicle:

- The battery must be disconnected before installing the airbag back into the vehicle.
 - Before handling pyrotechnic components (for example, disconnecting the connector), the person handling it must “discharge static electricity”. This can be done by touching the door striker, for example.
-
- Connect the connector to the airbag.
 - Press on the edge of the airbag unit <1> with both hands until it locks into place.
 - Gently pull on the airbag unit to make sure the airbag unit is secured correctly at all attachment points in the steering wheel.
