**June 21, 2018**

## Safety and Non-Compliance Recall: 2018 Civic Certification Label Missing Production Date

Supersedes 18-071, Non-Compliance Recall: 2018 Civic Certification Label Missing Production Date, dated June 15, 2018

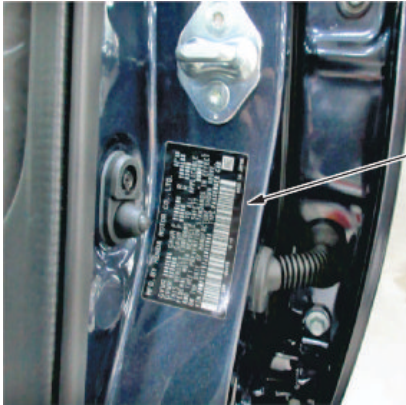
The certification label is located on the driver's side doorjam below the striker.

1. Open the driver's door, and locate the certification label.

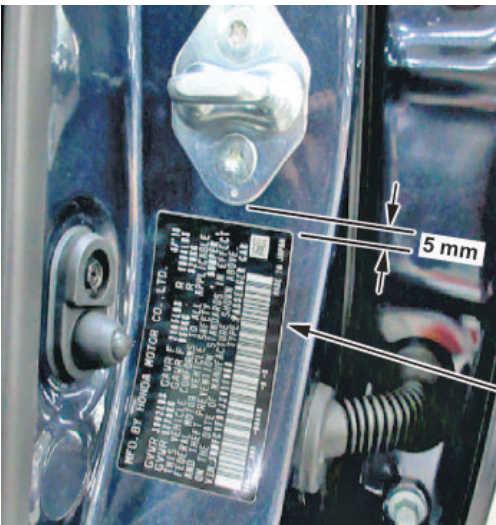
Mount the new label  
5 mm below the striker.

5. Apply the new certification label 5 mm below the striker. Make sure the label is applied in the same orientation as the removed label.

Make sure the label is properly applied to the body, and make sure there are no wrinkles, tears, or bubbles on the new label.
